MEMORANDUM 080513

To: Tracy Fogarty, Connecticut Department of Transportation
cc: Michael Milone, Town Manager, Town of Cheshire
Timothy Slocum, Town Council Chairman, Town of Cheshire
George Noewatne, Director of Public Works, Town of Cheshire
Neil Dryfe, Chief of Police, Town of Cheshire
Edgar Wynkoop, Connecticut Department of Transportation
From: Pat Gallagher, Regional Planner
Subject: Route 10 Signalized Intersection Safety Study

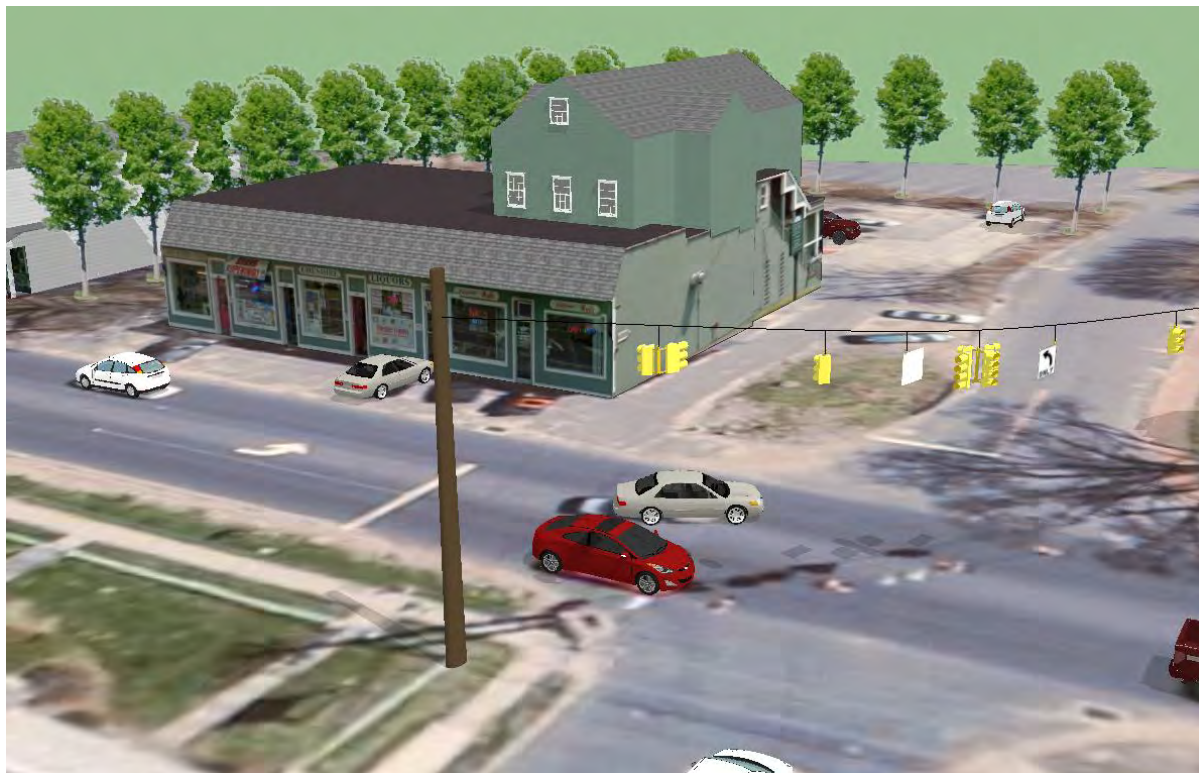
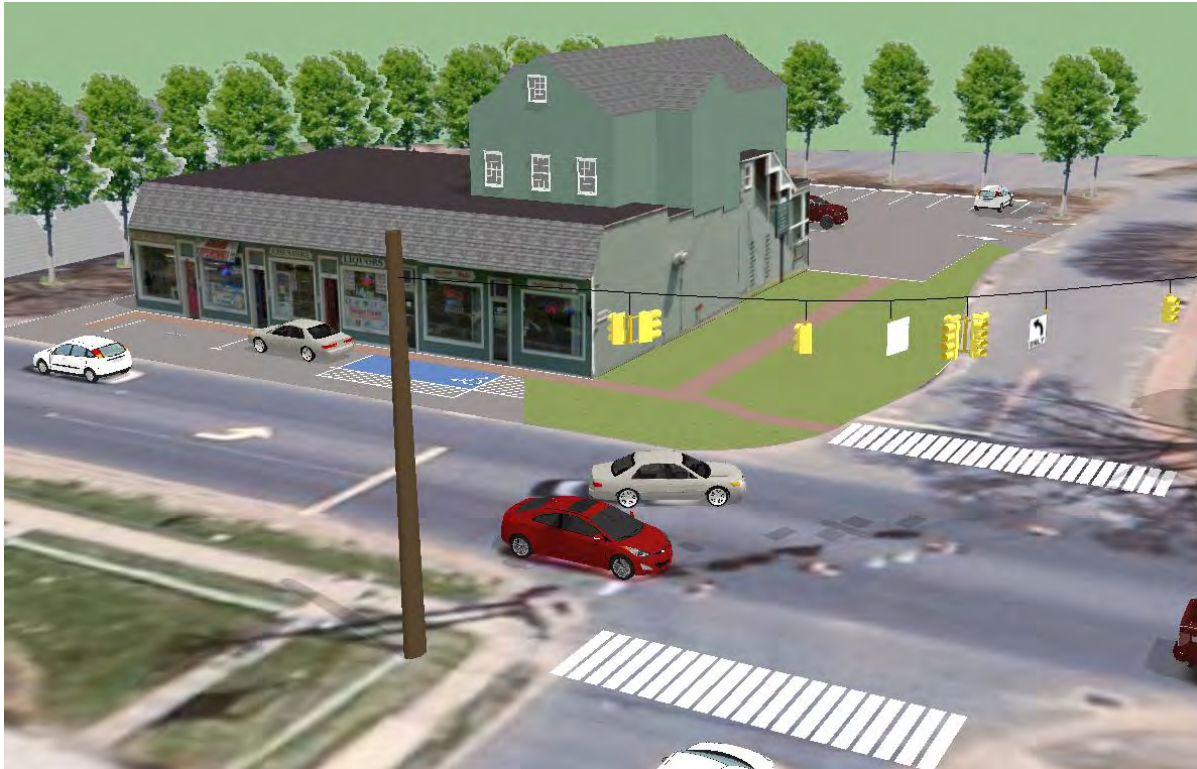
Figure 3. Improvement Option: Route 10 and Cornwall Ave Improvement Options

buffer between the parking spaces and the edge line of Route 10 NB. The 6 foot buffer is not adequate for backing vehicles, forcing them to back into the roadway. Reconfiguring the parking angle from 90 degrees (perpendicular to the curb) to 0 degrees (parallel to the curb) would help reduce the likelihood of backing collisions. The CMF Clearinghouse found that converting angled parking to parallel parking can reduce parking-related accidents by up to 65%. Parallel parking stalls would also leave adequate room for a sidewalk, eliminate the 120 foot gap in the sidewalk system, and reduce pedestrian conflicts. Suggested improvement options can be seen in Figure 3.

Install crosswalks across Cornwall Ave and Old Towne Rd. COGCNV staff observed 1 NB and 7 SB pedestrians during the AM peak (on a rainy day) and 9 NB and 9 SB pedestrians in the PM peak, all of which were crossing the street without a crosswalk. In 2008, a pedestrian crossing Cornwall Ave was hit by a vehicle turning right on red, resulting in an injury. Crosswalk markings provide guidance to pedestrians crossing roadways and increase driver awareness of pedestrians.

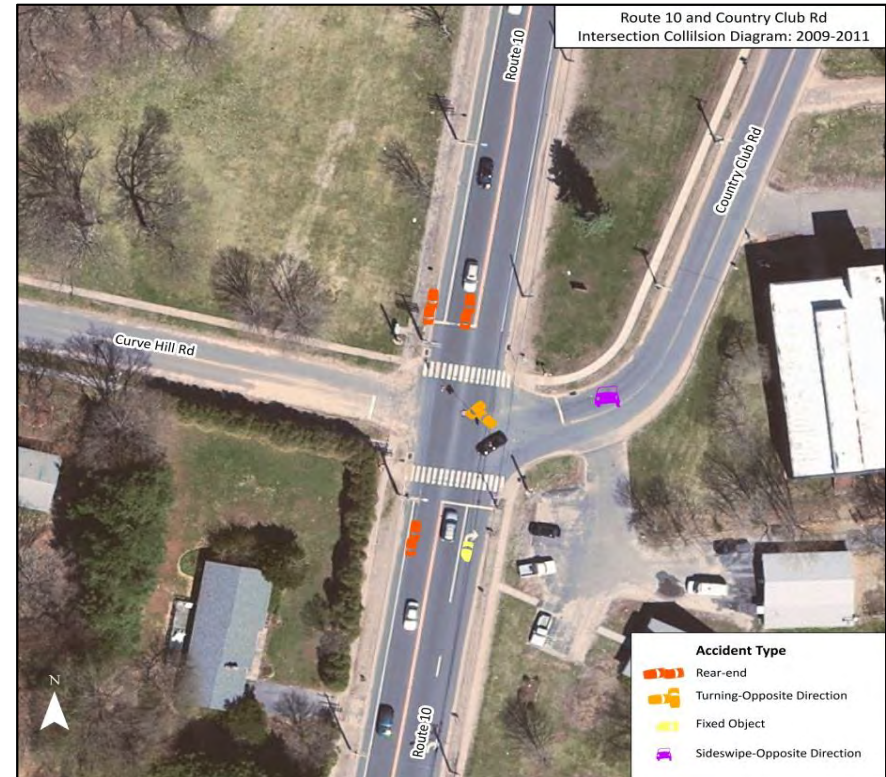
Figure A1. Intersection Collision Diagram: 2009-2011

The intersection of Route 10 and Country Club Rd saw 6 accidents between 2009 and 2011, 3 of which were rear-end collisions. All rear-end collisions occurred on Route 10 SB. The remaining accidents were turning-opposite direction, sideswipe-opposite direction, and fixed object accidents. The area adjacent to Country Club Rd is free of vegetation, and sightlines are good despite the horizontal curve. The curve on Country Club Rd slows down traffic which helps prevent high-speed collisions. COGCNV staff observed NB vehicles turning right onto Country Club Rd from Route 10 crossing the double yellow centerline into the oncoming lane. This maneuver resulted in a sideswipe-opposite direction collision in 2009. Vehicles turning right onto Country Club Rd may be making the turn too fast. A detailed examination of accidents occurring at the intersection of Route 10 and Country Club Rd can be seen in Appendix A.

While performing turning movement counts, COGCNV staff noticed that cars turning onto Country Club Rd from Route 10 were crossing over the double yellow line into the oncoming traffic lane and triggering the loop detector, causing the light to switch to the minor street phase even though no vehicles were present. The problem of vehicles crossing the double yellow line resulted in a sideswipe-opposite direction accident in 2009. The primary cause of the problem is that right turning vehicles are traveling too fast.

It is recommended that CT DOT re-examine the detector placement on Country Club Rd to see if there is a way to mitigate the unnecessary triggering of the detectors and subsequent delay. Another option would be to reduce the curb radius for vehicles turning right onto Country Club Rd. Reducing the turning radius is an effective way of slowing down right turning vehicles. A median island is not feasible on Country Club Rd because it would impede vehicles exiting the Campion Ambulance driveway, located just 40 feet from the intersection.

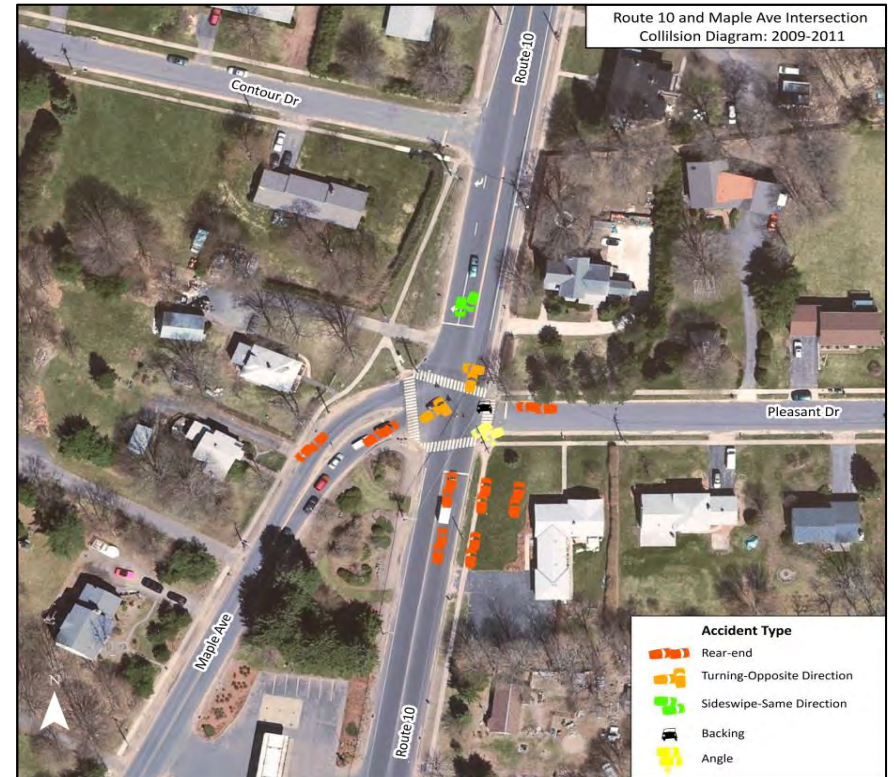
Figure B1. Intersection Collision Diagram: 2009-2011

The intersection of Route 10 and Maple Ave saw 13 accidents from 2009 to 2011, 12 of which occurred on Route 10. Rear-end accidents caused by drivers following too closely made up 61% of all accidents. 5 rear-end accidents occurred on Route 10 NB, 2 occurred on Maple Ave, and 1 occurred on Pleasant Dr. In addition, there were 2 turning-related accidents and 1 right angle collision. A detailed examination of accidents occurring at the intersection of Route 10 and Maple Ave can be seen in Appendix B.

There is no left turn lane or protected left turn phase on Route 10 NB. As a result, left turning vehicles cause delay to thru moving vehicles on Route 10 and may make unsafe turning maneuvers at the beginning or end of phases. CT DOT should investigate whether a left turn lane with or without a protected phase for NB vehicles on Route 10 turning onto Maple Ave is feasible.

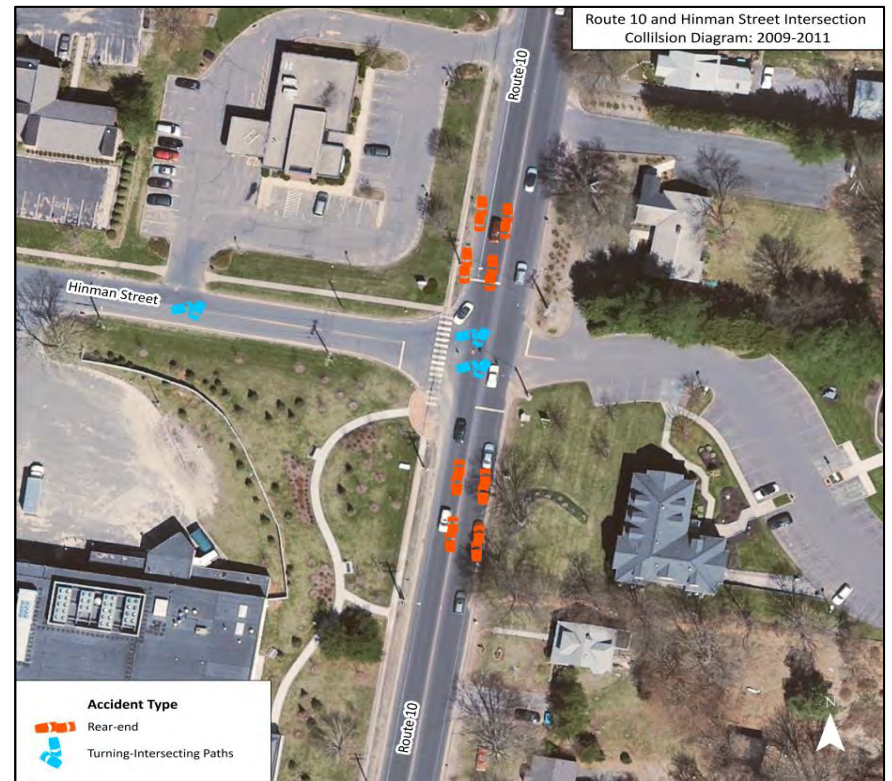
Figure C1. Intersection Collision Diagram: 2009-2011

The intersection of Route 10 and Hinman St saw 11 accidents from 2009 to 2011, 10 of which occurred on Route 10. 8 of the 10 accidents on Route 10 were rear-end collisions caused by vehicles following too closely. The remaining accidents were turning-intersecting path collisions caused by vehicles running red lights. A detailed examination of accidents occurring at the intersection of Route 10 and Hinman St can be seen in Appendix C.

While conducting turning movement counts during the PM peak hours, COGCNV staff observed numerous SB vehicles on Route 10 running red lights at the end phases. From 2009 to 2011, 2

turning-intersecting paths accidents occurred when SB vehicles on Route 10 ran a red light and collided with an EB or WB vehicle. One of these accidents resulted in injury. The all-red clearance phase is currently 1.8 seconds. It is recommended that CT DOT increase the all-red clearance interval to help prevent future collisions caused by vehicles running red lights.

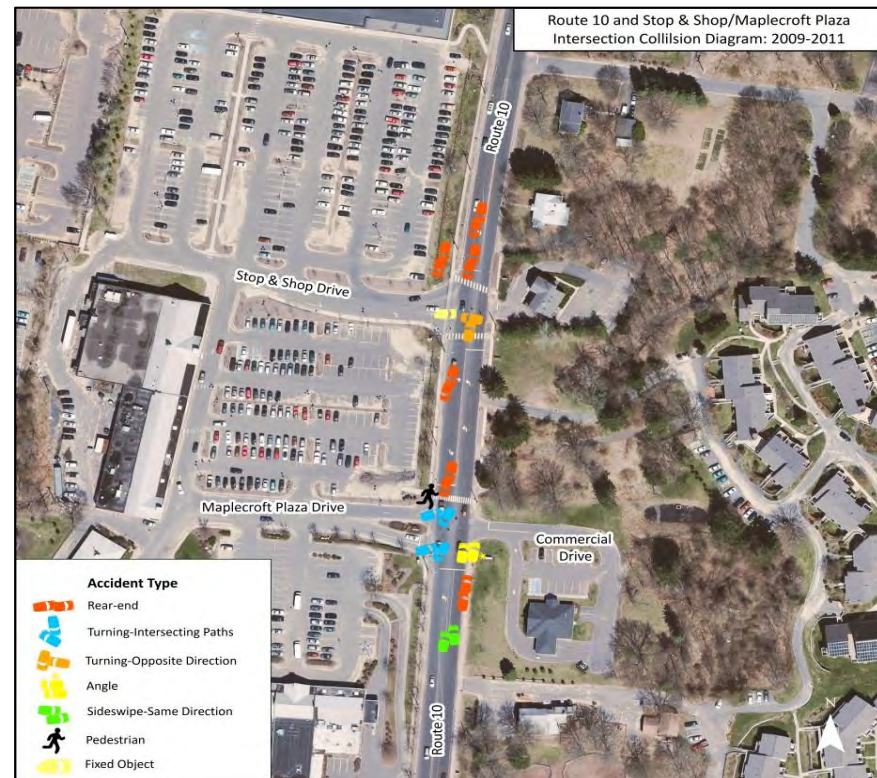
Figure D1. Intersection Collision Diagram: 2009-2011

The two intersections saw a combined 13 accidents from 2009 to 2011 with 6 occurring at the Stop & Shop plaza intersection and 7 occurring at the Maplecroft Plaza/Liberty Bank intersection. Rear-end accidents (46%) caused by vehicles following too closely were the most frequent type of accident. Turning related accidents made up an additional 23% of accidents. In 2009 an EB pedestrian was hit by a SB vehicle that violated the traffic control, resulting in an injury. A detailed examination of accidents occurring at the intersections of Route 10 and Stop & Shop and Maplecroft Plaza/Liberty Bank can be seen in Appendix D.

From 2009 to 2011, there were 3 turning-related and 1 right angle accidents at the intersections of Route 10, Stop & Shop and Maplecroft Plaza/Liberty Bank. The minor street phase at Stop & Shop Plaza has a 1.2 second all-red clearance interval while Maplecroft Plaza/Liberty Bank has a 2 second all-red clearance interval. It is recommended that the minor street phase all-red clearance interval at Stop & Shop plaza be increased from 1.2 seconds to 2 seconds to prevent future turning-related accidents. The Crash Modification Factor (CMF) Clearinghouse shows that increasing the all-red clearance interval reduced right angle, head on, and sideswipe collisions by up to 40%.

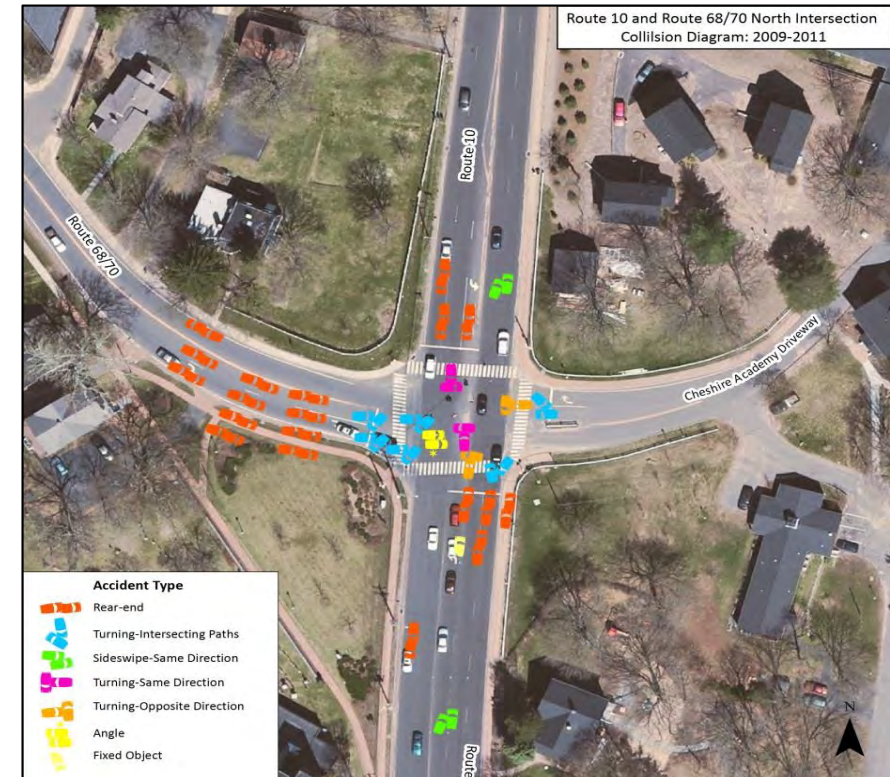
Figure E1. Intersection Collision Diagram: 2009-2011

The northern junction of Route 10 and Route 68/70 is listed on CT DOT's SLOSS list, indicating that it experiences an abnormally high accident rate. From 2009 to 2011, 34 accidents occurred at the intersection with 18 occurring on Route 10 and 16 occurring on Route 68/70. The most common types of accidents were rear-end accidents (56%), turning-intersecting paths (18%) and fixed object (11.8%). 37.5% of accidents on Route 10 were turning-opposite direction accidents where turning vehicles failed to grant right-of-way. Vehicles following too closely made up half of the total accidents at the intersection and 72.2% of accidents on Route 68/70. Poor sightlines on the EB approach contribute to the frequency of rear-end collisions. Route 68/70 was realigned in the 1990s to line up with the Cheshire Academy Driveway. While it

A short-term option involves improving signage and installing a flashing beacon on the EB leg of Route 68/70. The Manual on Uniform Traffic Control Devices (MUTCD) recommends that a traffic signal with an 85th percentile approach speed of 35 mph should have a minimum sight distance of 325 feet. The Route 68/70 EB approach does not meet the minimum sight distance requirement. MUTCD recommends that signals with inadequate sight distance be supplemented with warning signs and flashing beacons. The flashing beacon may be interconnected with the traffic signal controller to alert road users of a red light or queue ahead. The Crash Modification Factor (CMF) Clearinghouse found that dynamic flashing beacons can reduce rear-end collisions at signalized intersections by over 20%. Additional signage such as chevron signs may also help improve driver awareness around the horizontal curve and reduce speeds.

A long-term improvement option involves adding a channelized right turn to the EB approach of Route 68/70. A channelized right turn would straighten out the approach and dramatically improve traffic signal sight distance (Figure 2). 98% of peak hour vehicles using the EB approach of Route 68/70 turn right onto Route 10 SB. While this improvement option would reduce rear-end collisions, it may encourage motorists to drive faster through the intersection, resulting in higher-speed collisions, and creating a more hazardous environment for crossing pedestrians.

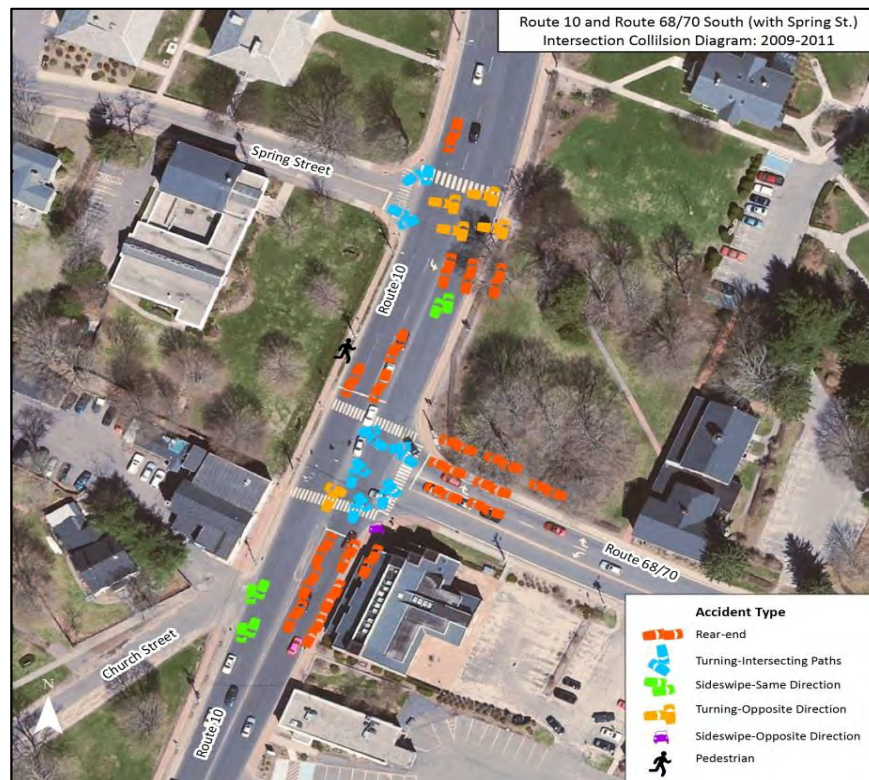
Figure F1. Intersection Collision Diagram: 2009-2011

The southern junction of Route 10 and Route 68/70 saw 30 accidents from 2009 to 2011 with an additional 11 occurring at the intersection of Route 10 and Spring Street. Rear-end collisions caused by vehicles following too closely made up 54% of accidents. 32% of accidents involved turning vehicles. Despite the peak hour left turn prohibition, 6 turning-related accidents occurred at the intersection of Route 10 and Spring Street, 5 of which were outside of peak hours, and 4 of which resulted in injury. A detailed examination of accidents at the southern junction of Route 10 and Route 68/70 and Spring St can be seen in Appendix F.

Despite a peak hour left turn prohibition on Route 10 NB, there were still 6 turning-related crashes at the intersection of Route 10 and Spring St between 2009 and 2011. COGCNV staff recommends implementing a full time left turn prohibition for NB vehicles on Route 10 turning onto Spring St and for EB vehicles on Spring St turning onto Route 10 NB. Both of these turning movements have poor sightlines and have to cross over three lanes of SB traffic. “No Left Turn” signs should be installed on both Spring St and Route 10. The MUTCD recommends that signs should be installed above the roadway, at the far left hand corner of the intersection, or in conjunction with a stop sign. The “No Left Turn” sign on Spring St should be mounted on the stop sign, while the peak hour prohibition sign on Route 10 should be removed from below the “No Left Turn” sign that is positioned at the entrance to Spring St. Placing a “No Left Turn” sign over the left lane of Route 10 NB would be the most effective way of communicating the turning prohibition to drivers. To supplement the signs, a solid double yellow line should be painted on Route 10 to indicate the turning restriction. Preventing left turns onto Spring Street could also help reduce rear-end collisions on Route 10 NB.

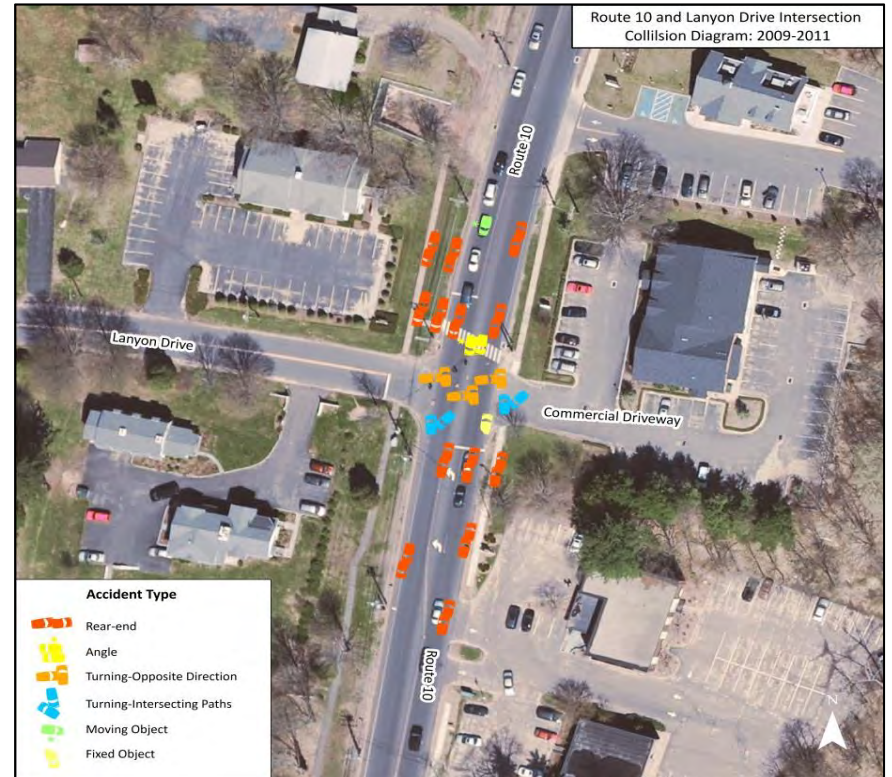
Figure H1. Intersection Collision Diagram: 2009-2011

The intersection saw 19 accidents from 2009 to 2011, all of which occurred on Route 10. Rear-end accidents were the most prevalent (58%) followed by Turning-Opposite Direction (16%) and Turning-Intersecting Paths (11%). Despite the presence of a left turn lane on Route 10 NB, vehicles turning left onto Lanyon Dr do not have a protected left turn. 3 of the 4 turning-related accidents involved vehicles on Route 10 trying to turn left. While conducting turning-movement counts, COGCNV staff observed several NB left turning vehicles fail to yield to oncoming traffic at the beginning and end of phases. A detailed examination of accidents at the intersection of Route 10 and Lanyon Dr can be seen in Appendix H.

COGCNV staff counted 26 vehicles in the AM peak hour, and 41 vehicles in the PM peak hour turning left onto Lanyon Dr from Route 10. Because there is no protected left turn, staff observed many left-turning vehicles failing to yield to oncoming traffic, or turning after the signal turned red. It is recommended that CT DOT add a leading left turn phase in the Route 10 NB left turn lane to prevent future turning-related accidents.

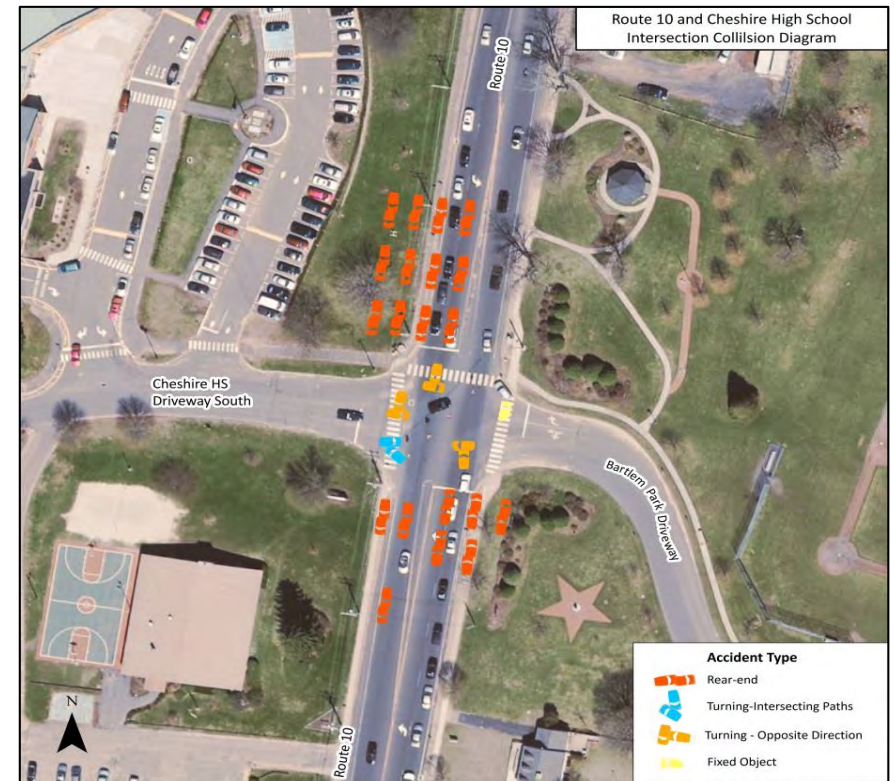
Figure I1. Intersection Collision Diagram: 2009-2011

The intersection of Route 10 and Cheshire High School is a high accident location that saw 25 accidents from 2009 to 2011. 80 percent of accidents were rear-end accidents caused by vehicles following too closely. The remaining accidents were turning-related (16%) and fixed object (4%). 15 of the 20 rear-end accidents occurred on Route 10 SB. The prevalence of rear-end accidents suggests that cars are accelerating through the intersection as the light is turning red, or that traffic is backed up downstream of the traffic signal. Congestion at the intersection increases driver frustration, and may encourage motorists to rush through the intersection at the end a traffic signal phase. A detailed examination of accidents at the intersection of Route 10 and Cheshire High School can be seen in Appendix I.

Prohibit right turns on red for all legs of the intersection. The right turn prohibition could be implemented full-time, or part-time to coincide with school hours. The intersection of Route 10 and Cheshire High School has a very high level of pedestrian traffic (121 in the AM peak and 46 in the PM peak). Prohibiting right turns on red minimizes pedestrian-vehicle conflicts. The MUTCD recommends that “No Turn on Red” signs be installed near the appropriate signal head. Because there are no right turn lanes on Route 10, the effect on traffic congestion should be minimal. Pedestrian safety can also be improved by installing new pedestrian signals. The existing signals contain the text “Walk” and “Don’t Walk” rather than the “Walking Person” and “Upraised Hand” symbols that are required for new signals. In addition, the signals are not lit by LEDs, resulting in poor visibility. The MUTCD recommends that pedestrian signals with pedestrian change intervals greater than 7 seconds use a countdown display to inform pedestrians of the number of seconds remaining in the change interval. The pedestrian phase at the intersection has a 17 second pedestrian change interval. Finally, detectable warning surfaces, as specified in the *Americans with Disabilities Act Accessibility Guidelines*, should be placed on all curb ramps at the intersection. Detectable warning surfaces are textured surface indicators that assist pedestrians who are visually impaired.

A long term improvement option would involve adding additional storage capacity to the intersection. The *Connecticut Route 10 Land Use & Traffic Study*, conducted in 1996, recommended that Route 10 be widened to two lanes in each direction plus turning lanes in the vicinity of Cheshire High School. While this would improve traffic operations, it may have detrimental impacts on pedestrians and bicyclists.

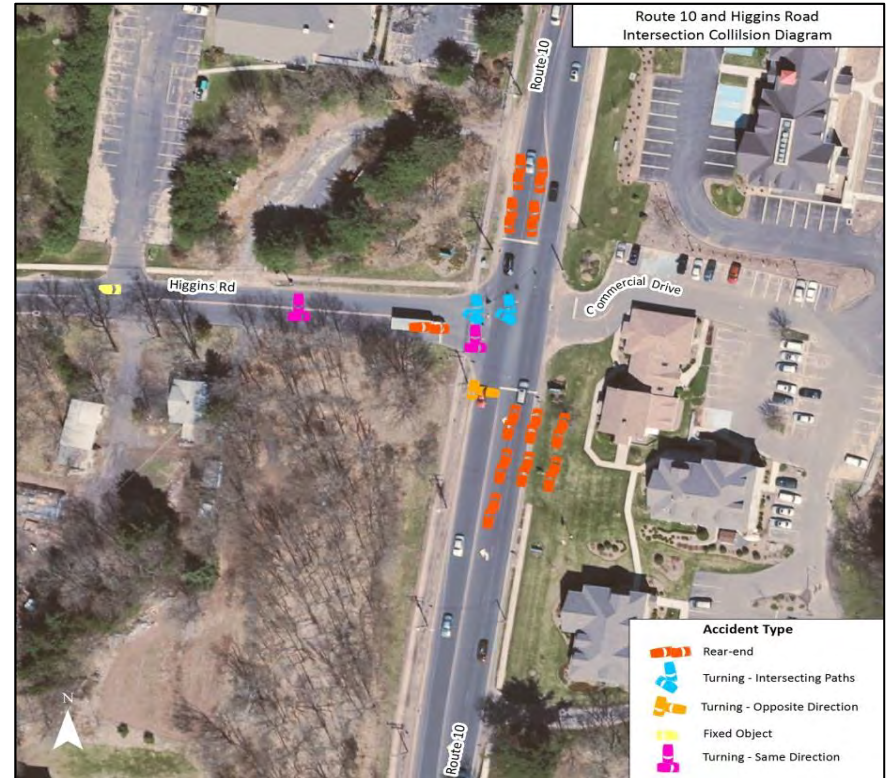
Figure J1. Intersection Collision Diagram: 2009-2011

The intersection of Route 10 and Higgins Rd saw 18 accidents from 2009 to 2011 with 16 occurring on Route 10 and 2 on Higgins Rd. 75% of accidents on Route 10 were rear-end collisions caused by vehicles following too closely. The remaining four accidents involved turning vehicles. A detailed examination of accidents at the intersection of Route 10 and Higgins Rd can be seen in Appendix J.

While conducting turning movement counts during the PM peak, staff observed cars on Route 10 NB queuing from Cheshire High School all the way to Higgins Rd. Coordinating the two traffic signals may help reduce congestion. In addition, the stretch of Route 10 between Higgins Rd and Elmwood Dr has a very narrow shoulder. Vehicles trying to make left turns into driveways along this stretch of roadway often block thru vehicles while waiting for a gap in traffic, resulting in an increased likelihood of rear-end collisions. Installing a 4 to 6 foot shoulder would allow thru traffic to pass left turning vehicles safely and help reduce congestion and rear-end collisions.

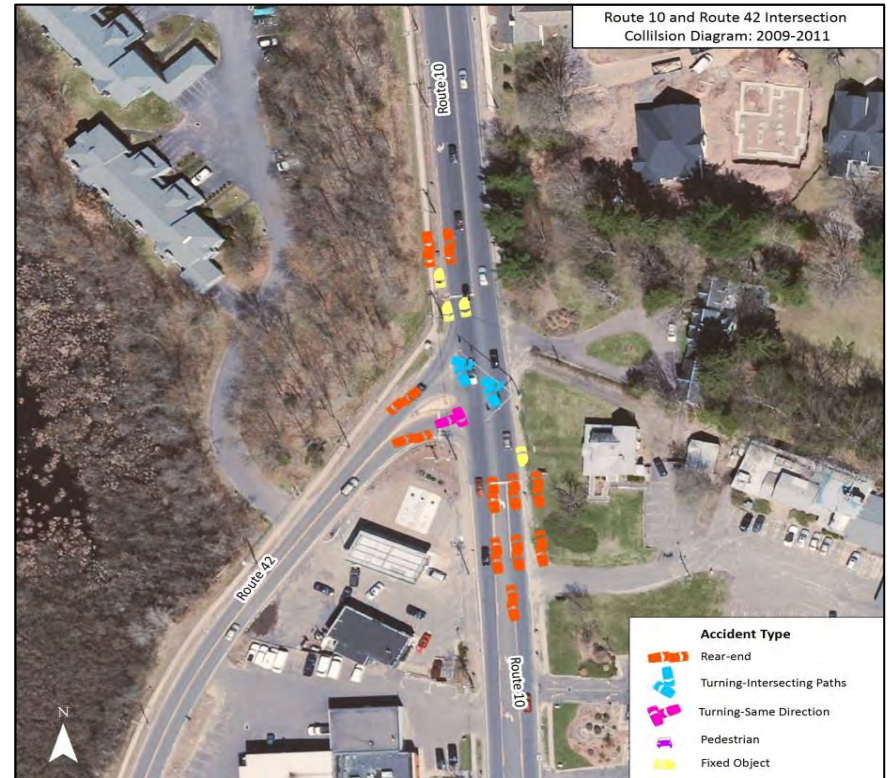
Figure K1. Intersection Collision Diagram: 2009-2011

The intersection is on CT DOT's SLOSS list indicating that it has an abnormally high accident rate. From 2009 to 2011, the intersection saw 18 accidents. Rear-end accidents (72%) were the most common type of accident followed by right angle (11%) and fixed object (11%) collisions. All of the rear-end accidents were caused by vehicles following too closely suggesting that vehicles may be rushing through the intersection at the end of the cycle.

The intersection of Route 10 and Route 42 has a high rate of fixed-object collisions. Three fixed-object collisions involved turning vehicles hitting the raised median on Route 42, two of which occurred at night. The raised median contains retroreflective pavement markers. However, increasing the retroreflectivity could result in additional safety improvements. COGCNV staff recommends that CT DOT increase the retroreflectivity of the markers and paint the median with retroreflective paint. The CMF Clearinghouse found that increasing pavement marking retroreflectivity helped reduce fixed-object collisions. In addition, the median object marker (which is currently facing WB) should be re-oriented towards NB and SB traffic to improve visibility to drivers.

Reducing congestion may also result in safety improvements. The intersection of Route 10 and Route 42 operates at LOS C in the AM and LOS D in the PM. Driver frustration caused by congestion may contribute to the high frequency of rear-end collisions. A traffic signal analysis performed using Synchro revealed that optimizing signal timing would improve operations to LOS B in the AM and LOS C in the PM. Signal optimization would increase the green time for thru vehicles on Route 10 and decrease green time for vehicles on Route 42 and left turning vehicles on Route 10 NB.
