Re: Kinneytown Hydroelectric Project, No. P-6985-005 and -006

The Naugatuck Valley Council of Governments, Save the Sound, and the Naugatuck River Revival Group (collectively, "Commenters") hereby provide the Commission with an updated assessment of on-site operating conditions at the Kinneytown Hydroelectric Project (the "Project"), owned by Hydroland Omega, LLC ("Hydroland"). Commenters wish to inform the Commission of the specific, ongoing failures by Hydroland to comply with action deadlines set by the Commission, natural resource agencies, or even deadlines self-imposed by Hydroland. This assessment provides the Commission with a factual update following the Commenters' last filed observations (December 8, 2021) and, crucially, informs the Commission of what the Commenters are able to externally observe regarding compliance with the directives contained in the Commission's December 22, 2021 Order and prior communications.

## **Downstream fish passage observations at Kinneytown Dam and Ansonia Bypass**

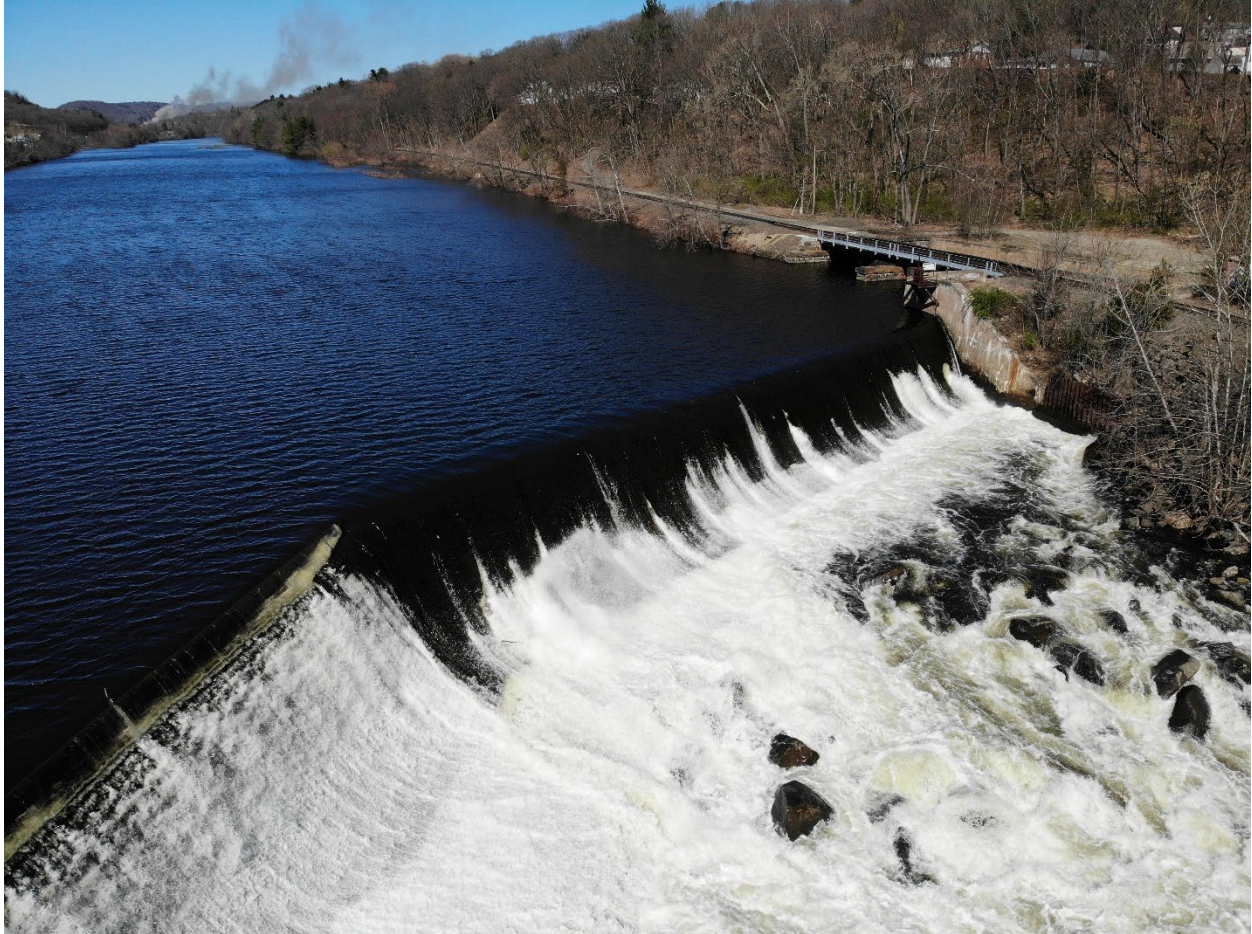
a. The boat boom has not been repaired or replaced.

Current status: Hydroland did not provide any further updates on this task in its March 14, 2022 status report.<sup>4</sup> As of April 20, 2022, the broken boat barrier that previously was draped over the face of the dam has been removed. However, no replacement boat barrier has been installed to effectively protect river users. See Appendix I, Photo 1. Commenters cannot speak to whether Hydroland has obtained bids for this task. Any further delays of this task pose significant and unacceptable risk to the safety of river users.

Current status: Hydroland did not provide any further updates on this task in its March 14, 2022 status report.<sup>9</sup> As of April 20, 2022, no flashboards have been installed on the east side of the dam. See Appendix I, Photos 1 and 2.

Photo 1: No boat barrier; no crestboards on east side of dam. (A. Budris, 4/20/22)

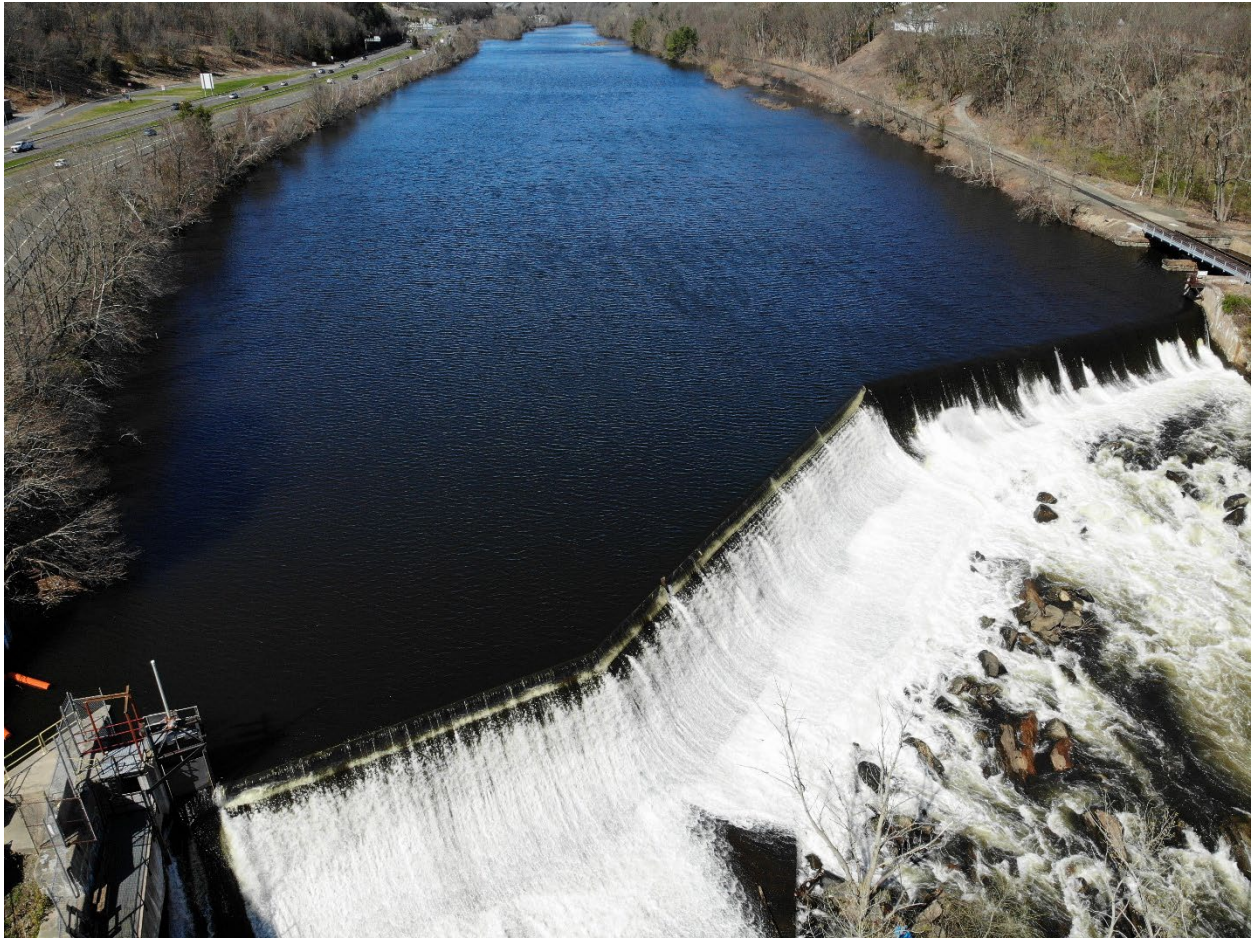
Photo 2: No crestboards on east side of dam. (A. Budris, 4/20/22)

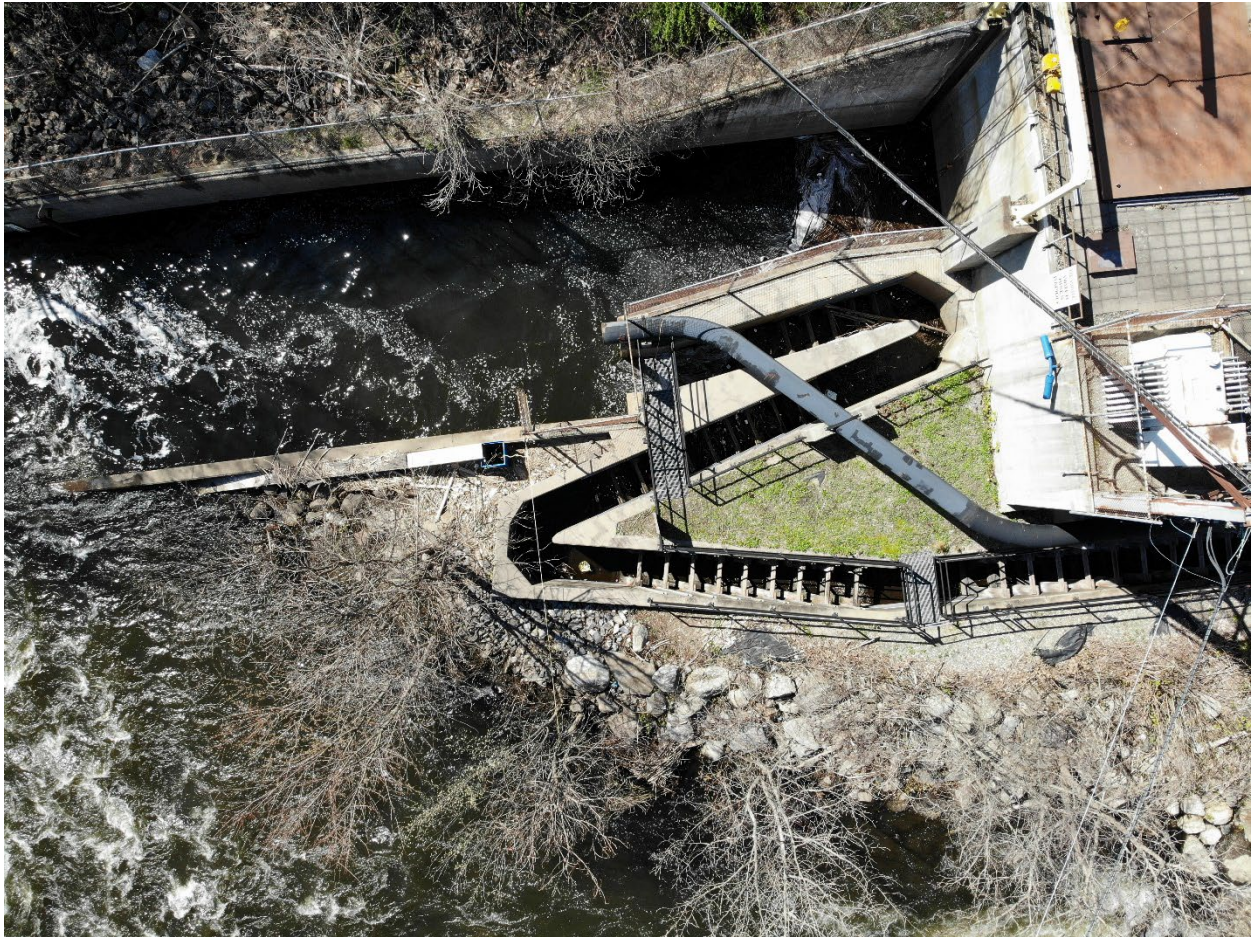
As of April 20, 2022, it is our understanding from site observations and river flow conditions that Unit 1 is still not in operation: no flow was observed exiting Unit 1, and all flow appeared to be spilling over the face of the dam. See Appendix I, Photos 3, 4, 6, and 8.

As stated above, as of April 23, 2022, the fish ladder has not been opened for the spring fish run, in order to facilitate this engineering assessment. See Appendix I, Photos 3-8, However, there has been no documentation of any contracted, scheduled, or actual activities towards the completion of this assessment provided to the agencies or FERC.

Photo 3: No flow out of Unit 1; fish ladder dewatered and closed. (A. Budris, 4/20/22)

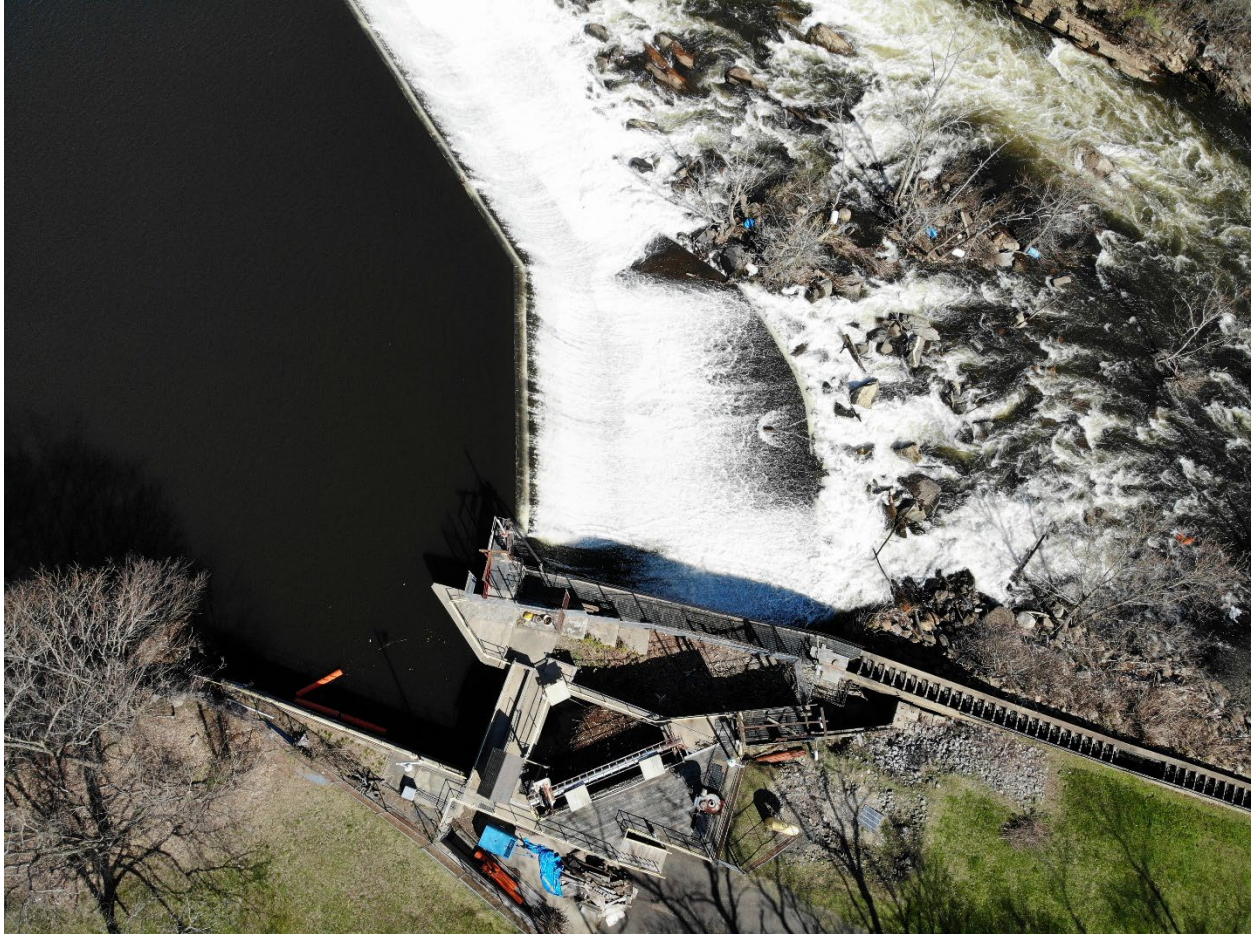
Photo 4: No flow into Unit 1; dewatered and closed fish ladder; all flow over face of dam. (A. Budris, 4/20/22)

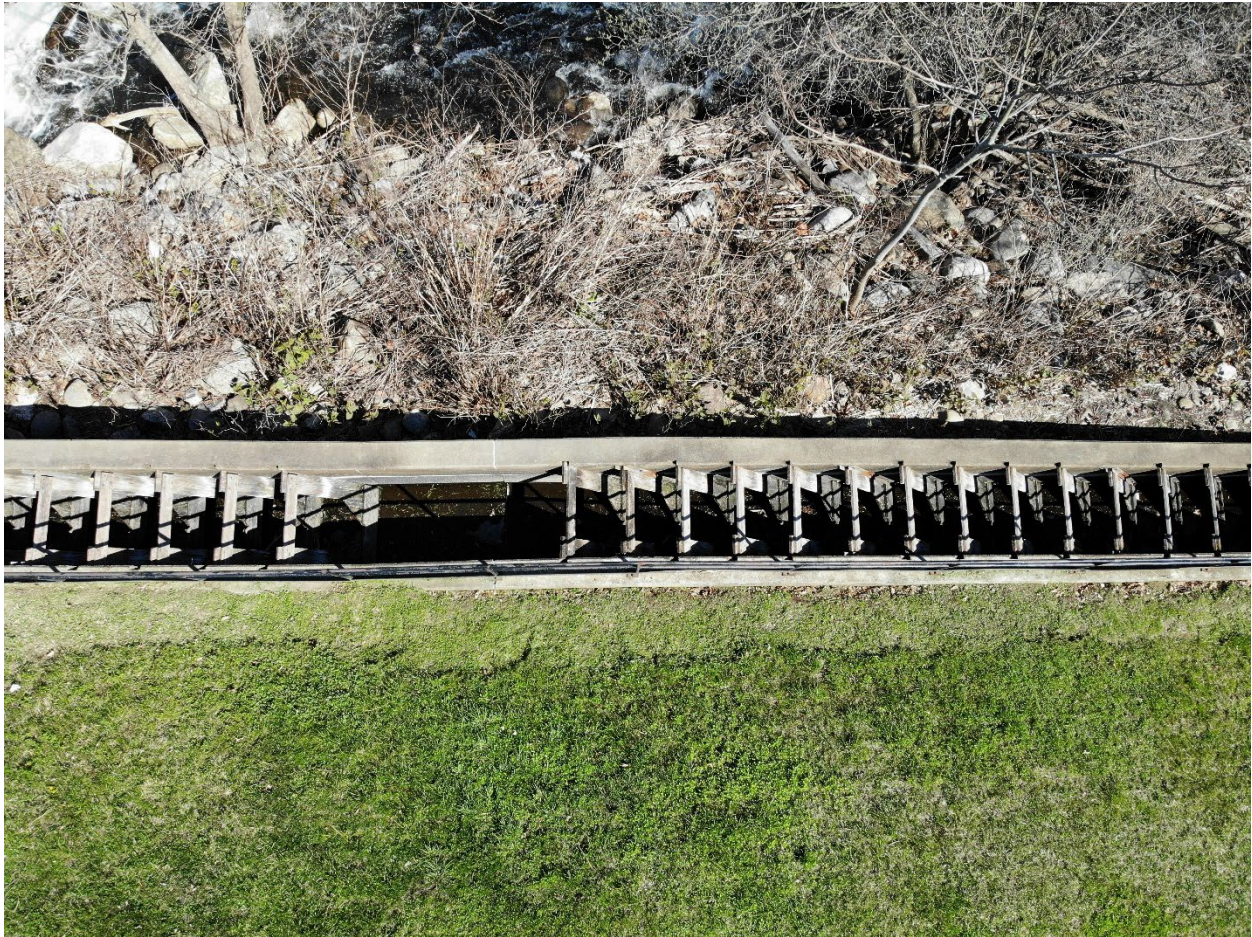
Photo 5: Dewatered fish ladder. (A. Budris, 4/20/22)

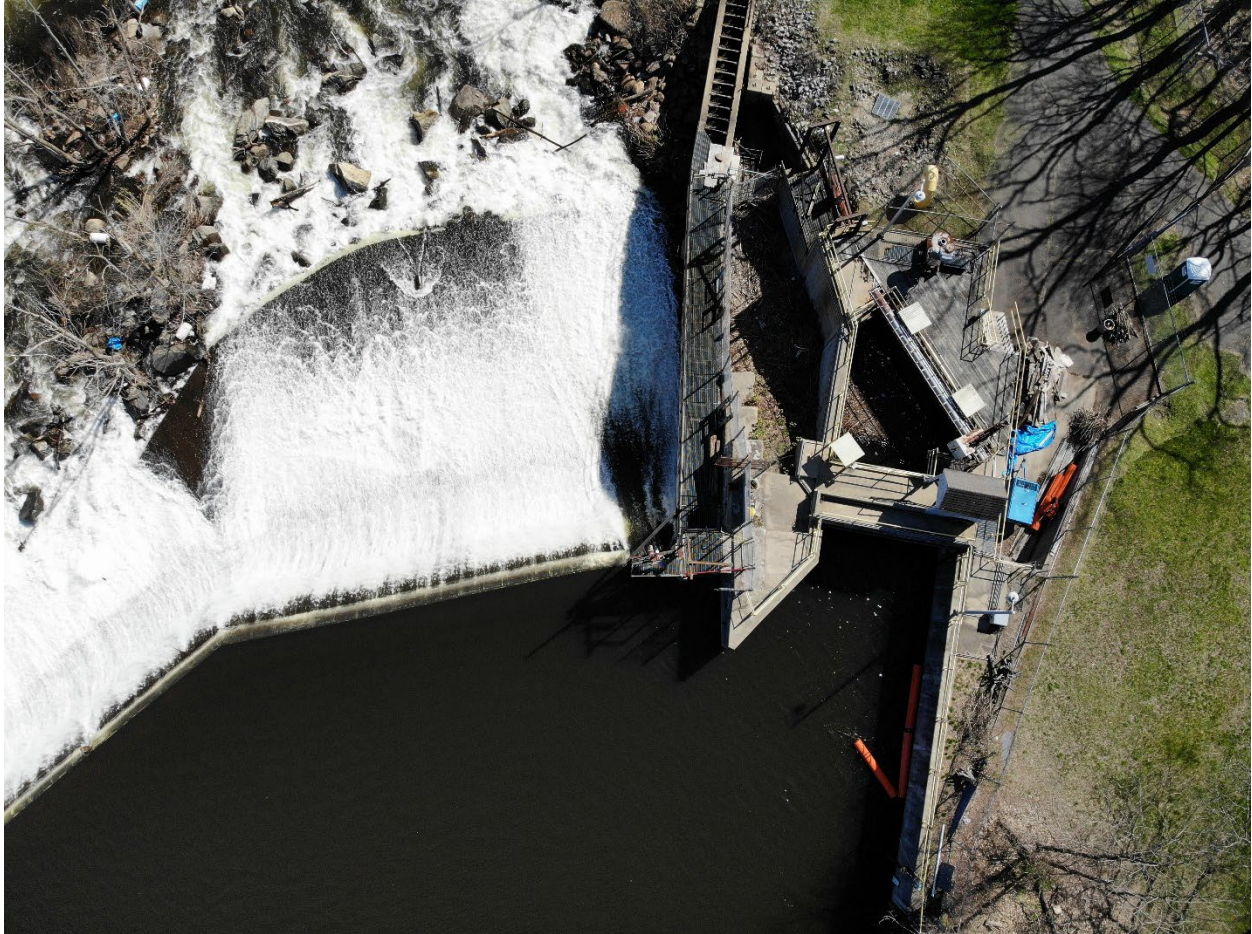
Photo 6: No flow into Unit 1; dewatered and closed fish ladder; all flow over face of dam. (A. Budris, 4/20/22)

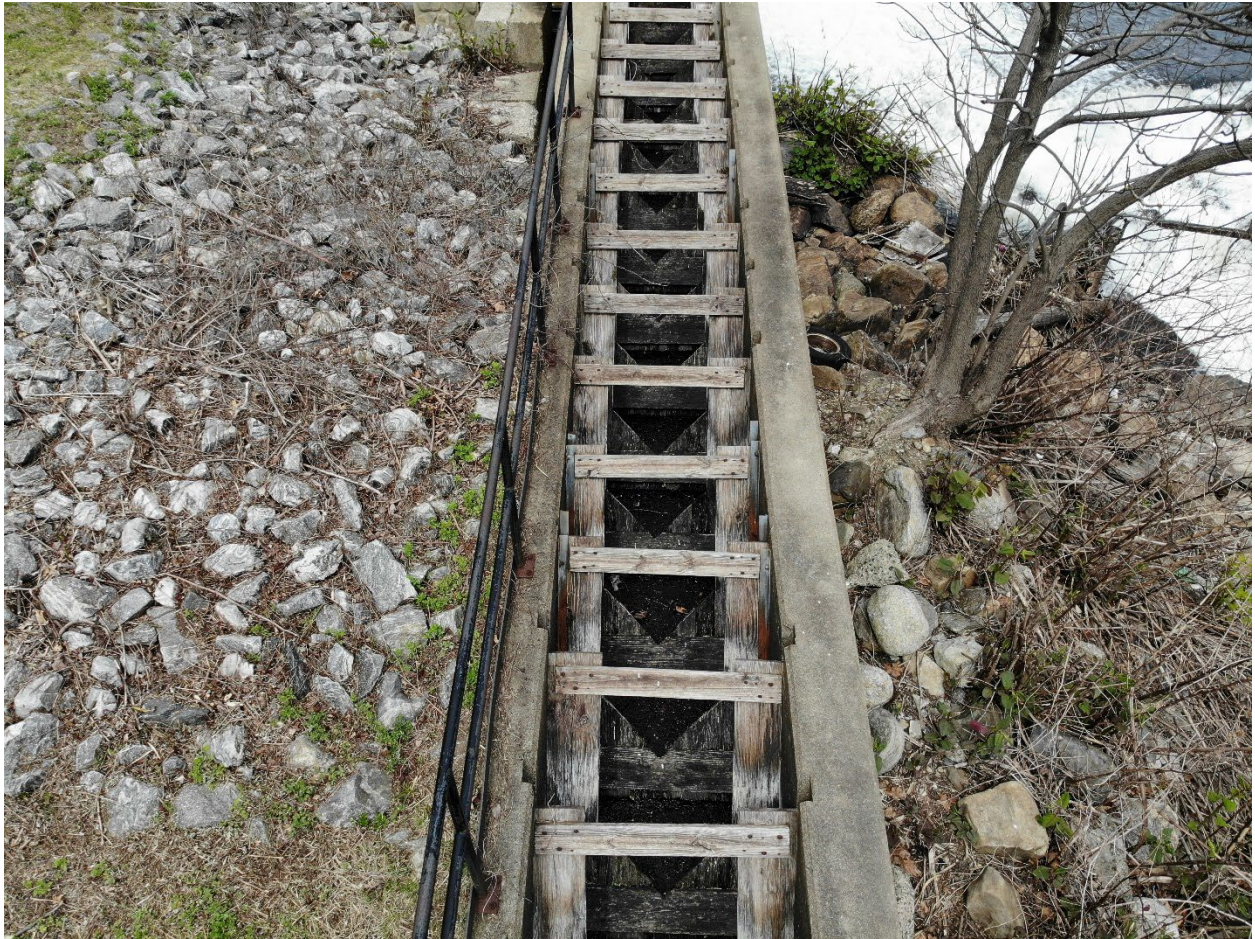
Photo 7: Dewatered and closed fish ladder. (A. Budris, 4/23/22)

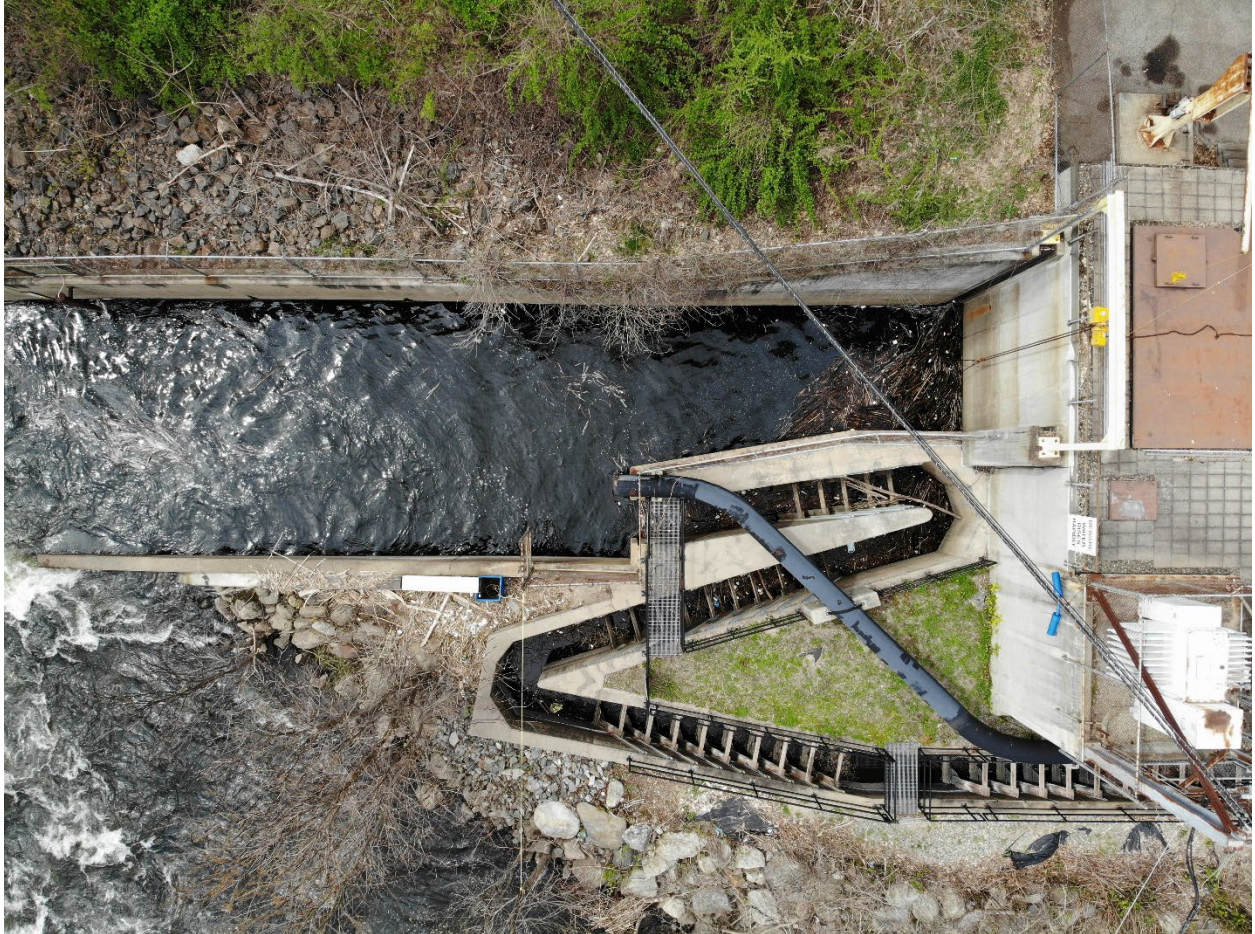
Photo 8: Dewatered and closed fish ladder, debris visible in bottom segments of ladder; no flow out of Unit 1, outflow blocked by debris (A. Budris, 4/23/22)

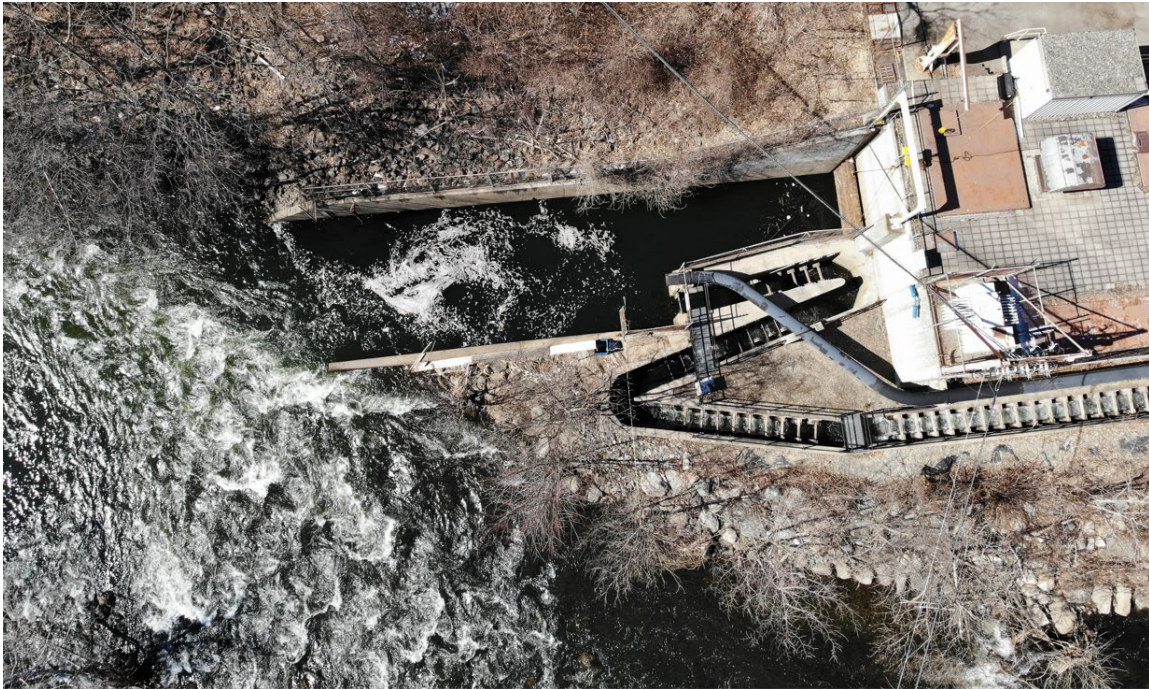
*Figure 1. The downstream fish bypass exits into tailrace of the Hydroland facility. Note the eddy foam indicating that there is no current running through either the bypass or the turbines. (Photo: Aaron Budris, March 4, 2022)*

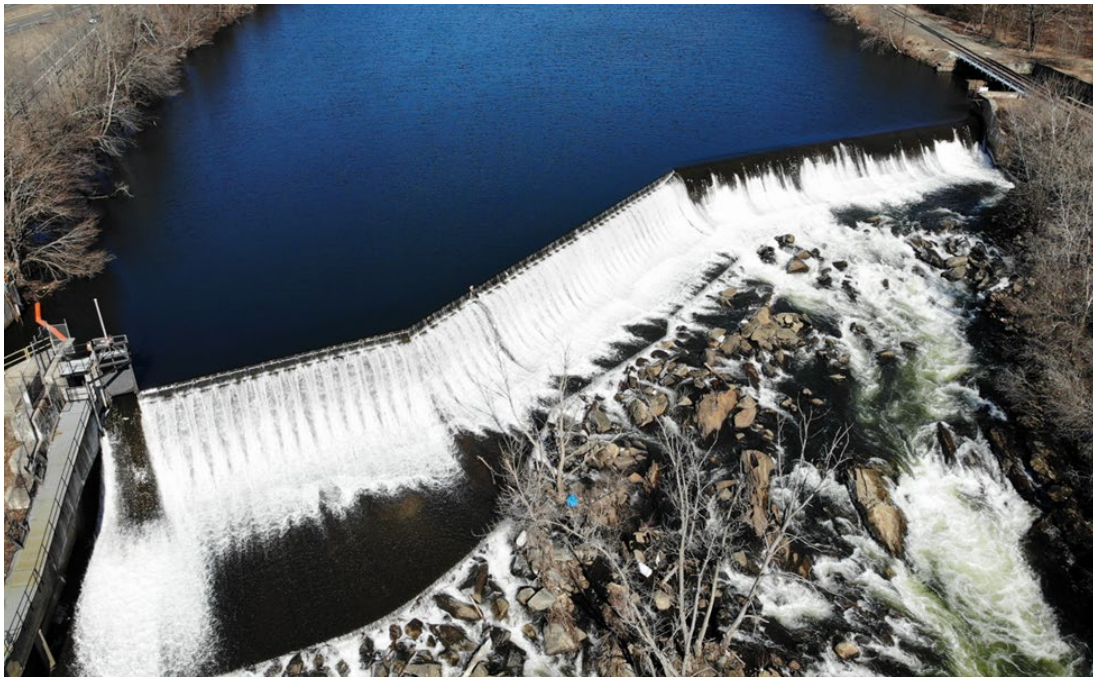
*Figure 2. Base of dam showing spillway impact sites. (Photo: Aaron Budris, March 4, 2022)*

Fish dropping over the eastern portion of the dam may end up in the plunge pool seen in Figure 2. However, the surface area of the dam face is rough and at higher flows fish may be driven into the bottom of the plunge pool or the cement apron at its edge. Shallow boulders line the outer edge of the apron. The west side located below the flash boards does not have a plunge pool and drops directly onto the cement toe of the dam followed by a large substrate bottom. It is possible that at certain flow conditions there is injury or possibly mortality to fish striking this cement apron. This will be dependent on the velocity and volume of the spill and the drop height from the top of the dam. To our knowledge the efficacy of spillway passage has not been evaluated for the current condition of the facility.

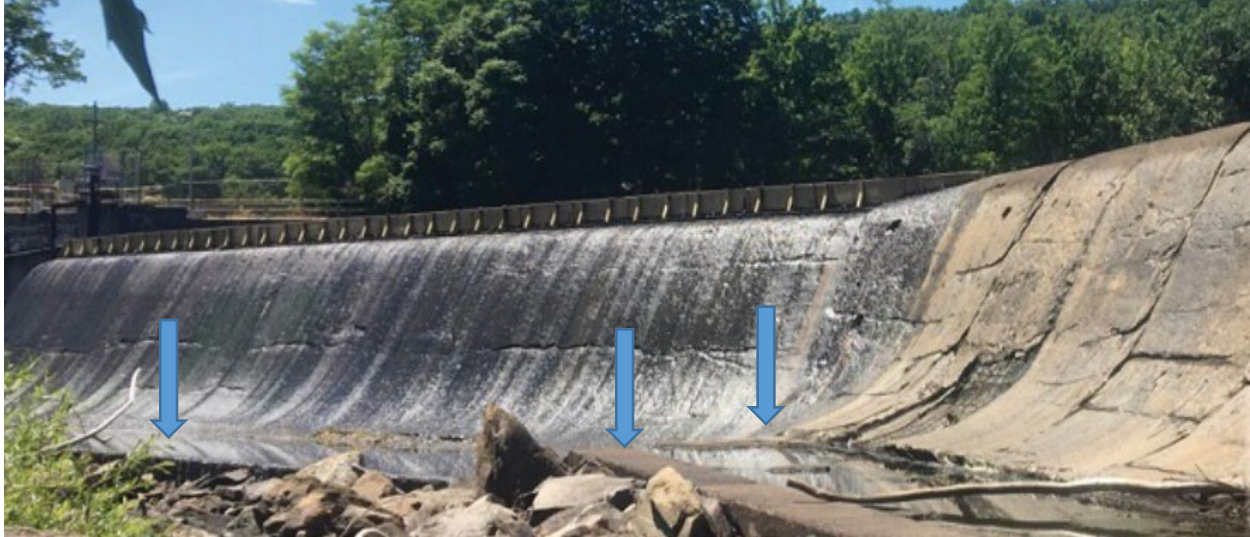
Figure 3. Dam toe revealed at low flows. Predators congregate here to forage on trapped fish.  
(Photo: Kevin Zak, undated)

The base of the dam also concentrates avian predators, primarily cormorants (*Phalacrocorax spp.*), blue herons (*Ardea Herodias*), and Night Herons (*Nycticorax spp.*). The birds have easy access to trapped fish when water levels are low.

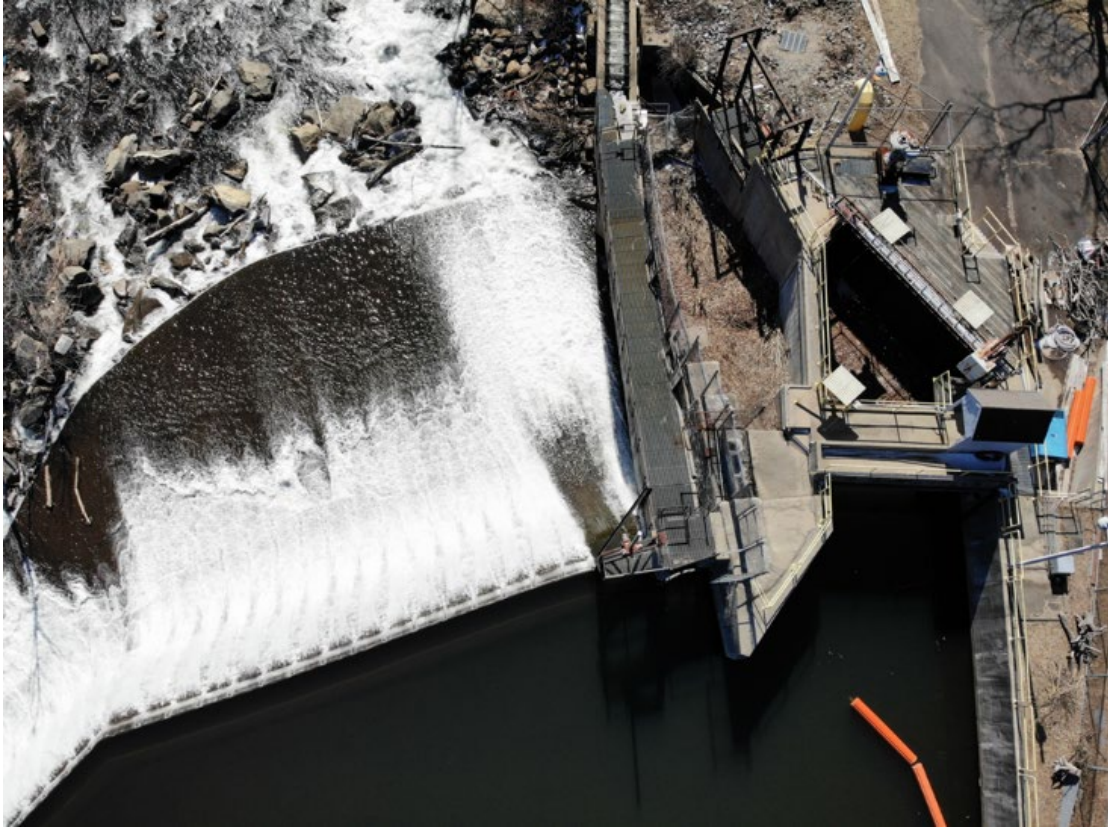
will have an equal chance of passing over the section that falls onto a wide apron of cement with a much greater chance of physical injury.

*Figure 4. Cement apron below western side of dam. (Photo: Aaron Budris, March 4, 2022)*

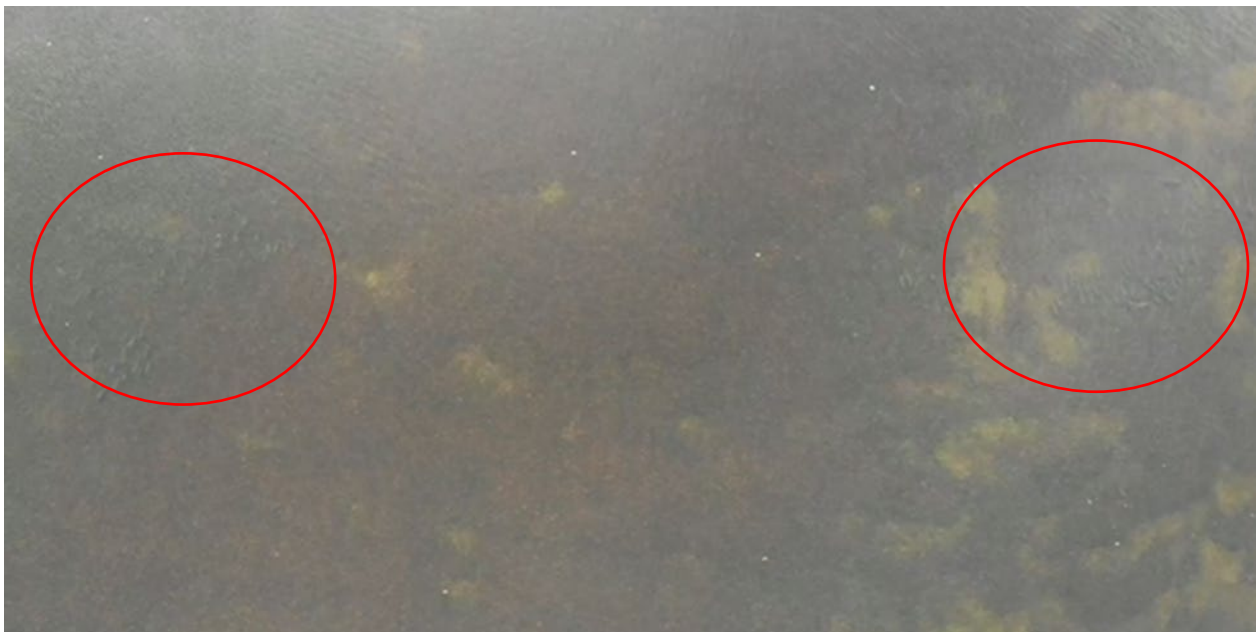
*Figure 5. This drone image shows unidentified fish, possibly alewives stocked by CTDEEP as a run restoration measure, gizzard shad or some other species upstream of the dam considering options for descending the river. (Photo: Aaron Budris, December 1, 2021)*

It is unknown what species of fish are in Figure 5. Small numbers of gizzard shad have been recorded using the ladder over the years as shown by historic ladder counts and based on ideal flow conditions (Lucey et al. 2021). It is also unknown if any upstream migrants passed the Tingue Falls area, but the impounded water behind the Kinneytown Dam and the channel between the Kinneytown Dam and the Tingue bypass have sufficient habitat area to produce gizzard shad offspring. There is also the possibility that these are post spawning alewives that were stocked by CTDEEP in the summer of 2021 and for some reason were delayed returning to saltwater. Timing of this outmigration may be trending later in the year compared to the normal outmigration period (pers. comm. Tim Wildman, CTDEEP Fisheries, January 5, 2020). Run-timing delays may be related to fish avoiding the falls at Tingue and the Kinneytown Dam initiating the flight response for extended periods. Figures 7 and 8 are photos taken by a biologist with the Housatonic Valley Authority indicating fish had entered the Ansonia Bypass that used to transport water to the Ansonia Power Station (Unit 2) (see Housatonic Valley Association Comments, January 31, 2022, accession no. 20220201-5011). It is unknown but possible that the fish observed in December are the same fish or species of fish that entered the canal. The fish at the head of the canal were reported to CTDEEP. A biologist went to the site to verify the species which were determined to be young-of-year (YOY) gizzard shad.

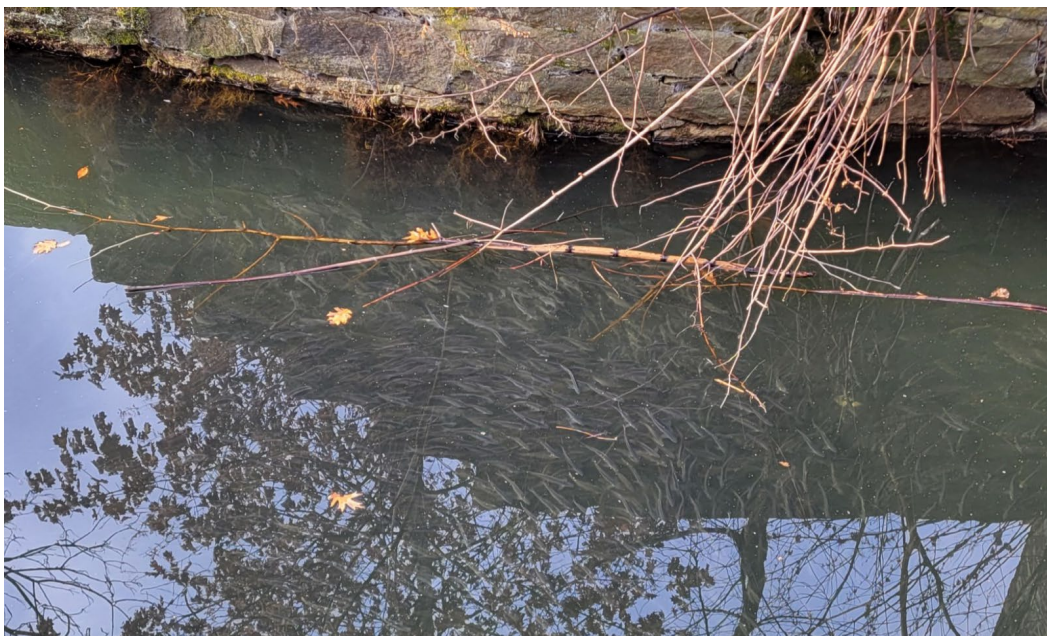
*Figure 7. Fish schooling at by gatehouse inside the Ansonia channel, January 4, 2022. (Photo: Housatonic Valley Association Comments, January 31, 2022, accession no. 20220201-5011)*

It is unknown how frequently, or the method by which, fish enter the Ansonia channel. There is either a bypass pipe above the canal gate into the channel or the canal gate itself is open. Given the reportedly slow current observed in the canal, if the gate is open it is likely a narrow opening. Regardless of the mode of entry, fish are getting into the Ansonia channel. In 2019,

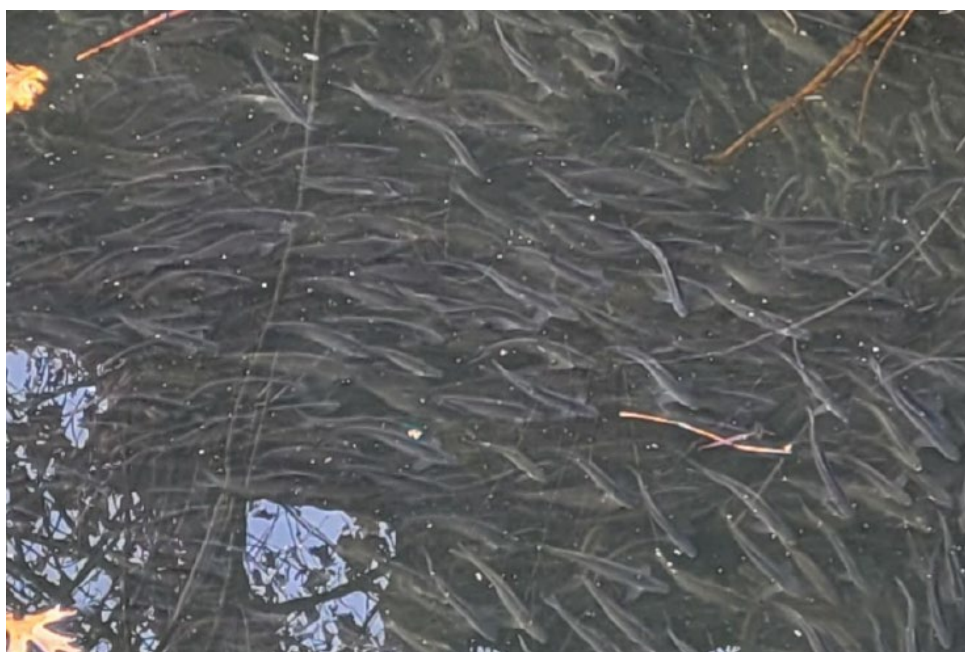
*Figure 8. Magnified view of juvenile gizzard shad in the Ansonia Canal. (Photo: Housatonic Valley Association Comments, January 31, 2022, accession no. 20220201-5011)*

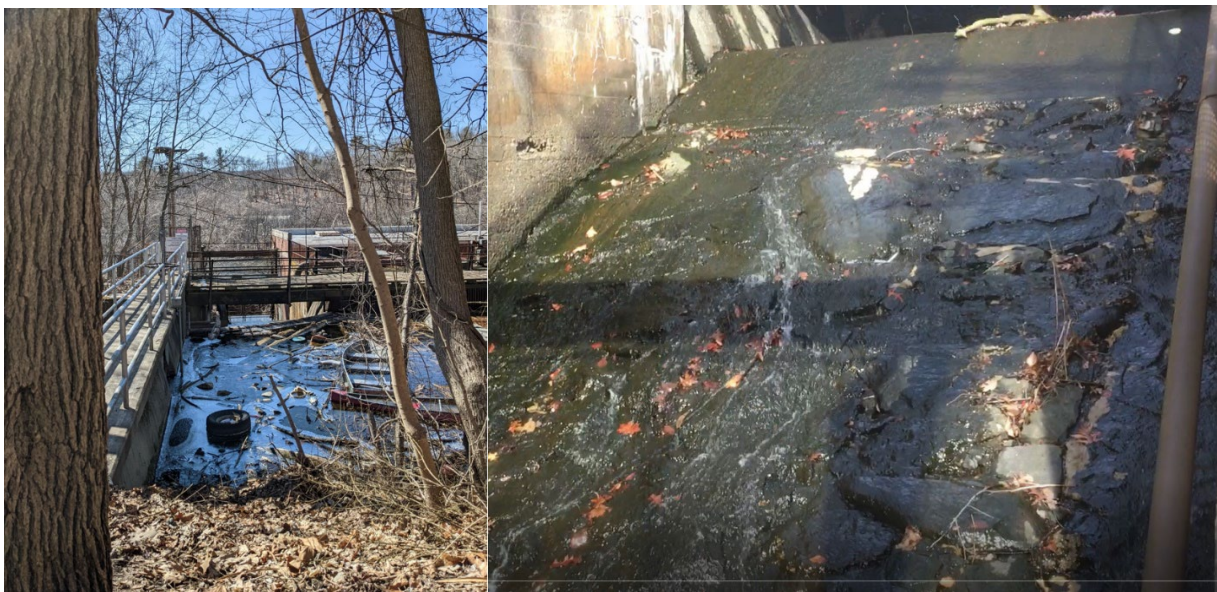
Figure 9. Trash accumulating at the outflow of the Ansonia Powerhouse (Unit2) and the Ansonia spillway showing little downstream flow. (Photos: (Left) Aaron Budris, March 4, 2022; and (Right), Kevin Zak, undated).

The canal is essentially acting as a fish trap directing outmigrating diadromous species into a dead-ended backwater. Therefore, the few fish making it up the ineffective fish ladder may be losing what little offspring they produce to the Ansonia canal. Additionally, alewives stocked by CTDEEP upstream could also be redirected into the canal along with any YOY that have been produced. This would help further explain why runs have not been able to establish themselves above the dam. This is a critical issue and should be addressed prior to the 2022 spring fish run.

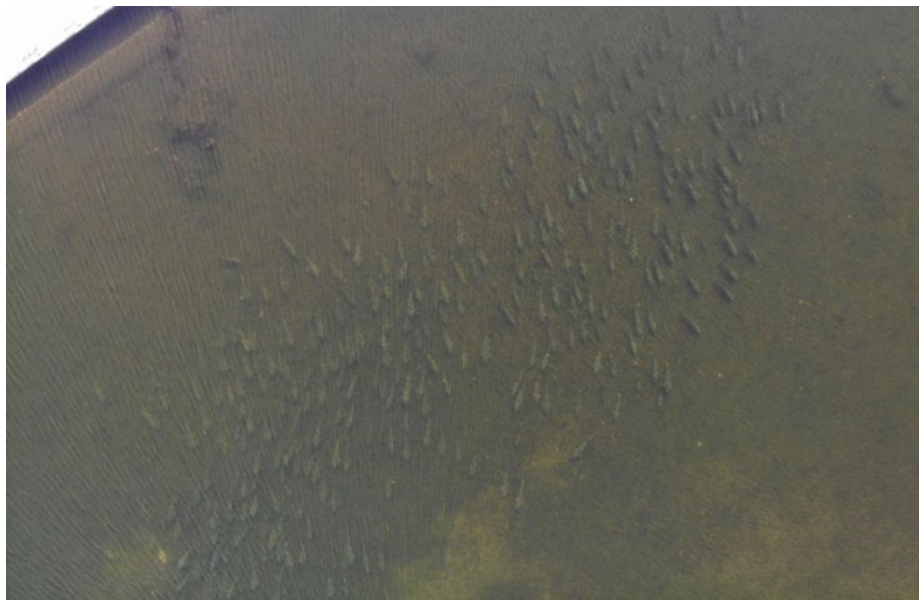
In general, the Kinneytown Dam is acting as a barrier to downstream migration of various fish species. Figure 11 shows another school of larger fish on the river left side of the impoundment avoiding the spillway portions of the dam. Since these fish are larger they would likely risk greater injury going over the spillway and may choose not to migrate downstream.

*Figure 11. Unidentified fish school upstream of dam (Photo: Aaron Budris, March 4, 2022)*

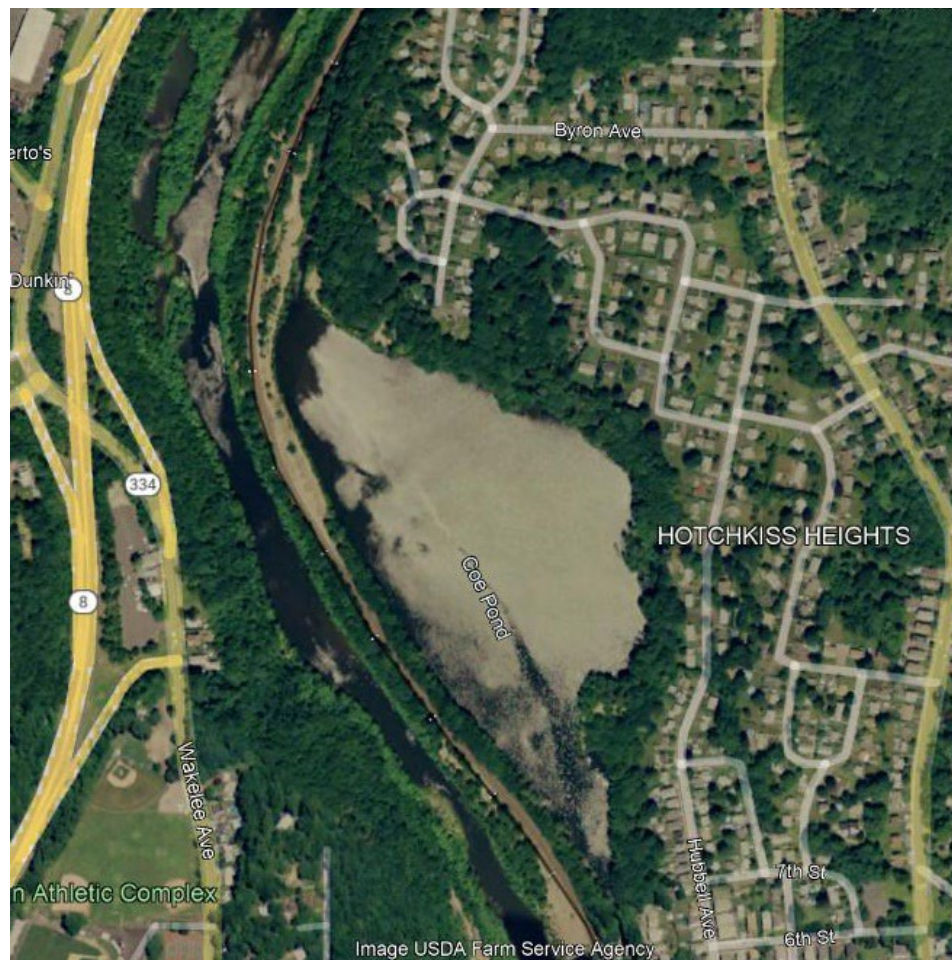
*Figure 13. Water discoloration in Coe Pond of unknown origin. (Google Earth 2008)*

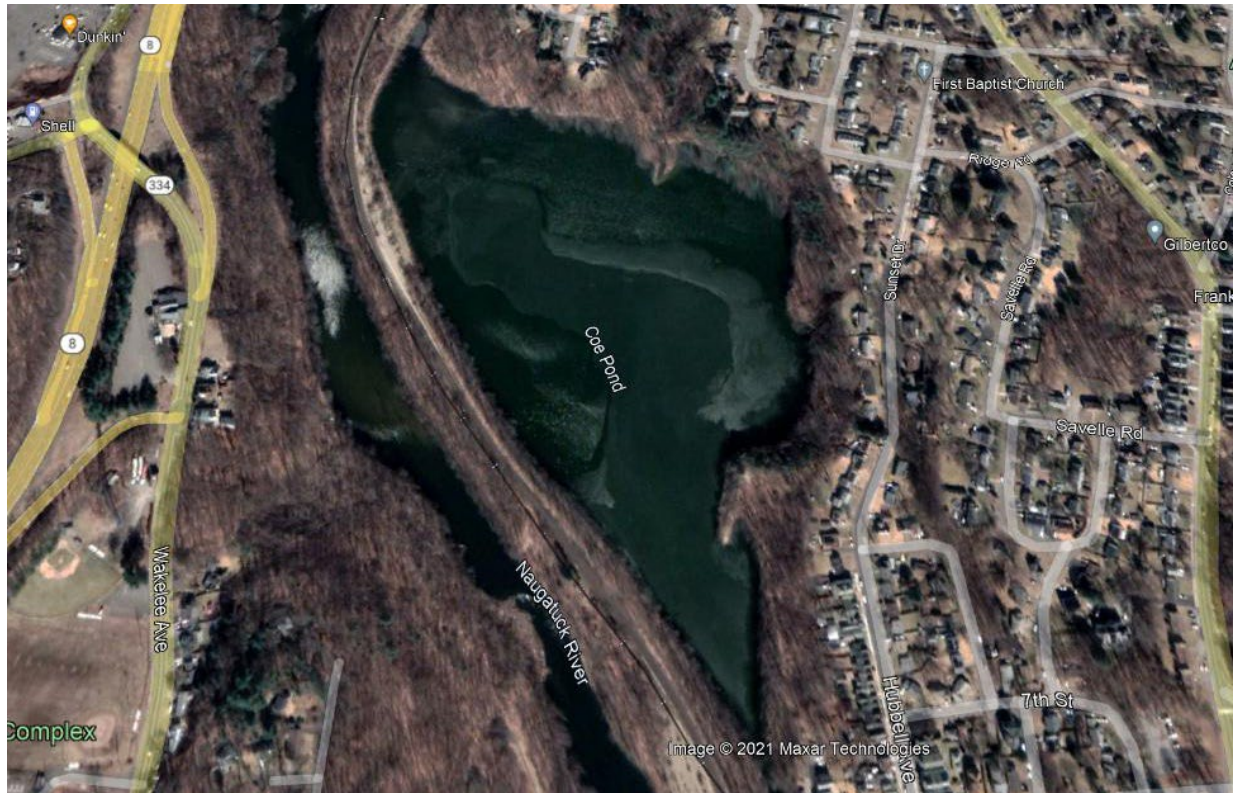
The bypass channel appears not to have been maintained since at least since 2010 when the Ansonia Power House was shutdown. A 1991 image shows a channel free from brush. Current conditions show an accumulation of trash, sediment, brush, and trees. It is likely that, along with the clearing of debris in the channel, any sediment accumulation that has occurred along the channel and into Coe Pond which may require dredging. Given the manufacturing history of the river it is possible, if not probable, that these sediments are contaminated. Any work on the channel to improve hydraulic function could mobilize sediments. Prior to initiating work in the channel, there should be adequate sediment sampling within the pond and channel to characterize any toxics present. Mobilizing accumulated toxins downstream may adversely affect the shell fishing industry at the mouth of the Housatonic River depending on type of contaminant and mobilization characteristics. The following Google Earth time series shows potential accumulation zones.

Figure 14. Coe Pond from 2020 showing possible accumulation of sediment. (Google Earth 2020)
