Coe Pond Dam Inspection Findings

Kinneytown Hydroelectric Project (FERC No. 6985)

MARCH 2024

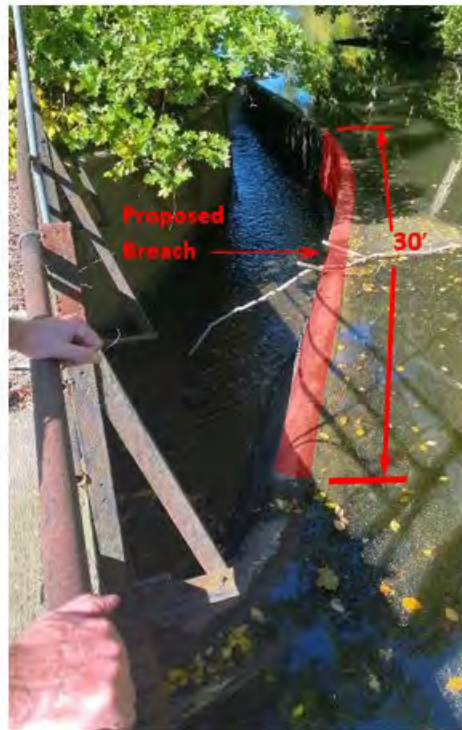
Figure 6.1-1. Proposed Breach of the Northern Weir

A photograph showing the approximate location to breach the northern weir is shown in [Figure 6.1-1](#). The removal will lower the weir crest to be within 6 inches of the concrete base slab (sizing of the weir breach is discussed below). This removal will result in lowering the normal water level in Coe Pond and Coe Pond by

In summary, we recommend addressing the most urgent need of lowering Coe Pond's water level in 2024. Removing 20-30 feet of the weir would provide ample flow capacity, and more importantly lowering the weir by 3.33 feet would create considerably more freeboard Coe Pond water level and the top of the earthen dam. As noted above, it is also anticipated that by removing a portion of the northern weir, the potential of developing an ice dam at south end of Coe Pond may be reduced.

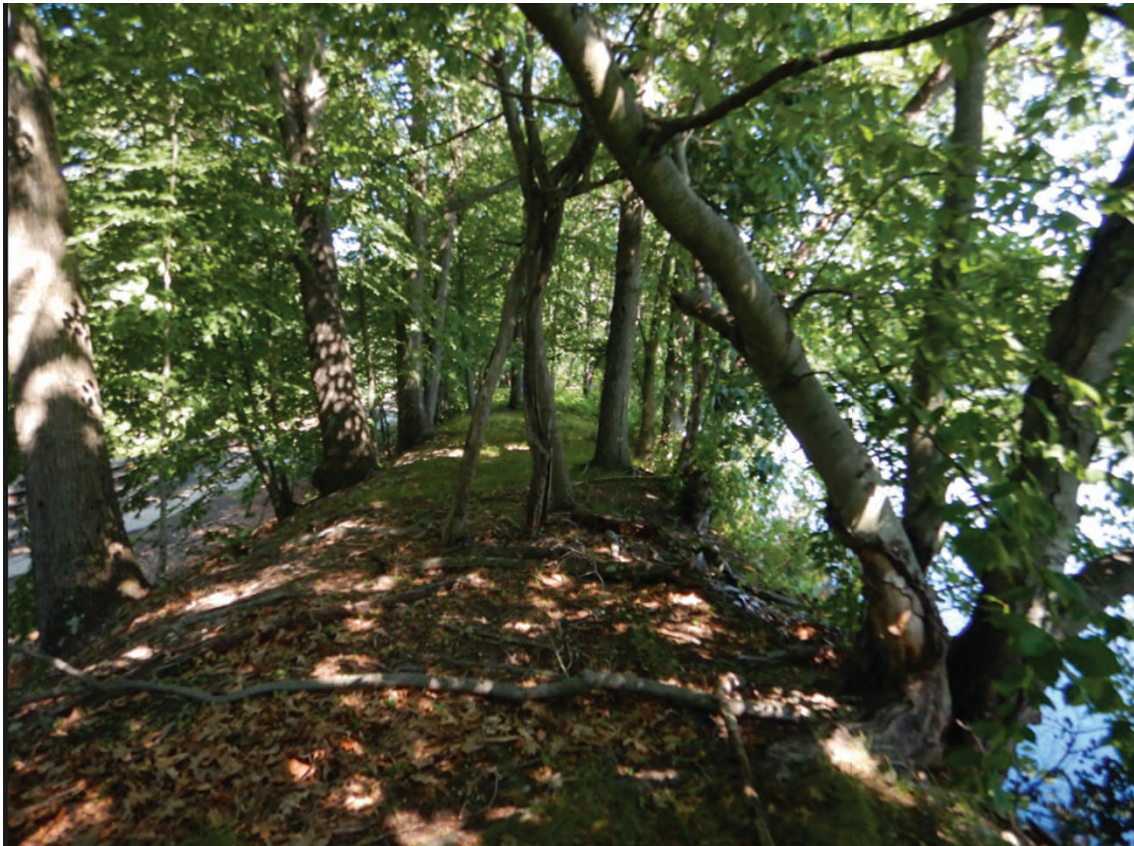
Photo 1: Woody vegetation along the canal embankment

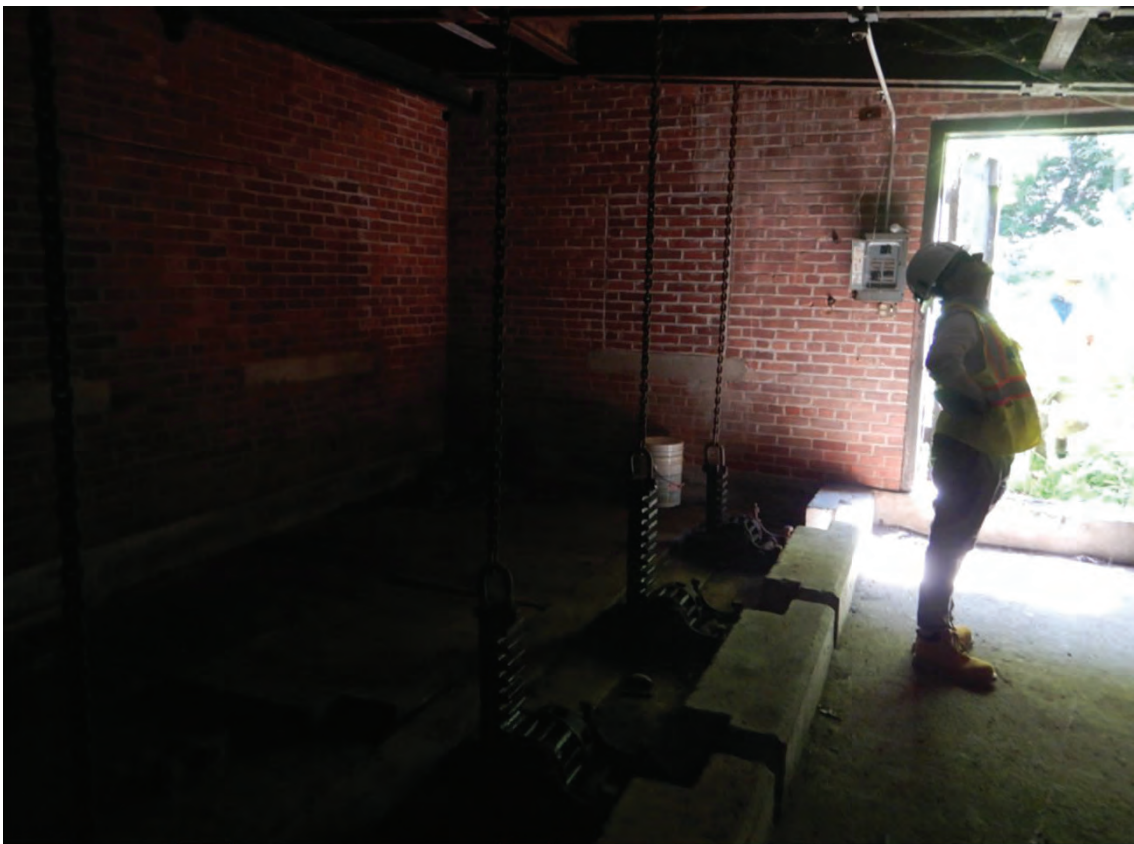
Photo 2: 3 of the 5 gates stuck partially open seen from inside the gatehouse

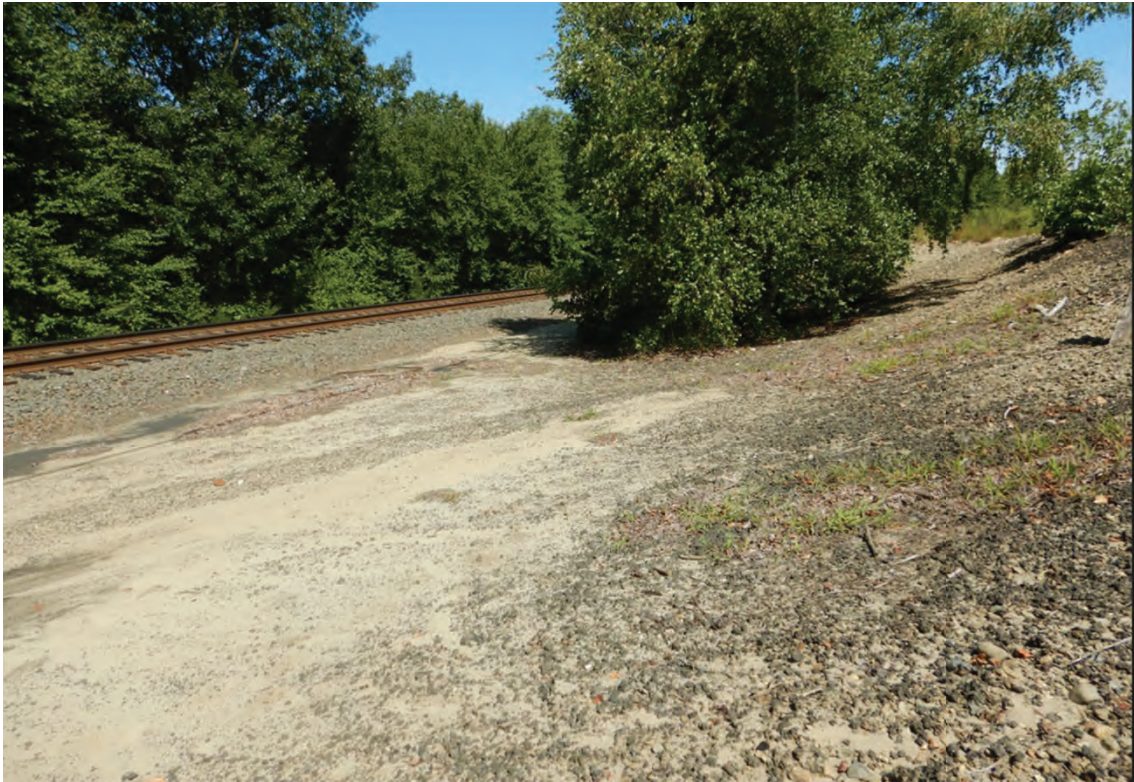
Photo 3: Evidence of washout and possible overtopping of the canal embankment

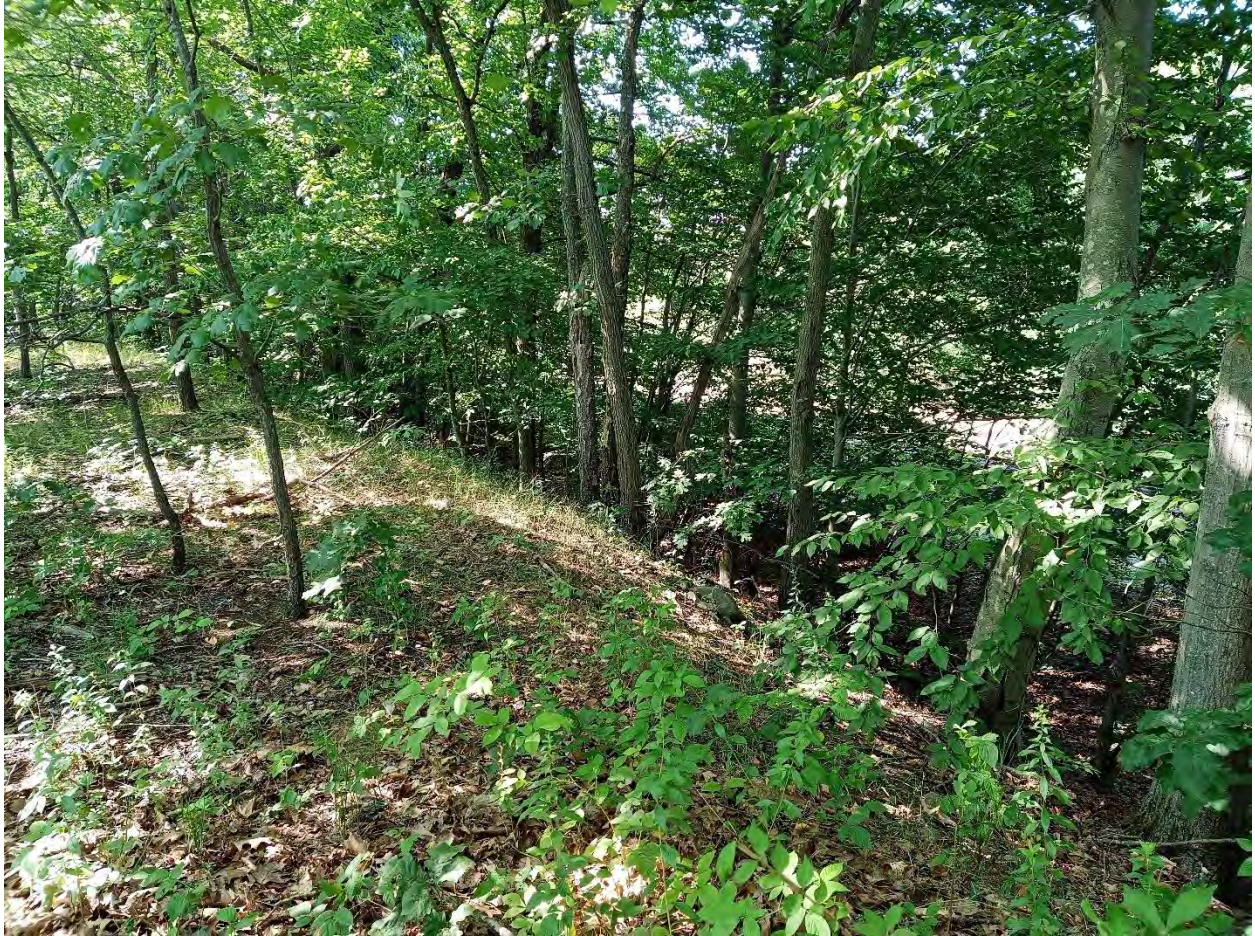
Photo 1-Crest of the dam is overgrown with trees and other woody vegetation.

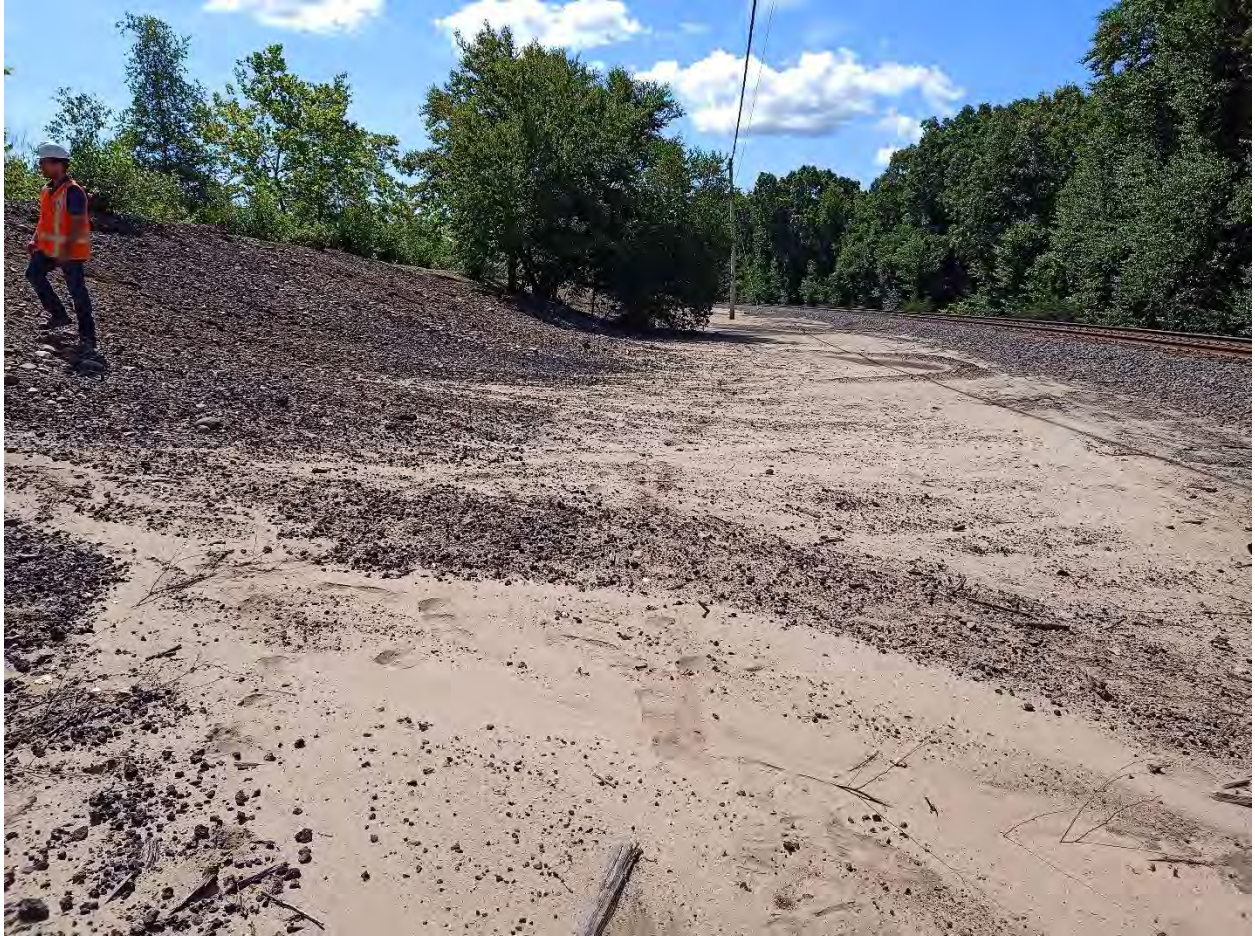
Photo 2-Toe of embankment with accumulated sediment.

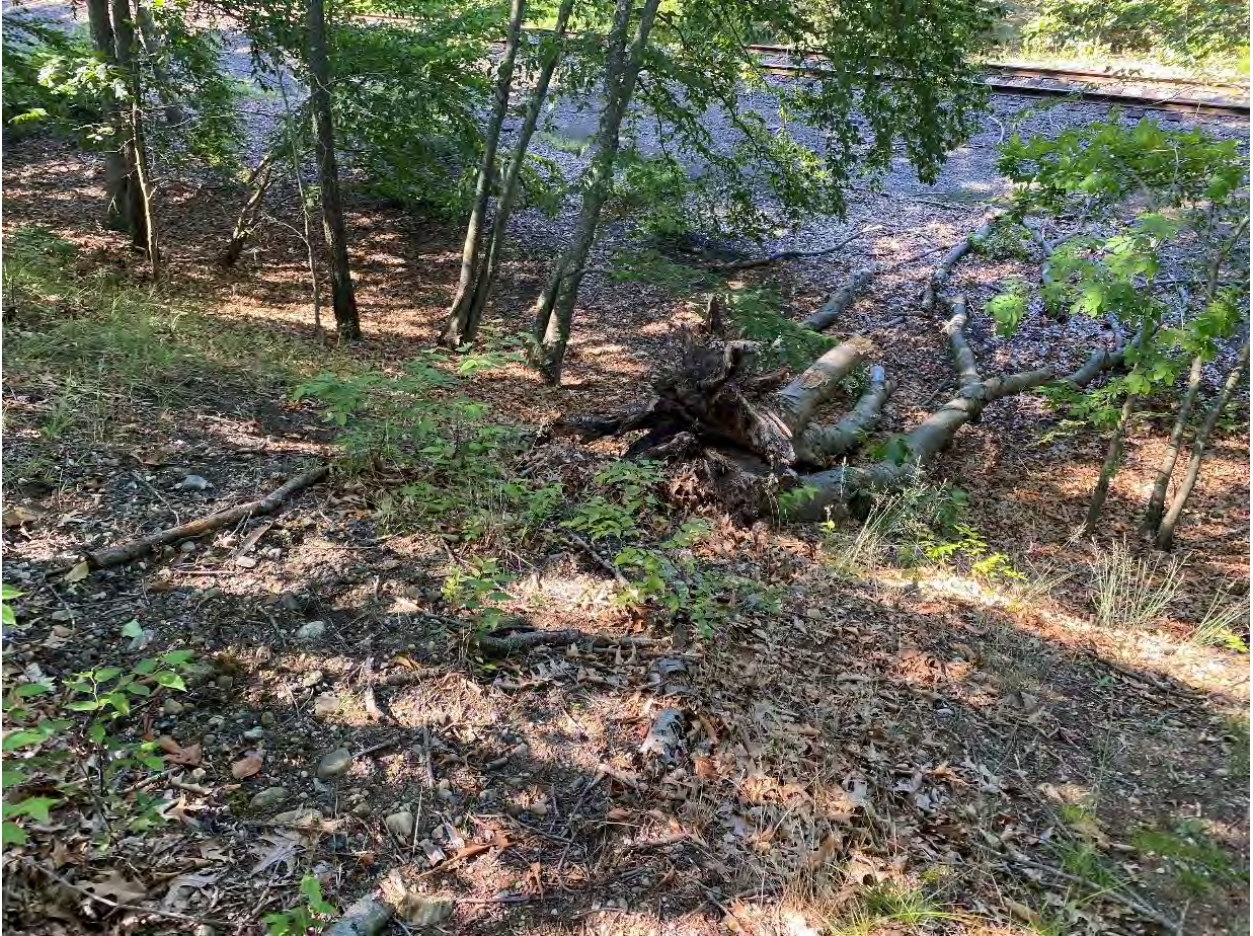
Photo 6- Trees and down trees on the downstream slope near the tracks

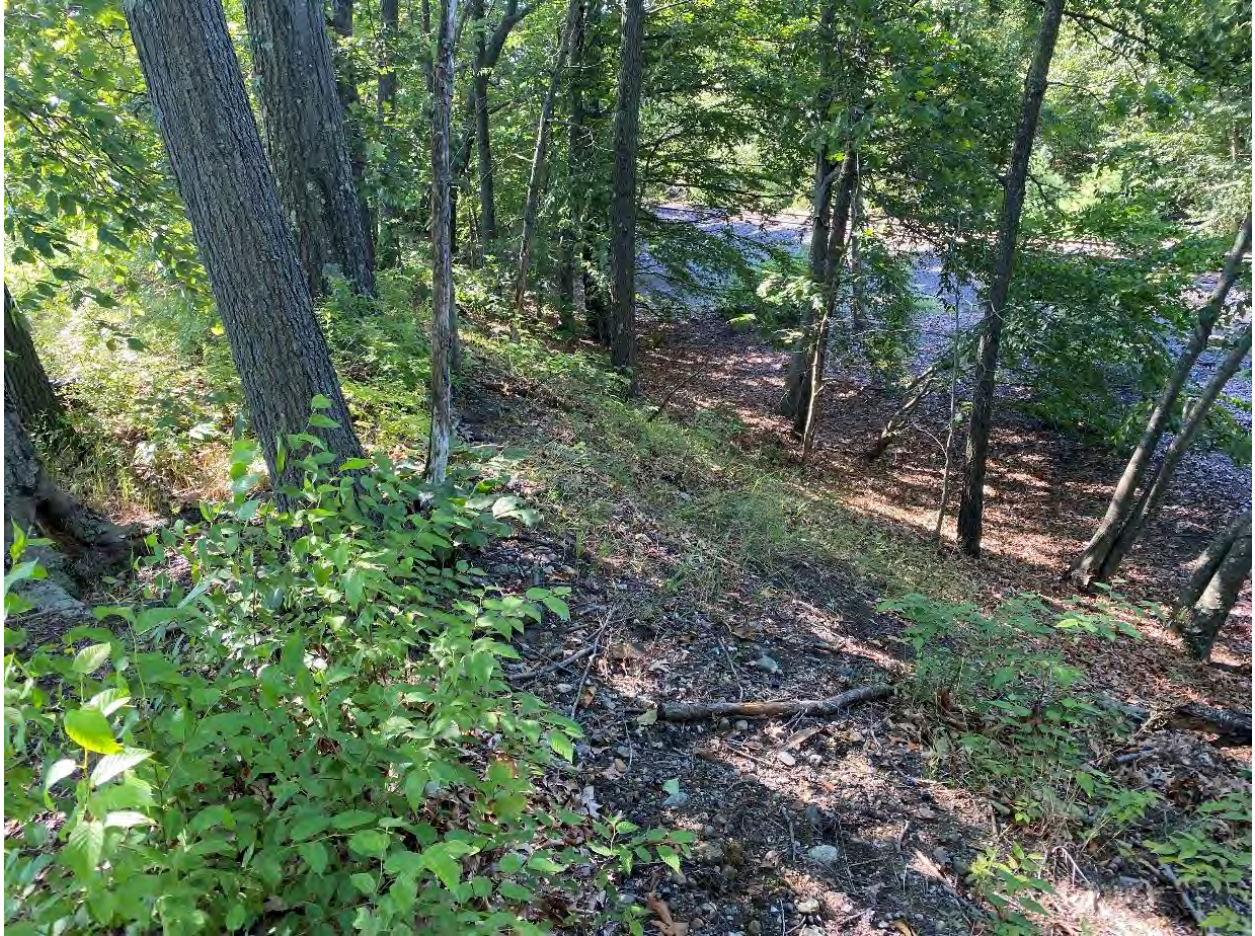
Photo 7- Downstream slope extremely steep

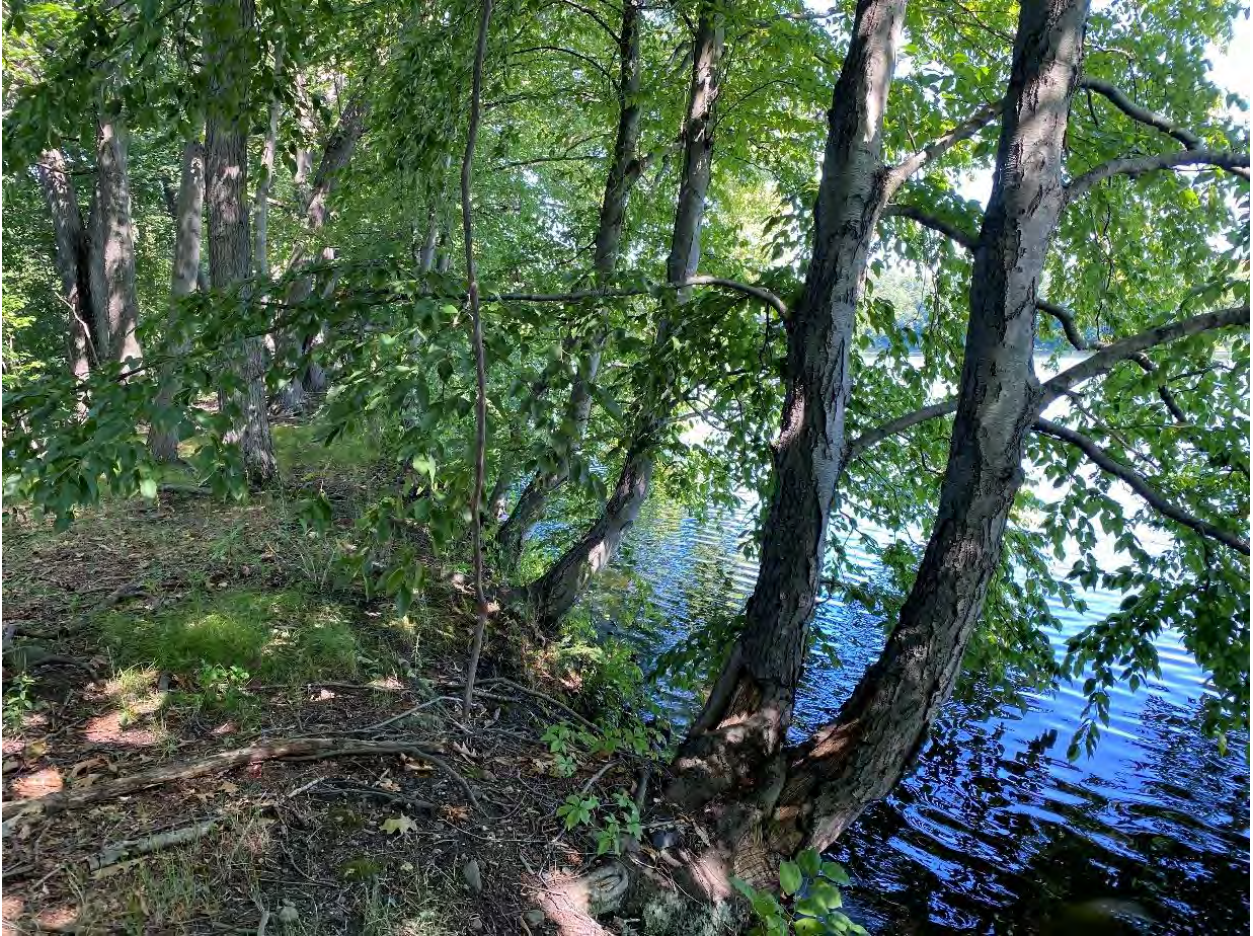
Photo 8- Erosion of the upstream slope, large trees along the water line and across the dam crest

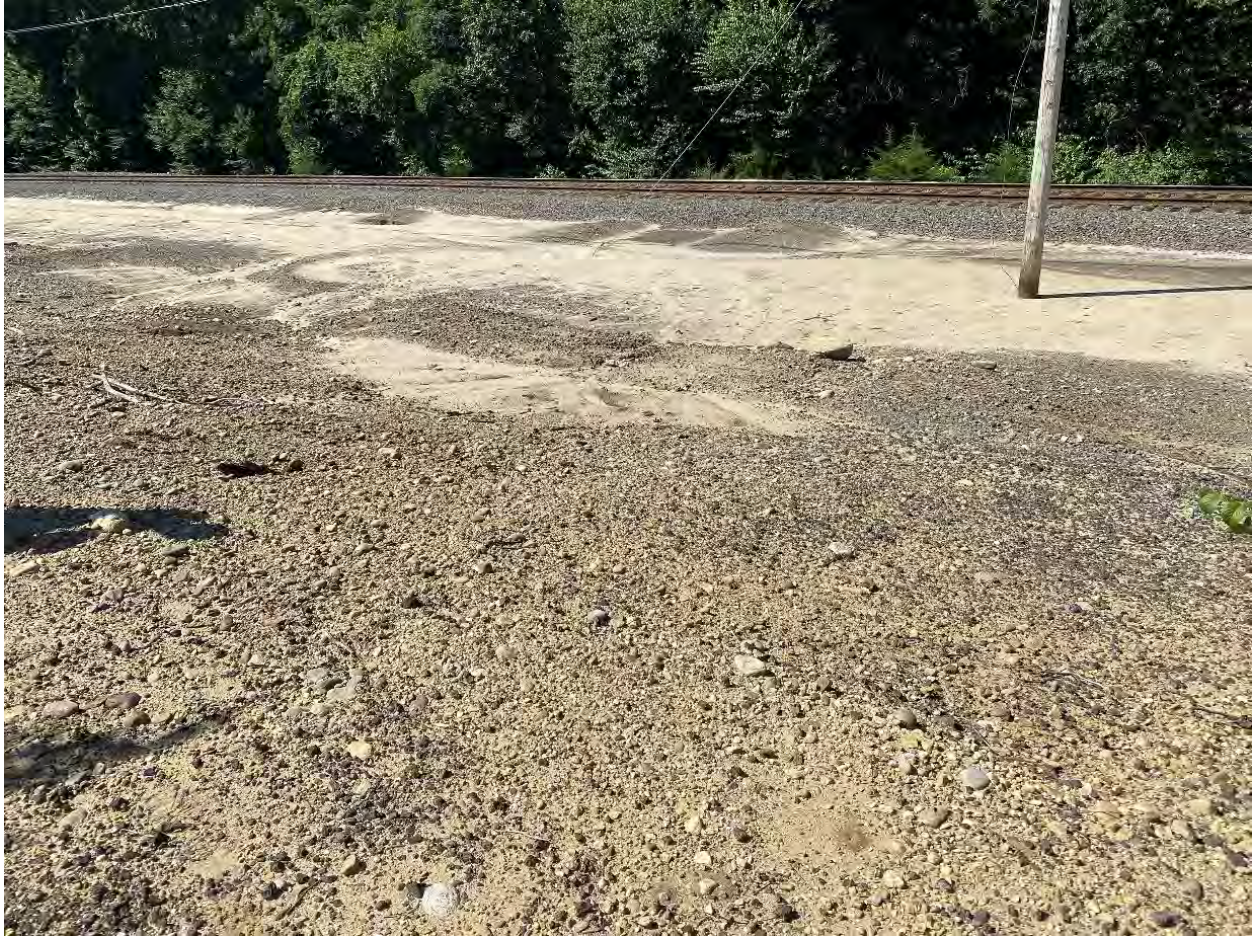
Photo 9- Evidence of water at the toe of the dam next to the railroad tracks.

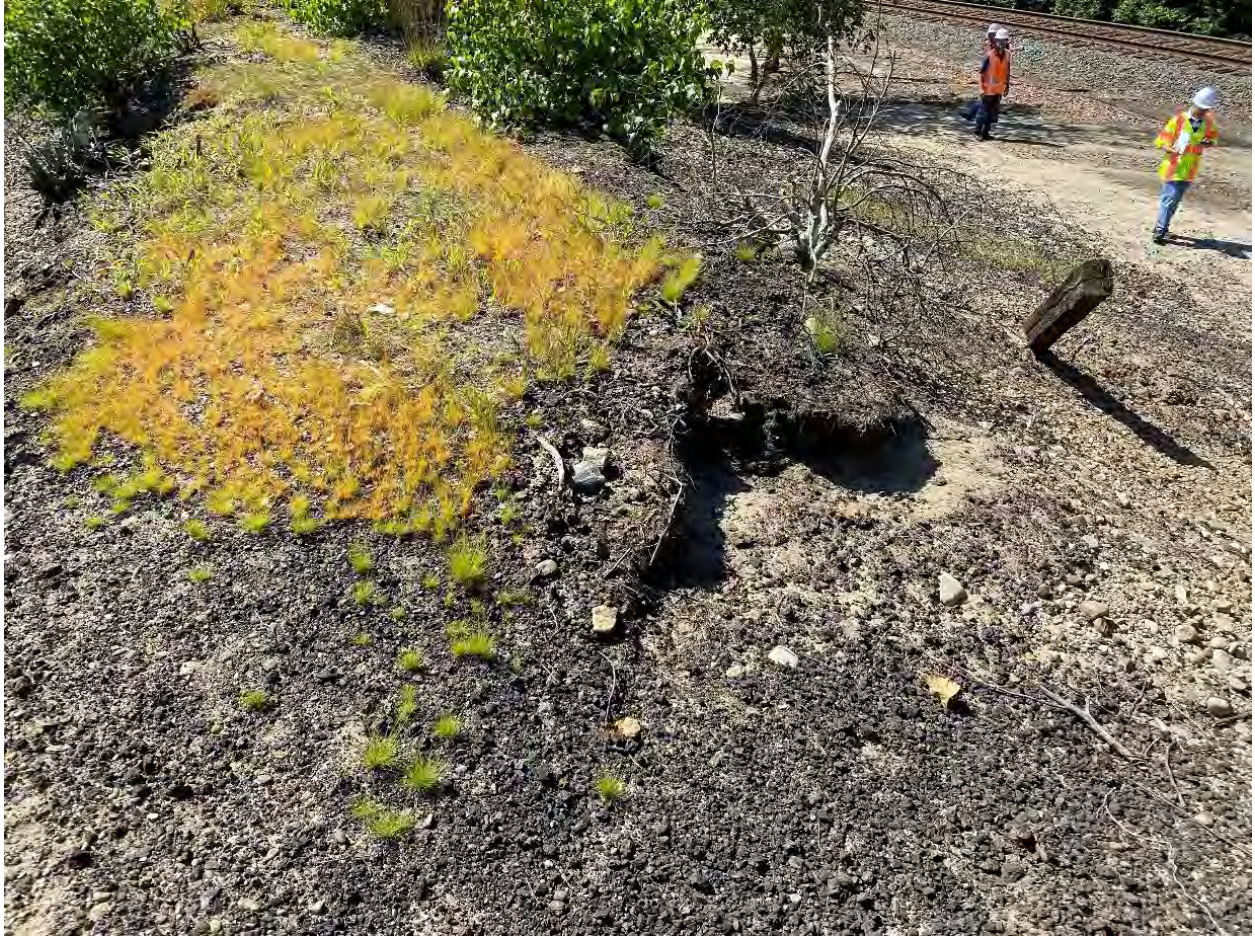
Photo 10- Erosion and rutting in the dam crest

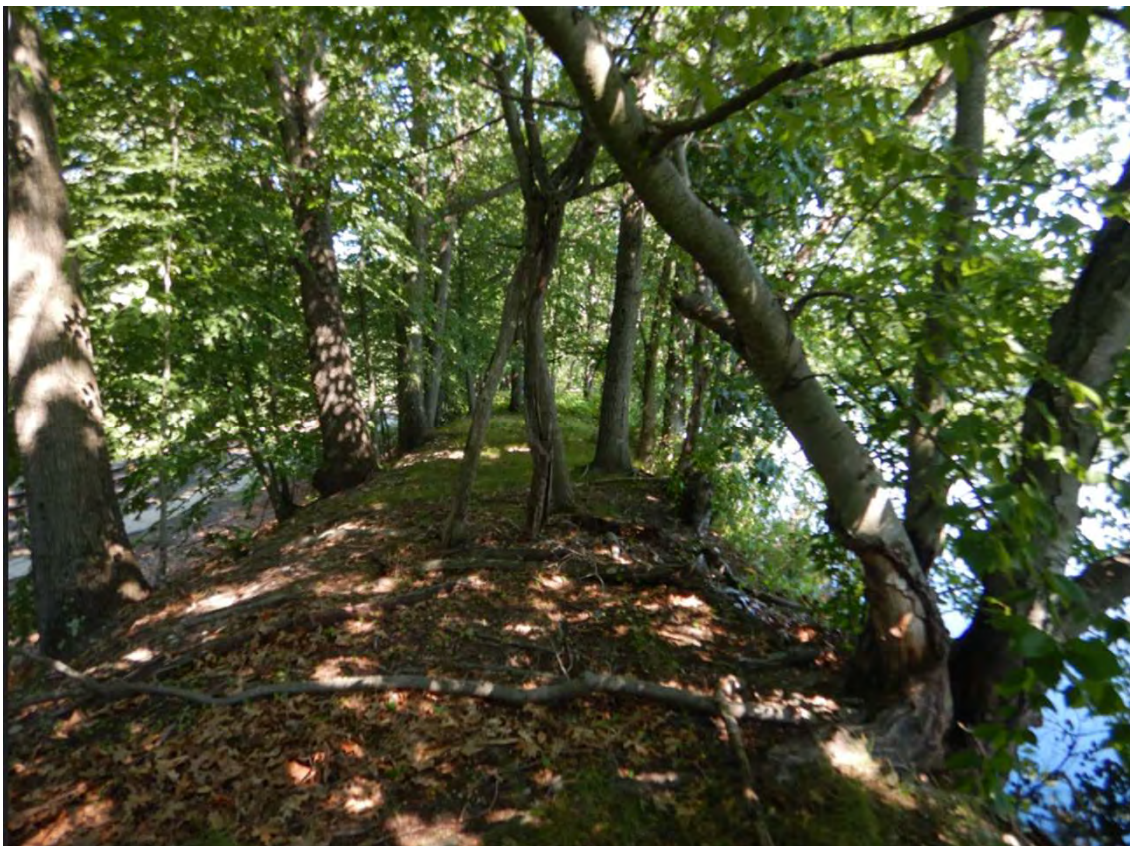
Photo 1: Woody vegetation along the canal embankment

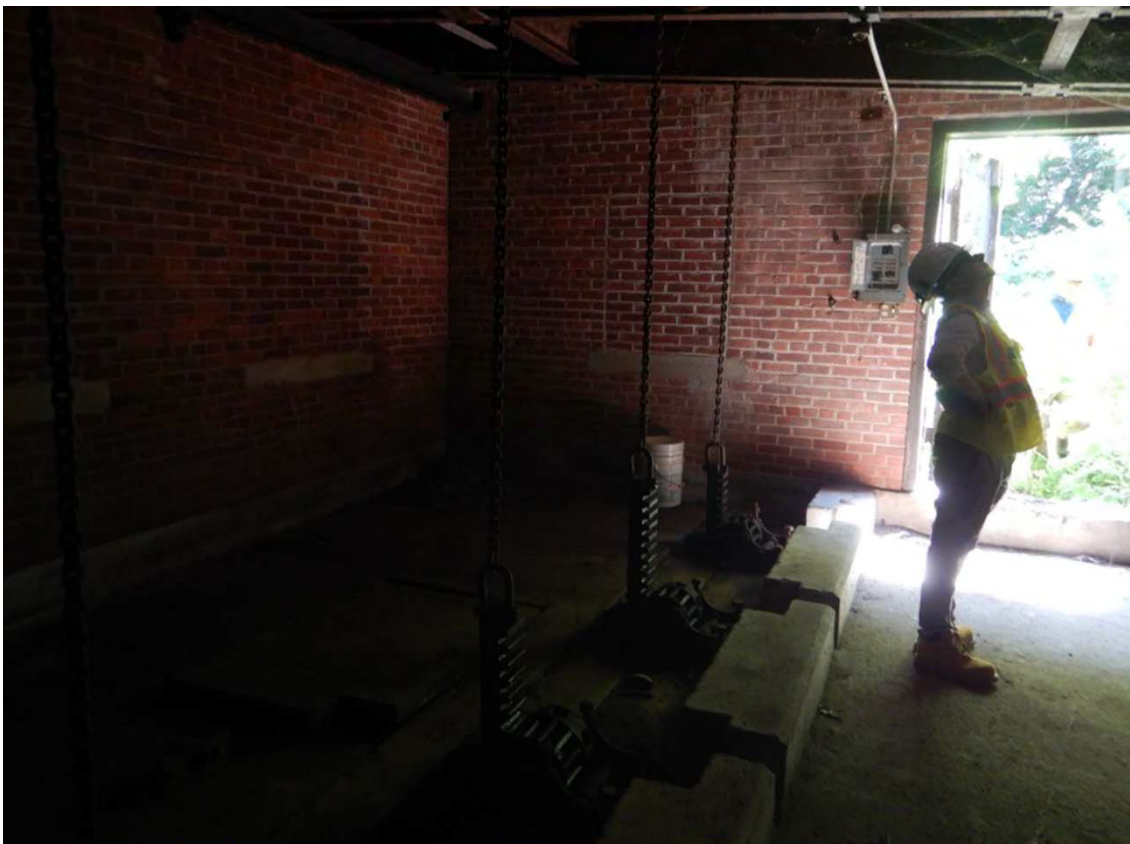
Photo 2: 3 of the 5 gates stuck partially open seen from inside the gatehouse

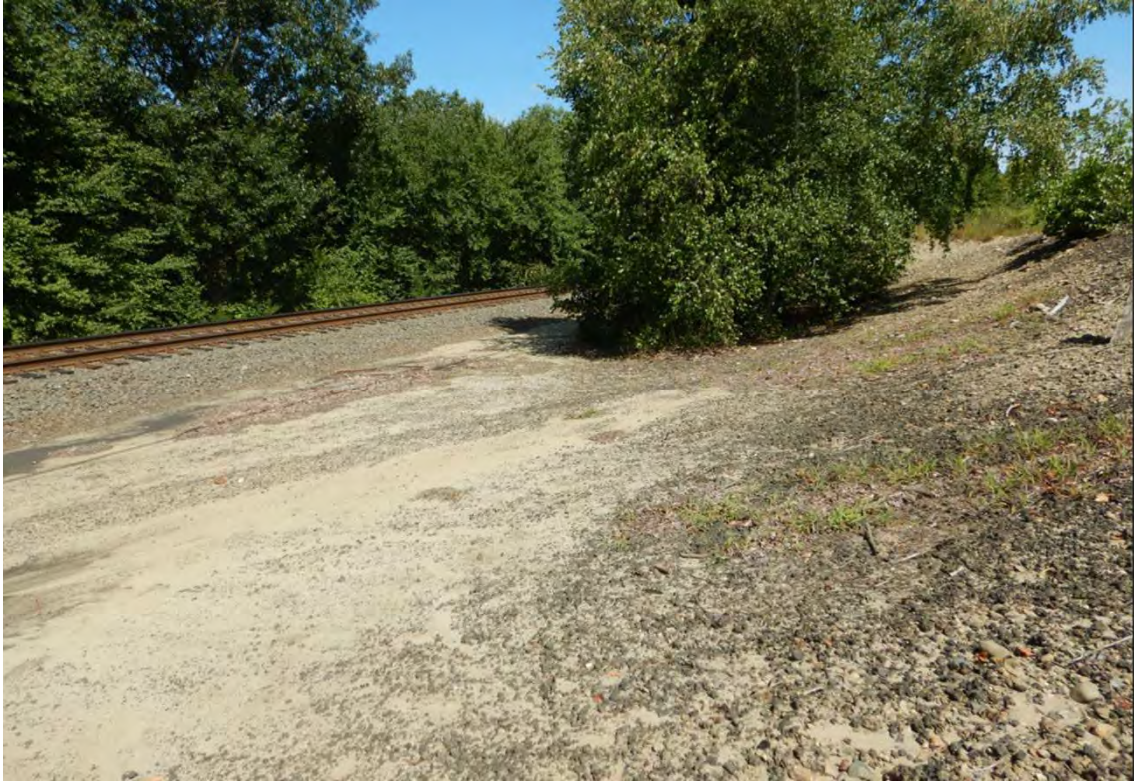
Photo 3: Evidence of washout and possible overtopping of the canal embankment

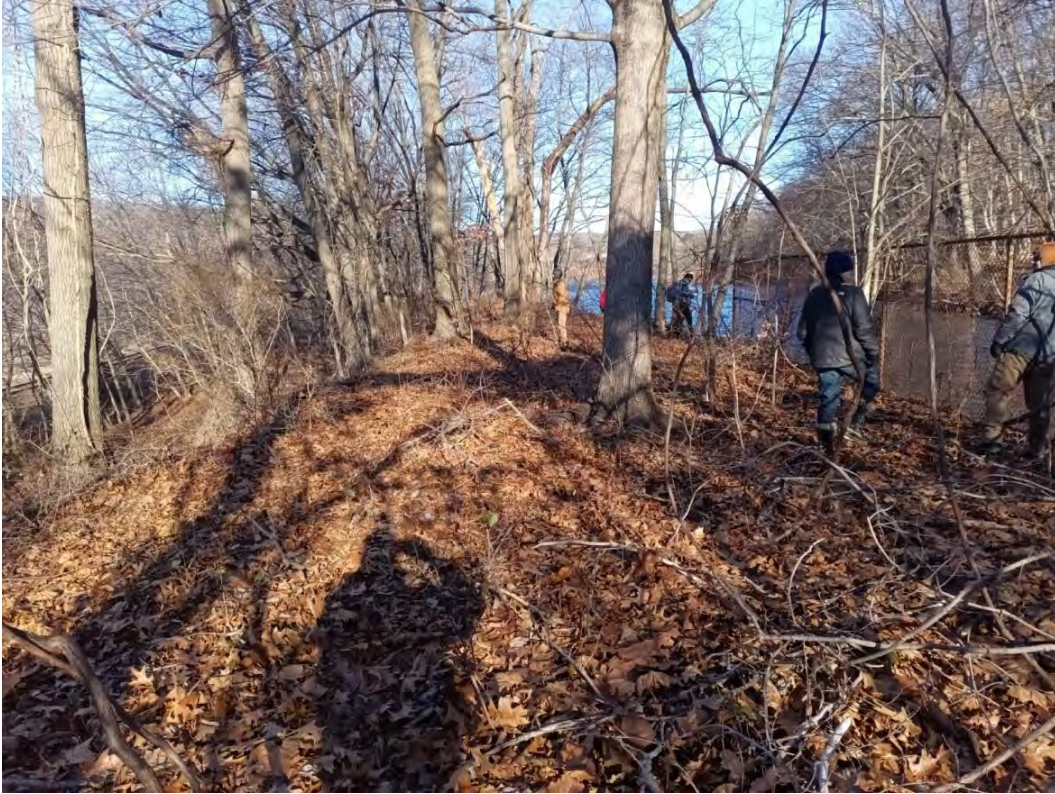
The crest of the earthen dam was covered with brush and trees up to 18 inches in diameter measured 4.5 above ground level, at breast height (DBH) feet (**Photos 3-6**). As noted

Photo 3. View of Embankment Crest and Outboard Slope of Dam. Note Large Diameter Trees

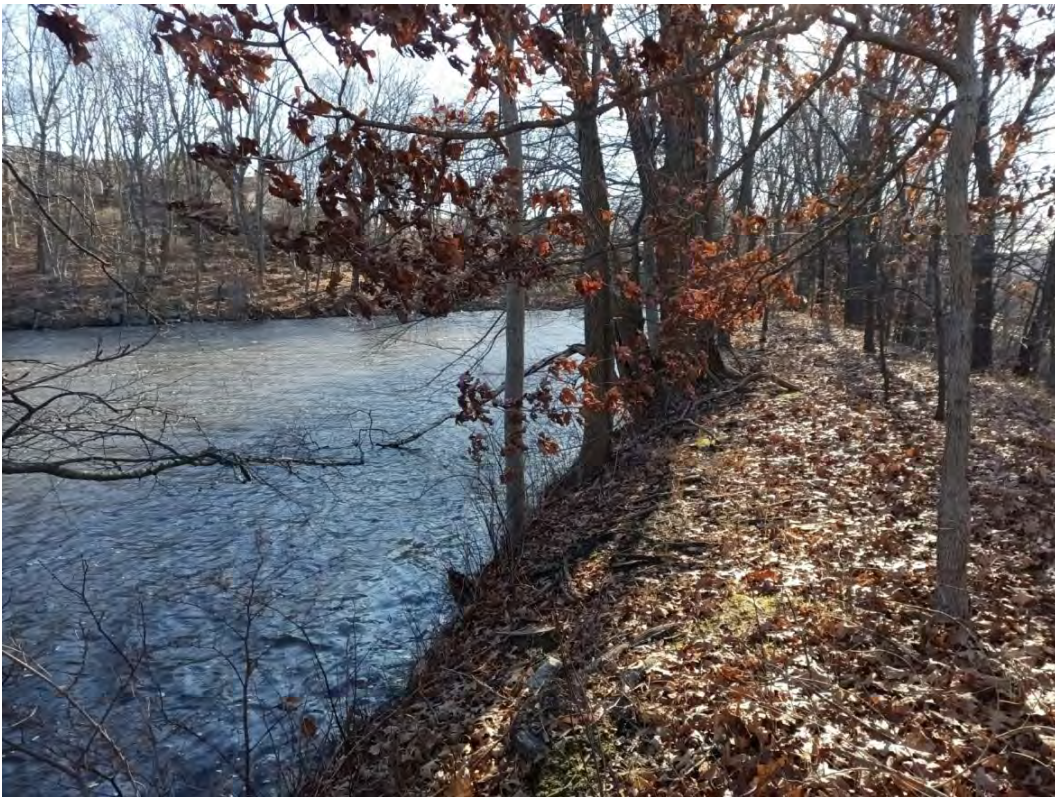
The inboard slope of the earthen dam is overgrown with woody vegetation, and trees up to 24 inches in diameter (DBH) are located along the shoreline (**Photos 7 and 8**). The slope is near vertical in some locations (**Photo 4**) and has numerous areas of erosion due to wave action (**Photo 16**). Some trees located near areas of undermining are leaning towards Coe Pond (**Photo 17**). In addition, significant portions of the slope have exposed tree roots. Much of the slope lacks protective armoring such as riprap or other stabilizing materials (**Photo 15**). As noted above, the potential for uprooting of mature trees has the potential to breach the earthen dam, jeopardizing public safety and damaging the adjacent railroad and electrical lines. There are areas appearing to have some small riprap, but the extent of the armoring is unknown. Signs of beaver activity were also observed along the inboard slope including chewing of trees, and apparent abandoned bank dens (**Photos 12, 13 and 14**). The presence of bank dens (burrows) on the inboard and/or outboard slopes of an earthen dam can dramatically alter how an earthen dam controls the water pooled behind it. Specific concerns with burrows include:

Photo 4. View of Embankment Crest. Note Near Vertical Bank to Water

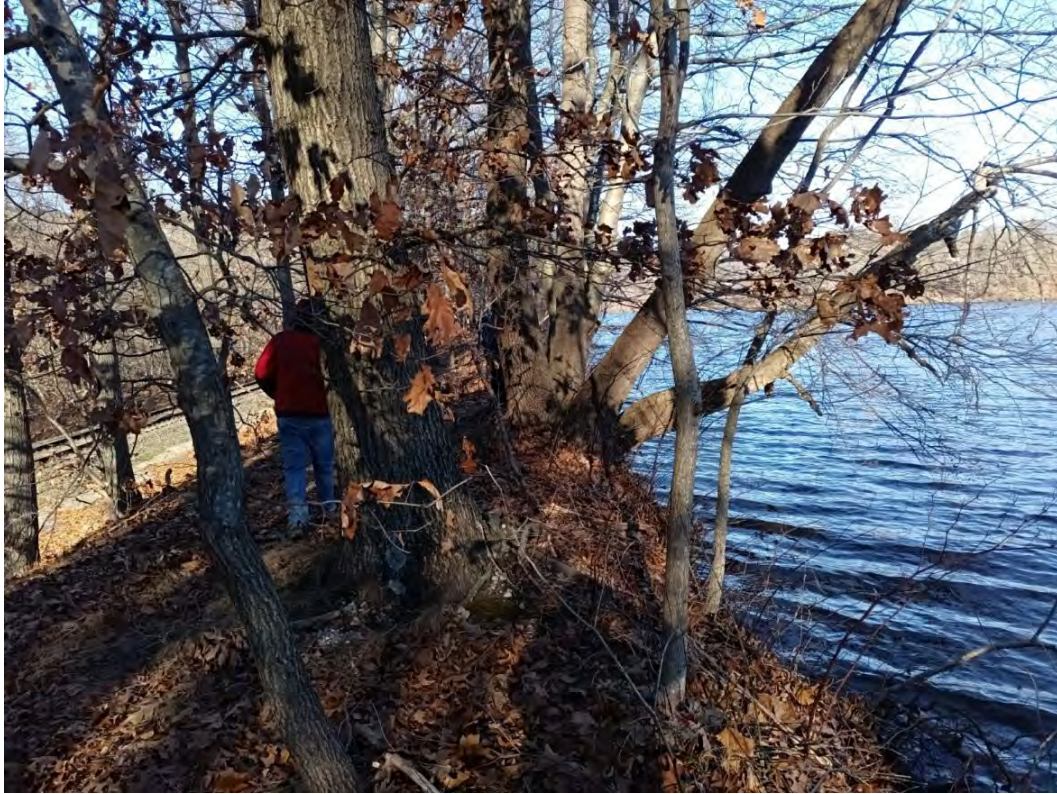
Photo 5. View of Tree on Narrow Section of Embankment Crest (Approximately 14 Feet Wide)

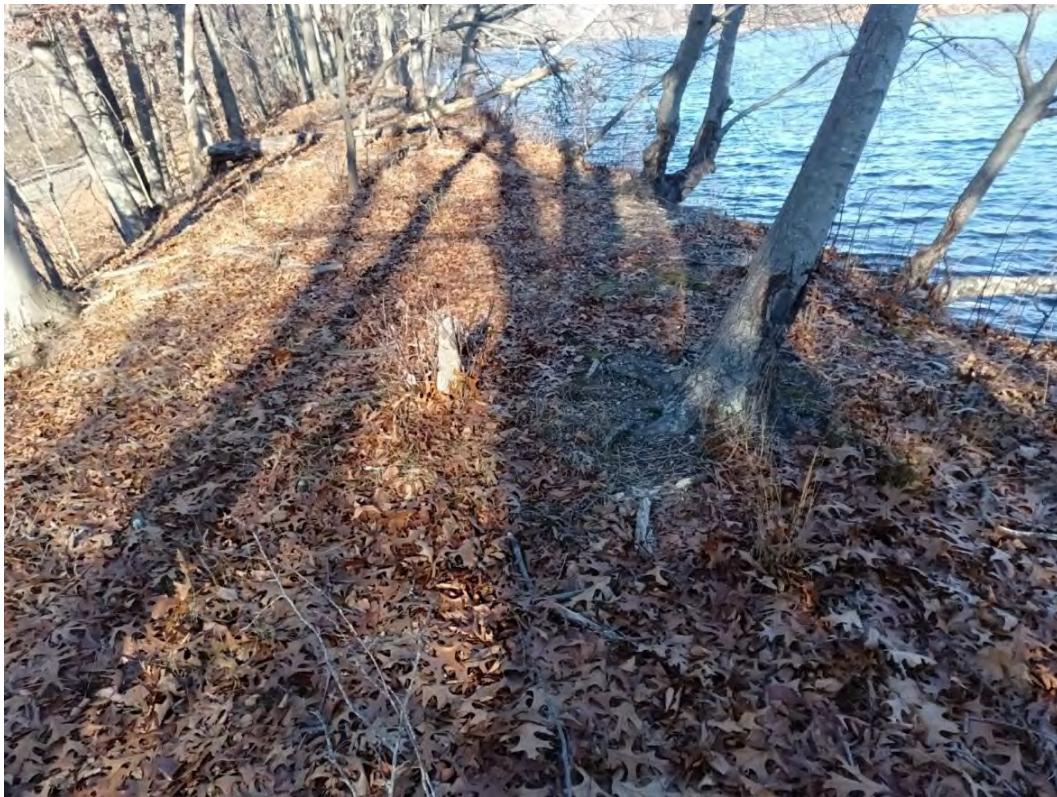
Photo 6. View of Dam Crest. Note Large Diameter Trees and Woody Vegetation

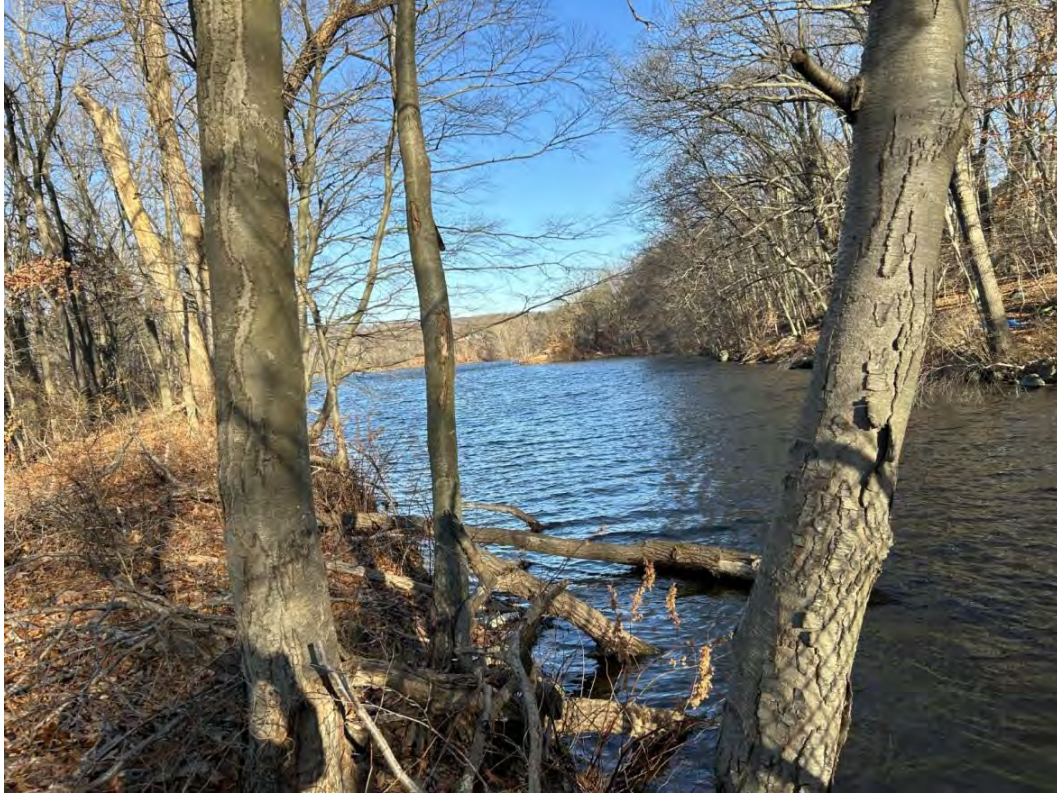
Photo 7. View Inboard Slope of Embankment Dam. Note Large Diameter Trees

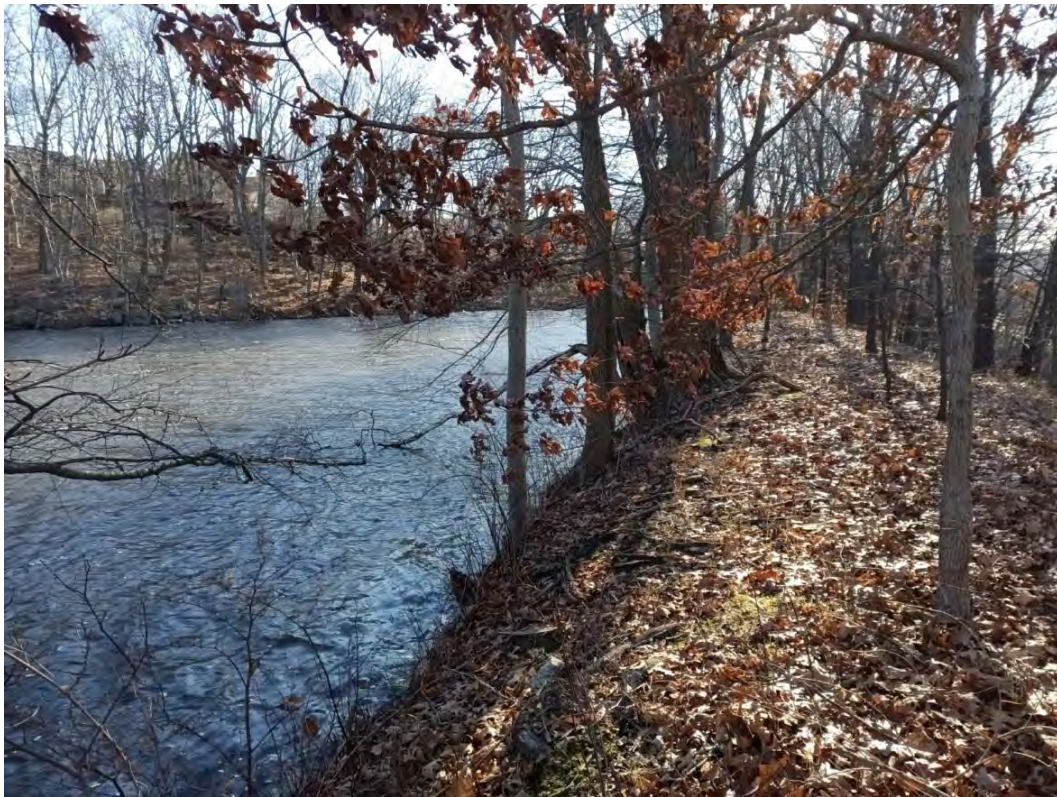
Photo 8. View of Dam Crest and Inboard Slope. Note Steepness of Bank and Large Diameter Trees

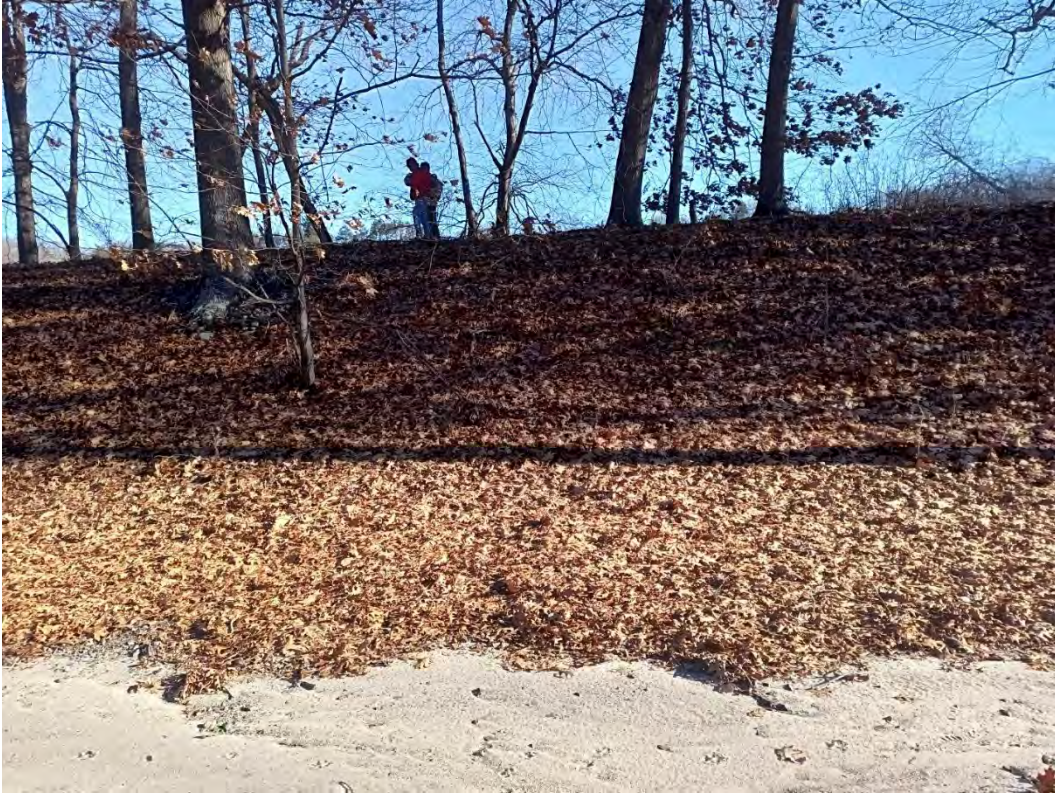
Photo 9. View of Dam Crest. Note Varied Vertical Alignment

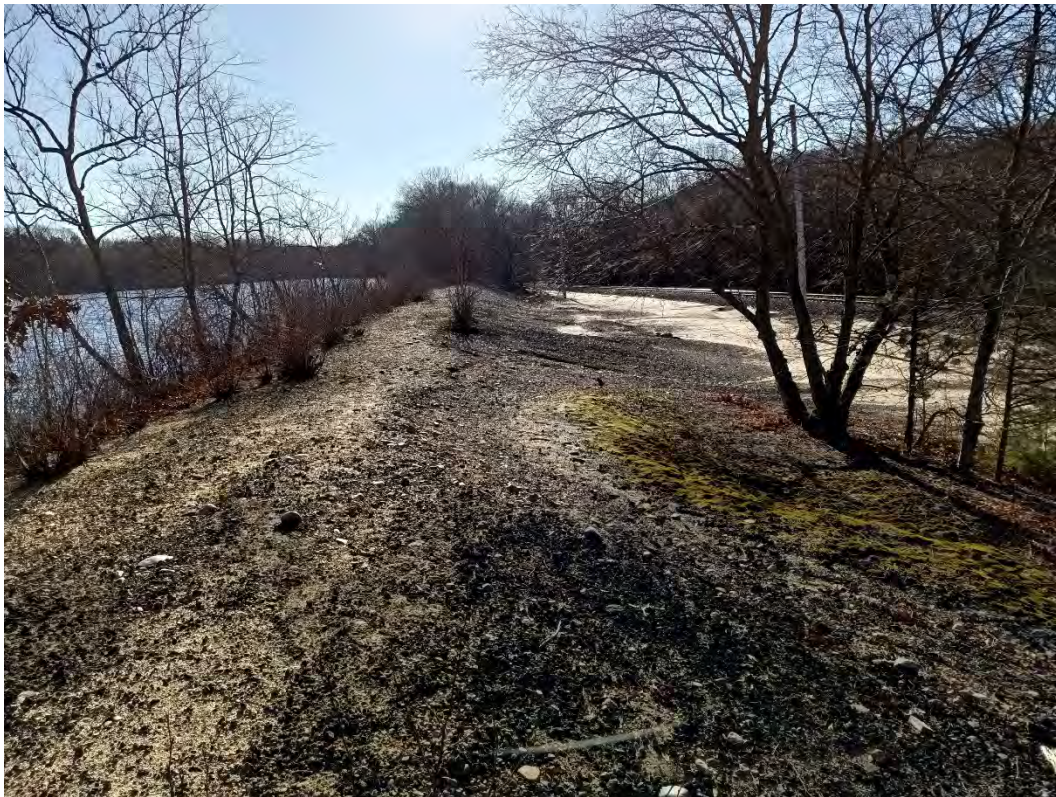
Photo 10. View of Dam Crest. Note Inconsistent Horizontal Alignment

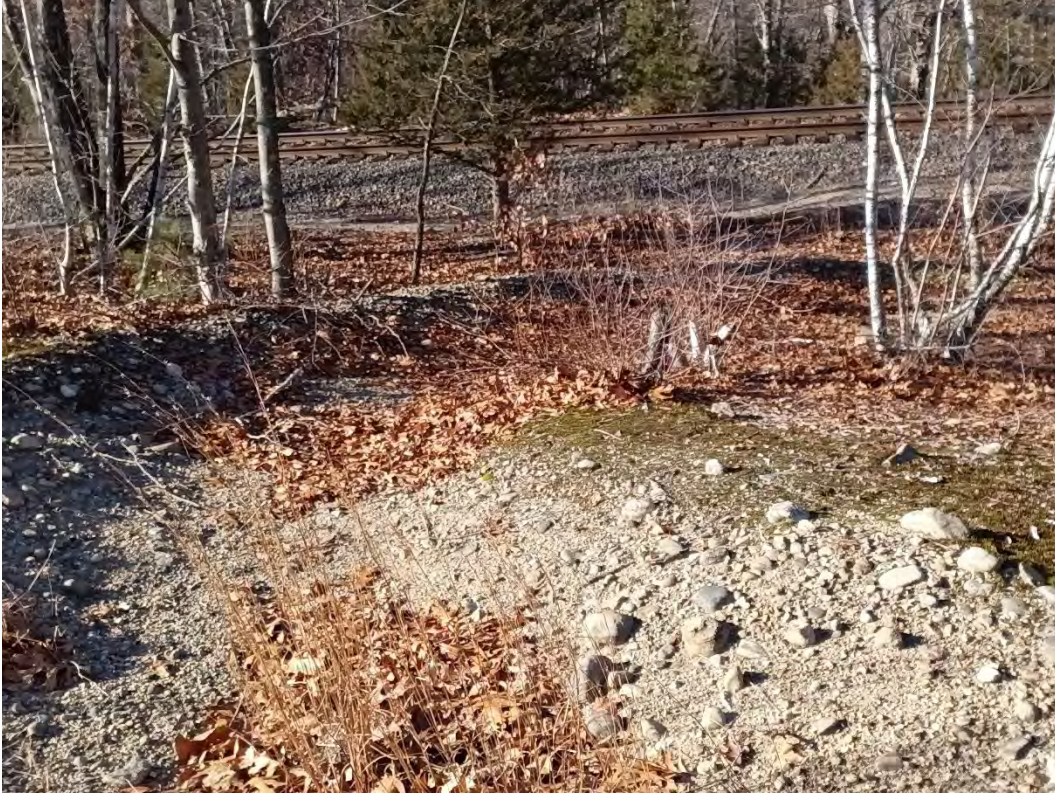
Photo 11. View of Dam Crest. Note Erosion Gully and Gravel
