Coe Pond Dam Inspection Findings

Kinneytown Hydroelectric Project (FERC No. 6985)

MARCH 2024

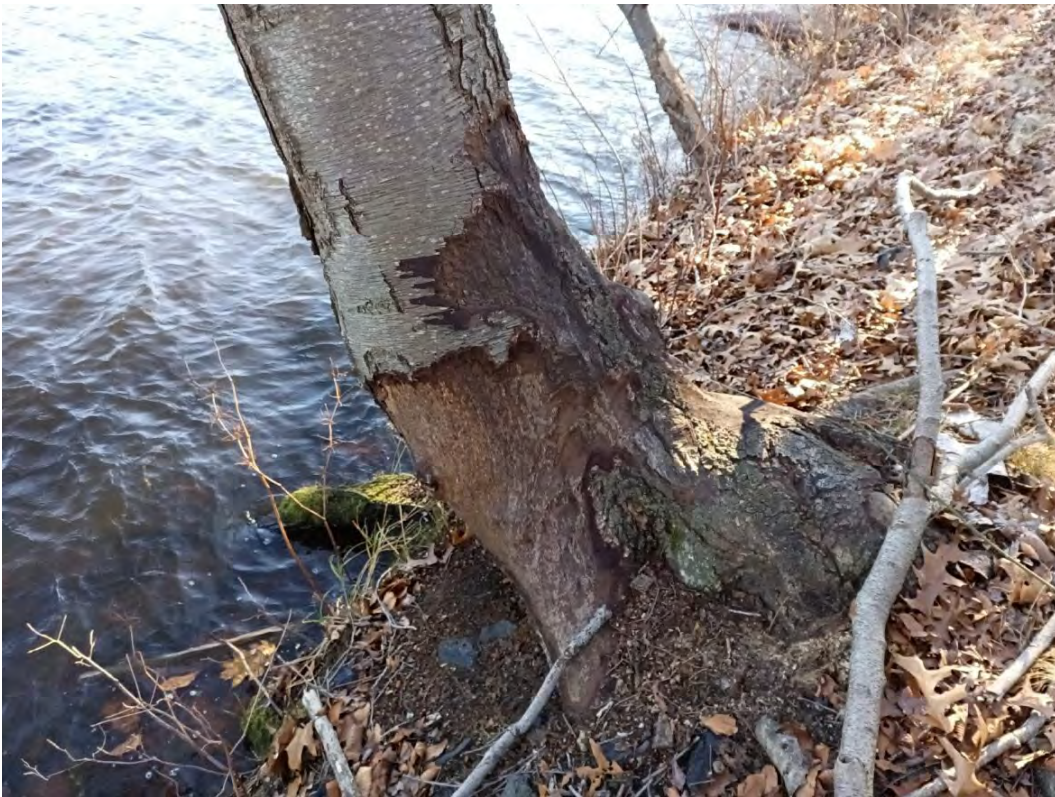
9. Signs of beaver activity along the inboard slope was noted including chewing of trees and abandoned bank dens were observed. Dens within the earthen dam allow water from Coe Pond to potential seep through the earthen dam which can impact the integrity of the earthen dam.

Photo 12. View of Tree on Inboard Slope. Note Damage to Tree Likely Caused by Beavers

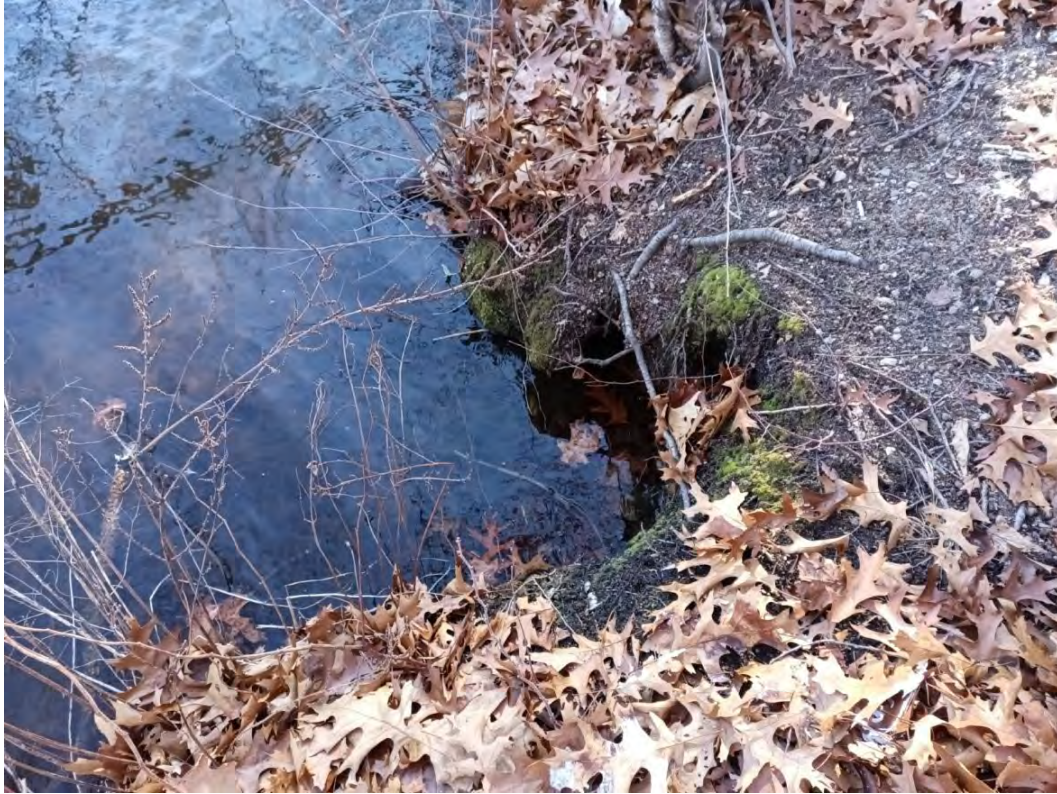
Photo 13. View of Inboard Slope. Note Woody Vegetation and Apparent Rodent Burrow

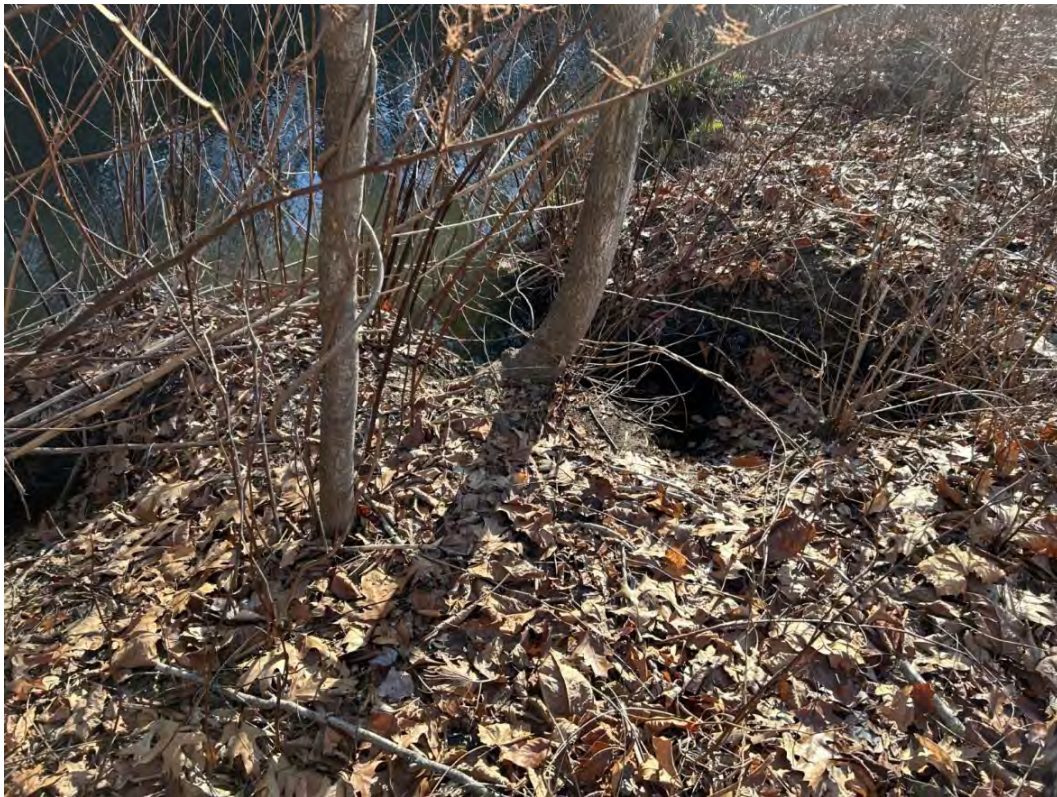
Photo 14. View of Inboard Slope. Note Presence of Woody Vegetation and Evidence of Rodent Burrow

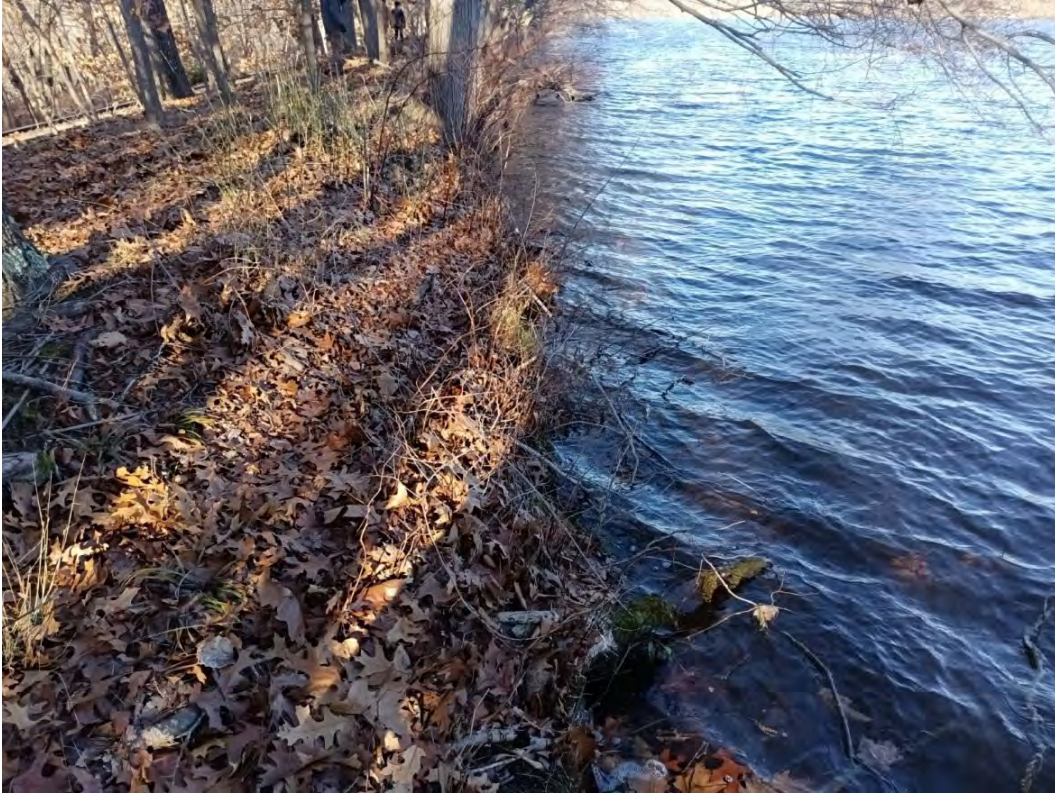
Photo 15. View of Inboard Slope. Note Near Vertical Bank and Lack of Riprap Armoring

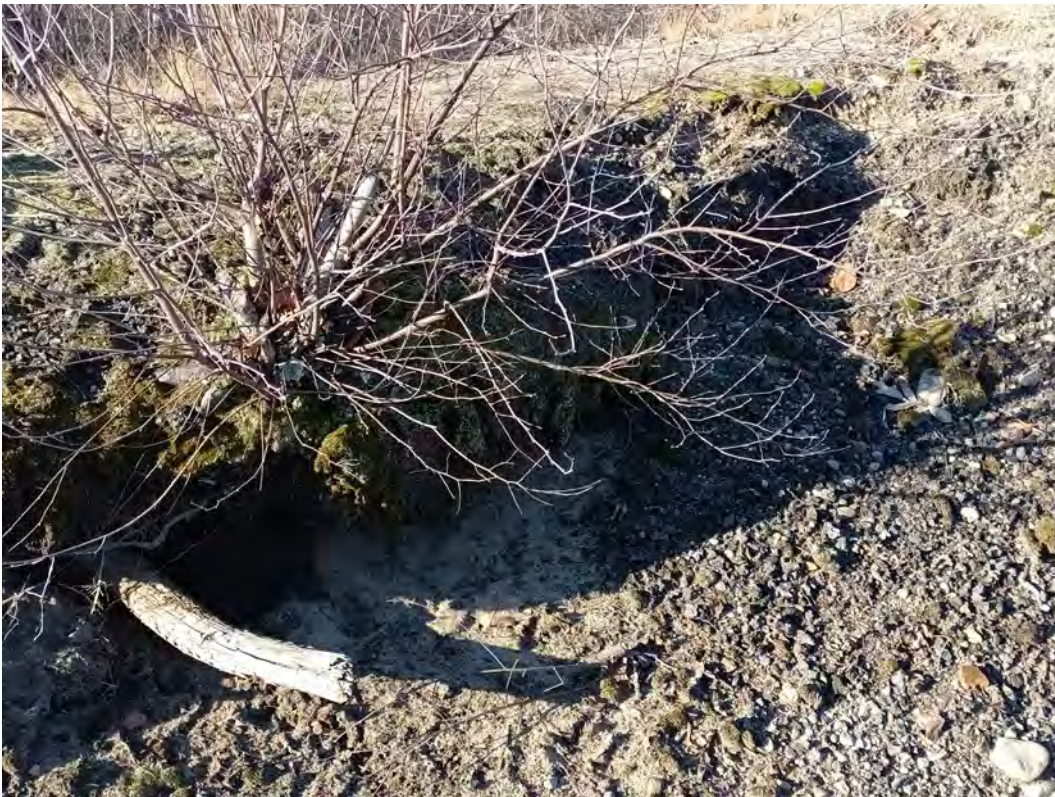
Photo 16. View of Inboard Slope with Erosion Due to Wave Action

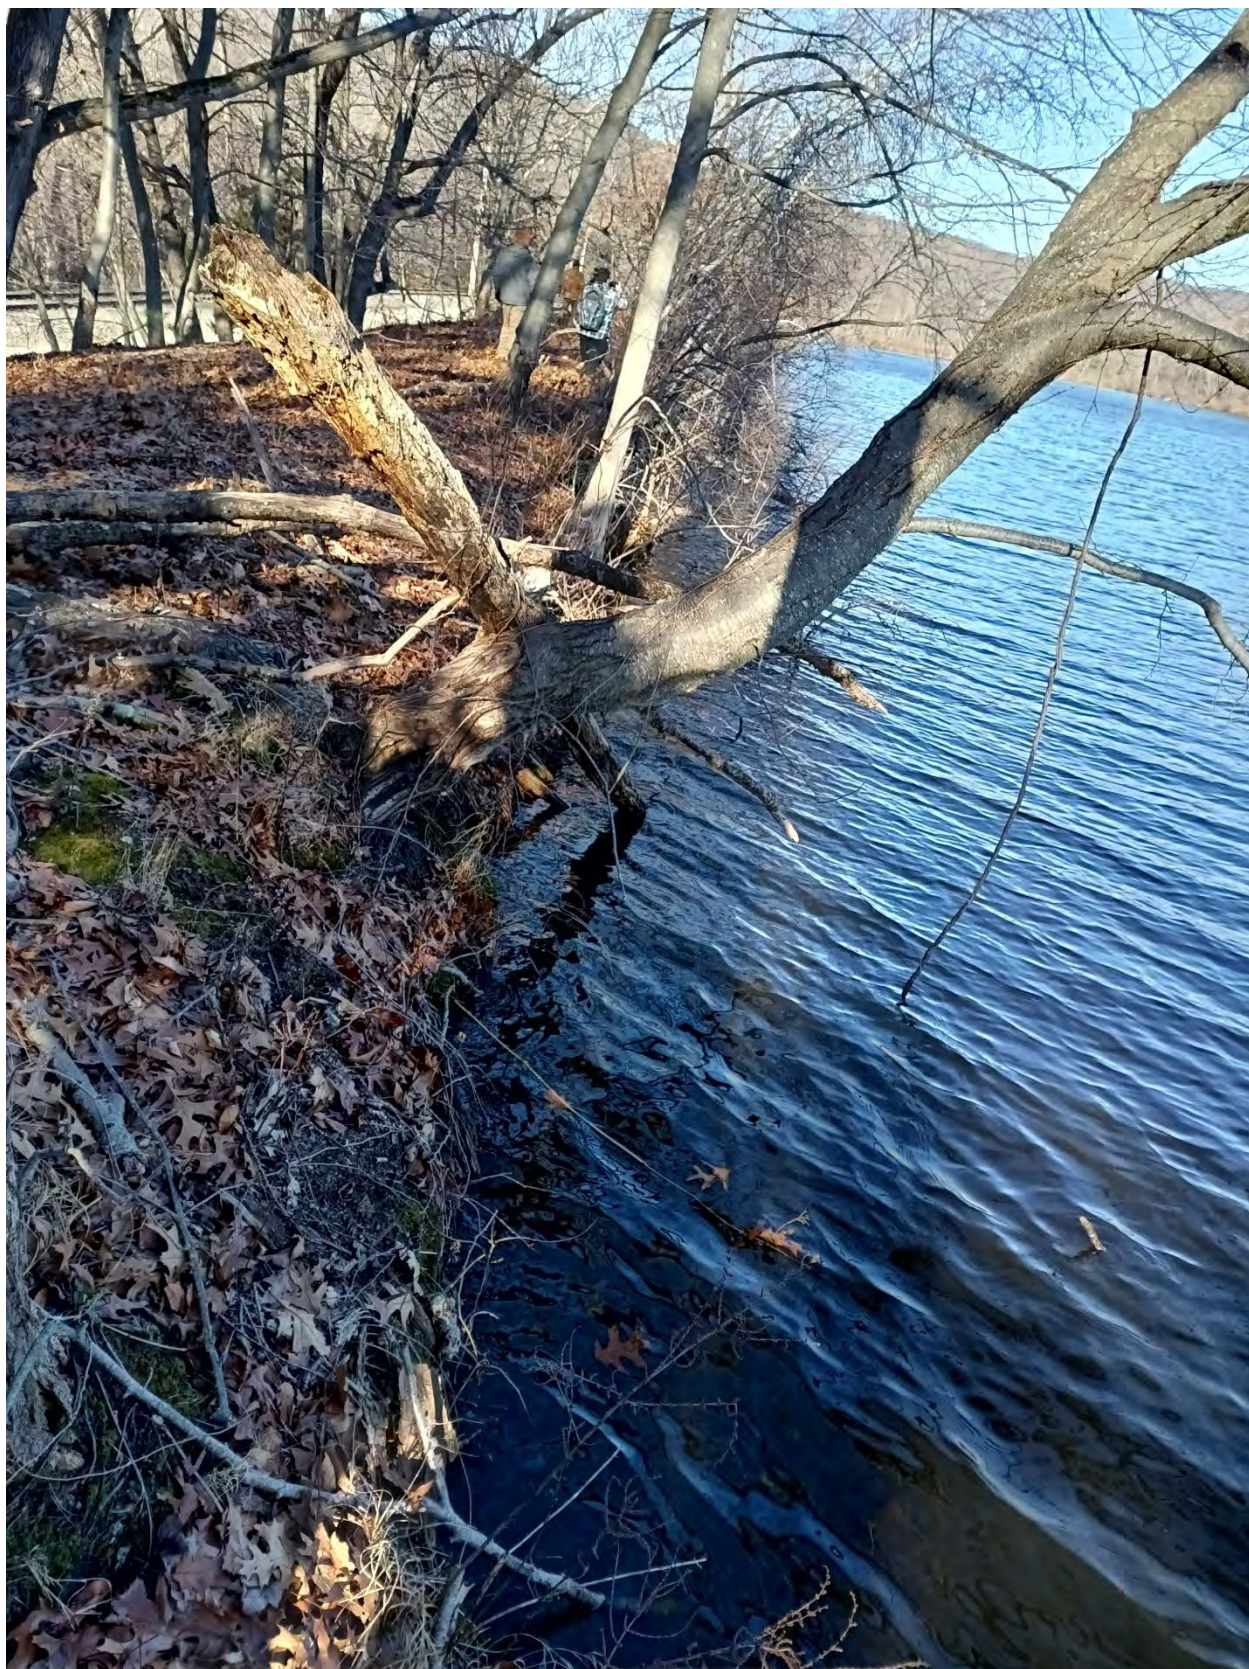
Photo 17. View of Trees Overhanging inboard slope

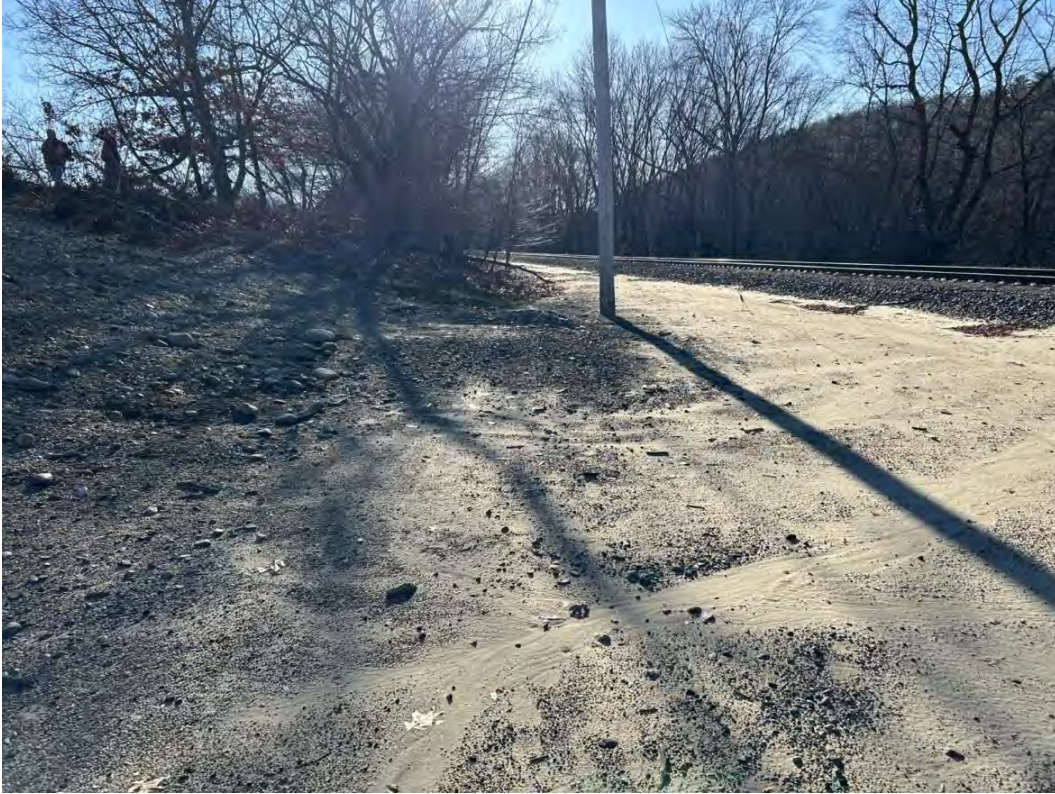
11. Erosion rills⁶, surface erosion of granular materials and areas of possible seepage, were observed in unvegetated areas of the outboard slope.

Photo 20. View of Outboard Slope. Note Heavy Vegetation Beyond, and Erosion Rills in Foreground

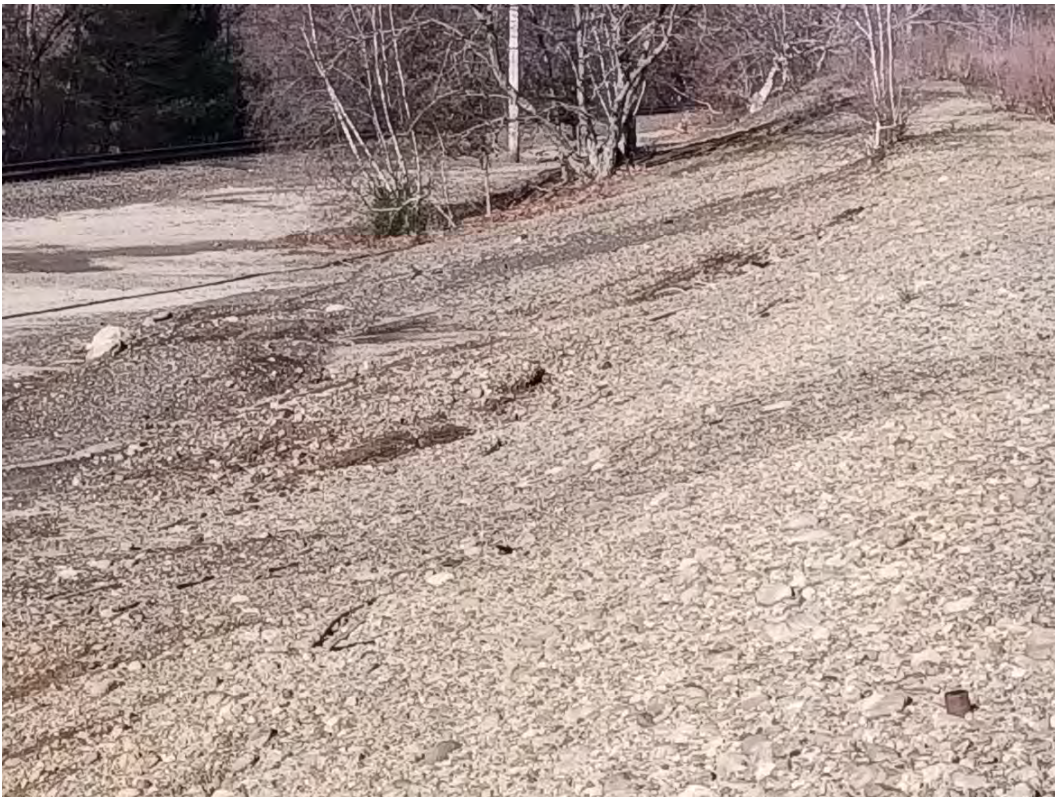
Photo 21. View of Outboard Slope. Note Presence of Silty Sand with Railroad in Background

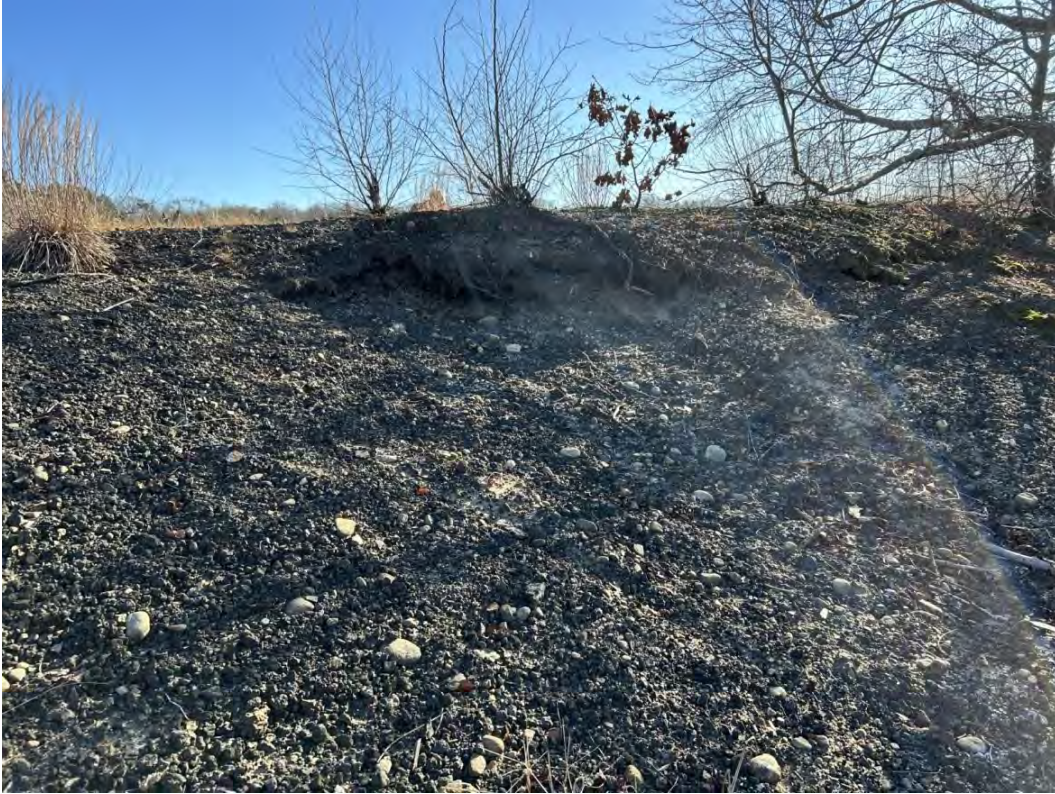
Photo 22. View of Outboard Slope. Note Surface Erosion and Lack of Healthy Vegetation

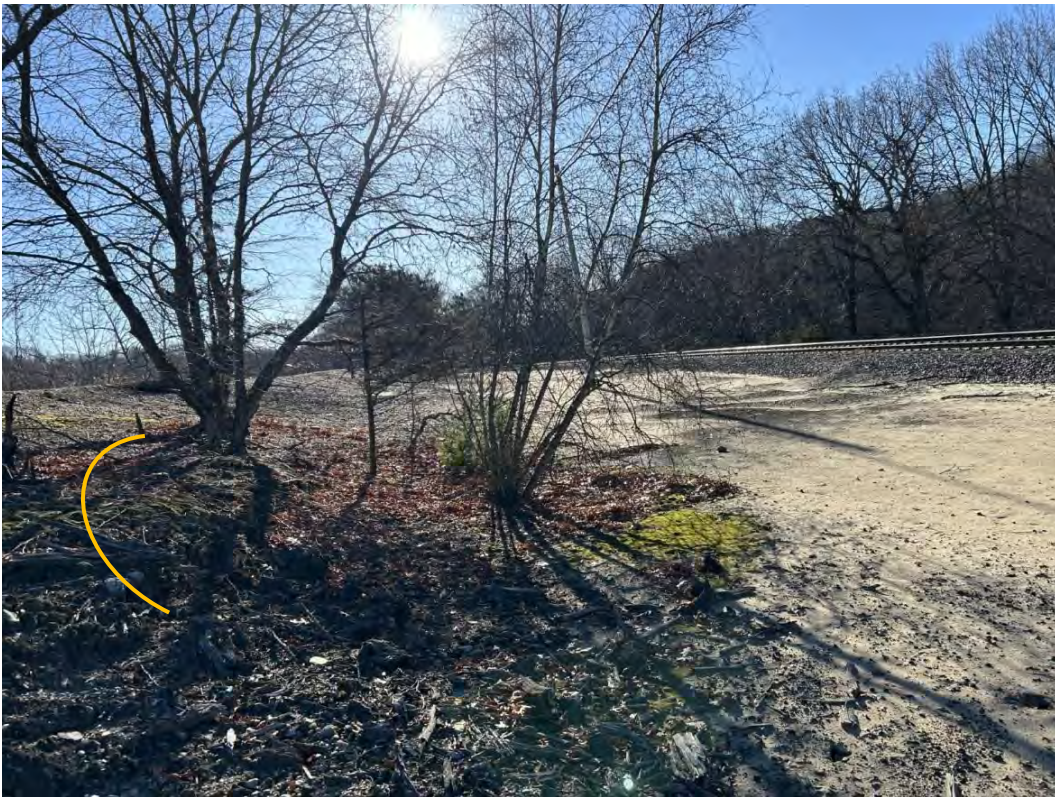
Photo 23. View of Outboard Slope. Note Apparent Shallow Slope Failure

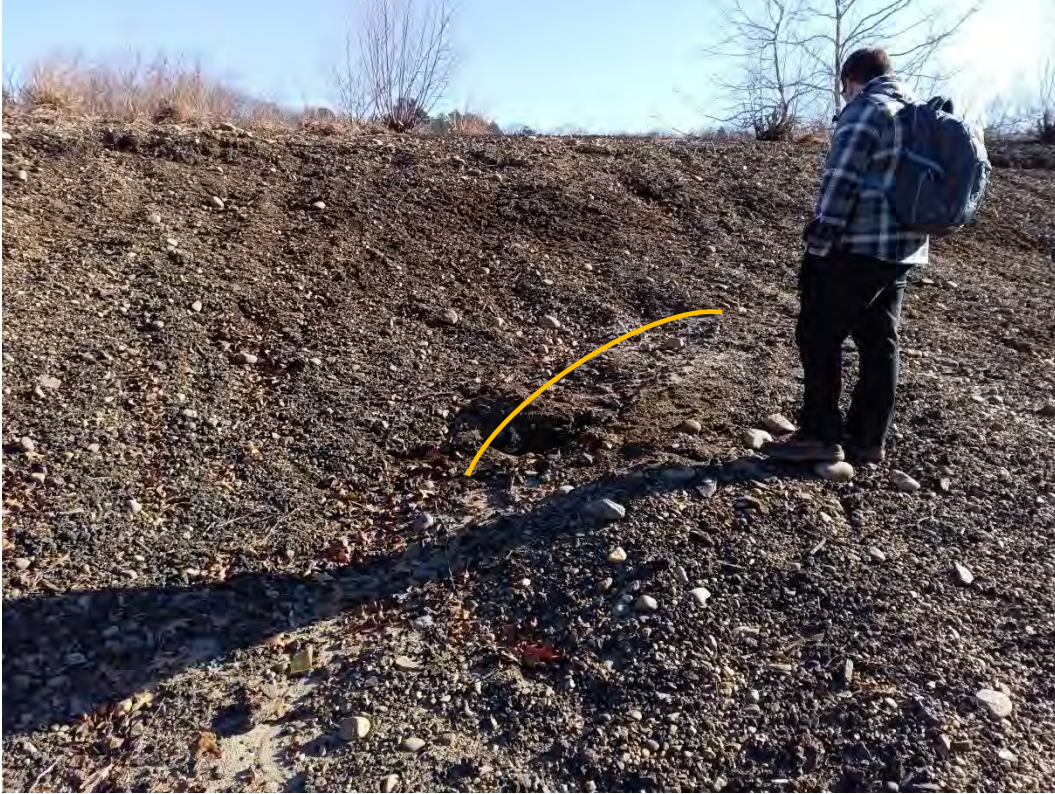
Photo 24. View of Outboard Slope. Note Apparent Shallow Slope Failure

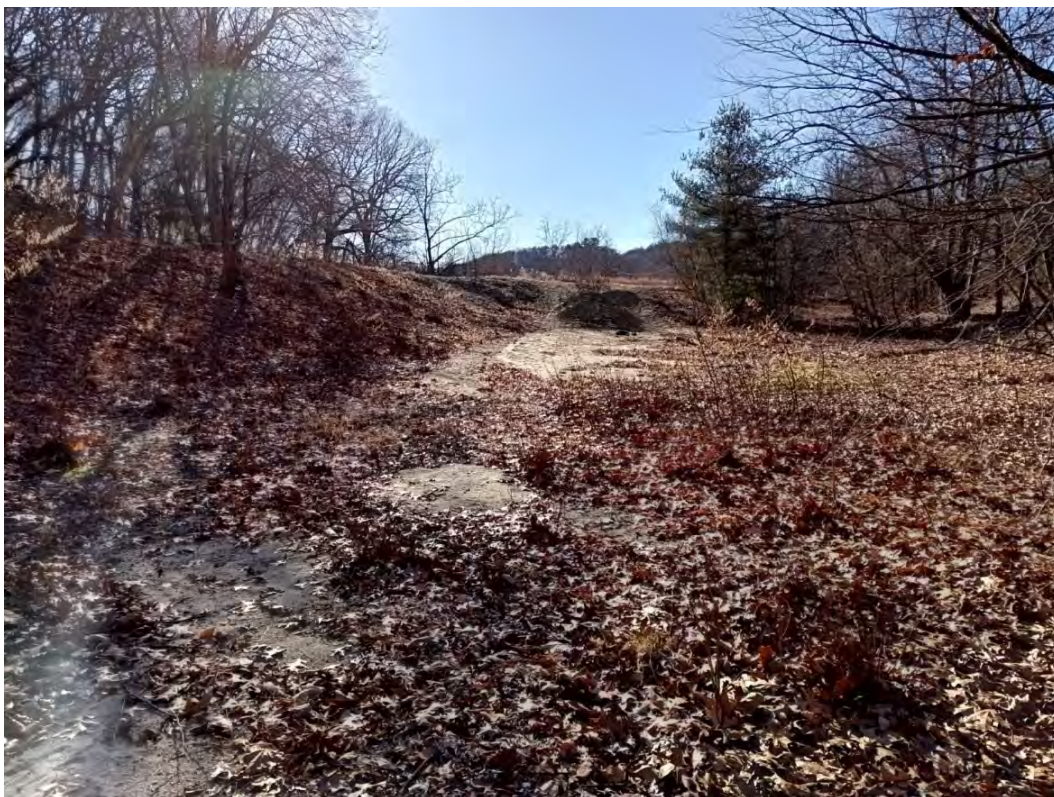
Photo 26. View of Area West of Railroad. Note Presence of Silty Sand

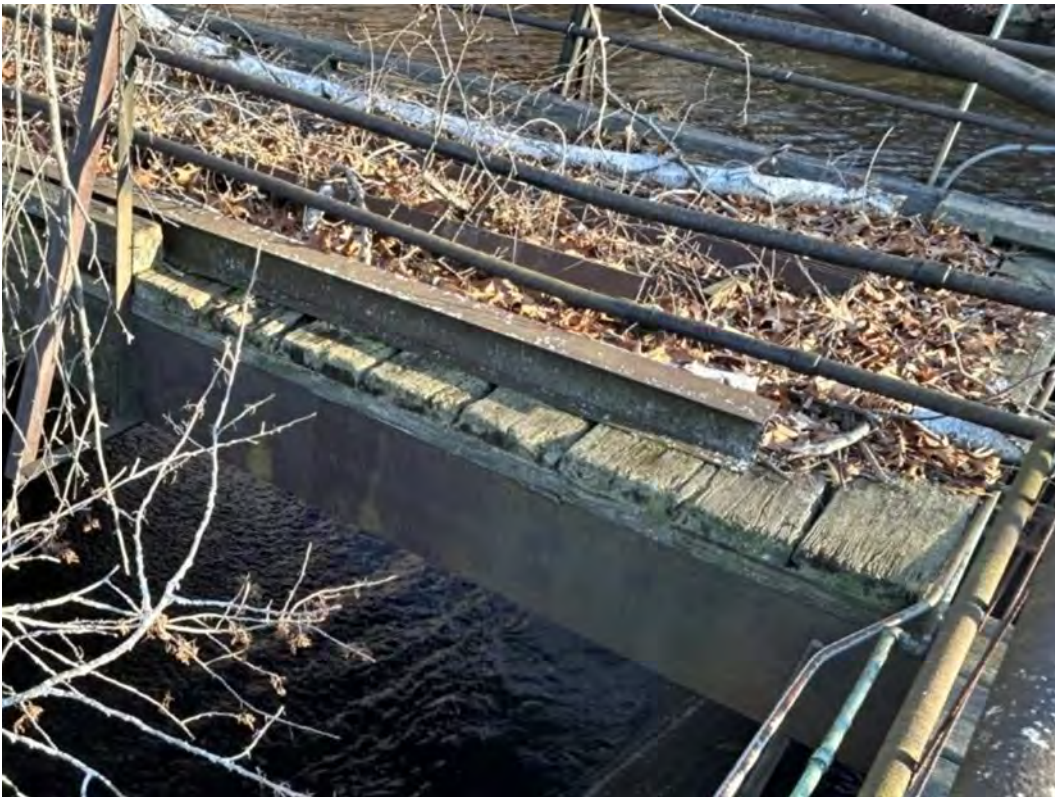
Photo 31. View of Deteriorated Decking
