ROUTE 67 (BANK STREET)
SPOT IMPROVEMENTS
PRELIMINARY ENGINEERING REPORT
SEYMOUR, CONNECTICUT

State Project No. 124-165

February 19, 2014

(Revised March 2016 to include Public Involvement Program)

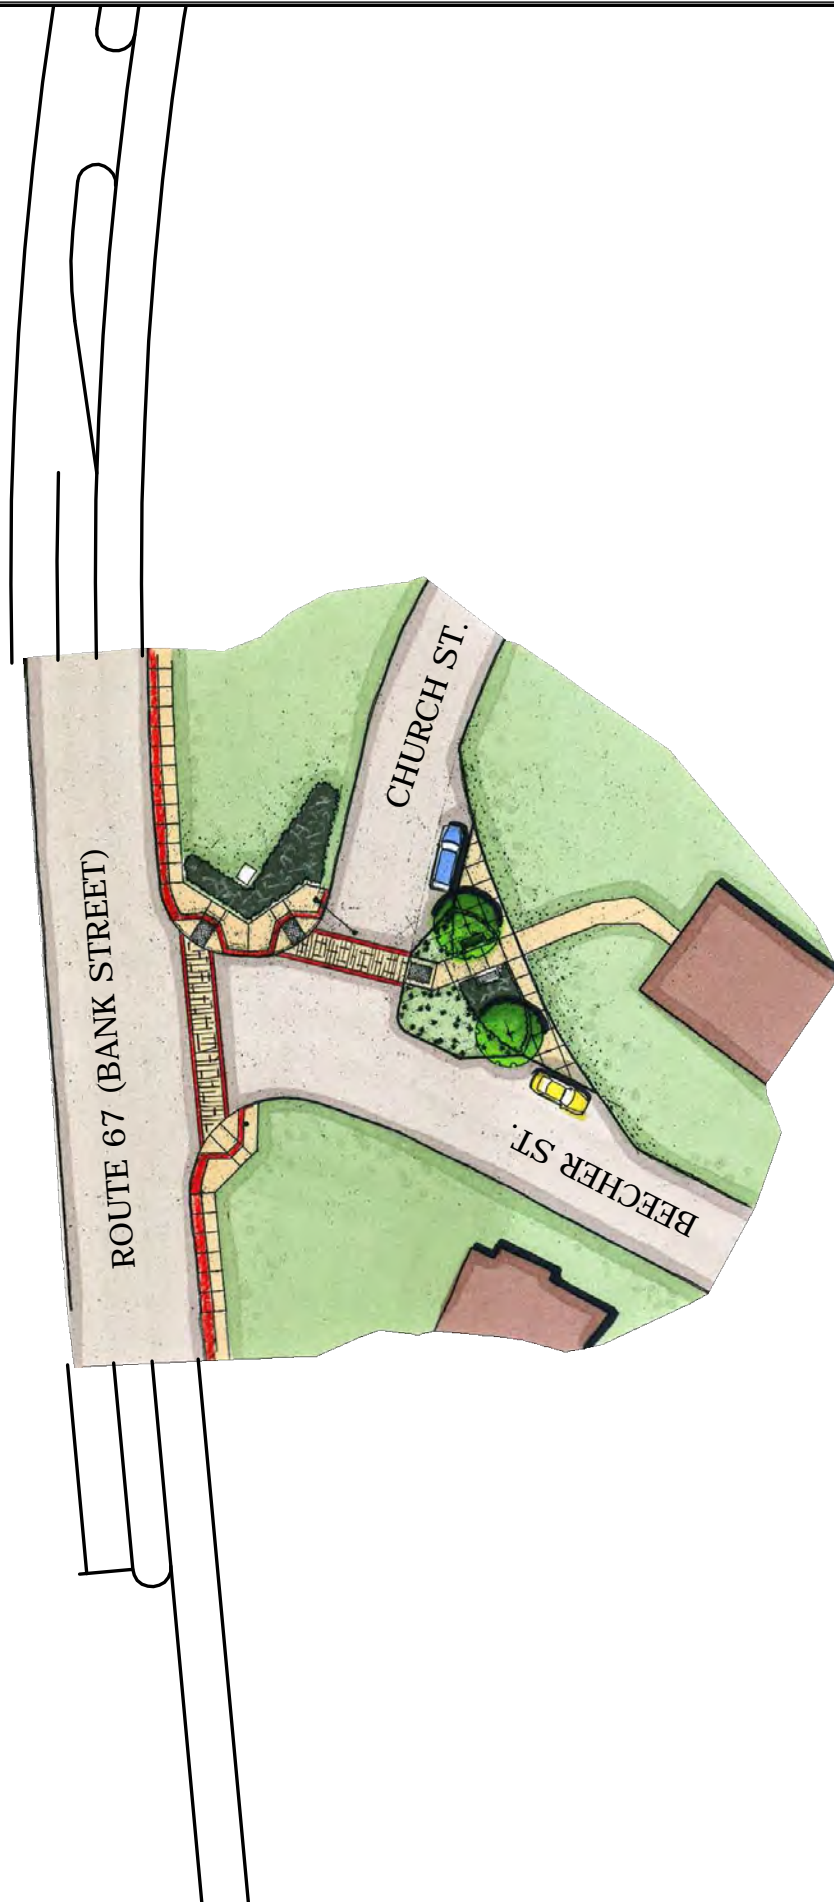
CONCEPTUAL ILLUSTRATION #1

MMI initially considered reconfiguring Church and Beecher Streets such that Beecher Street forms the leg of a T-intersection with Church Street with two northbound approach lanes. In turn, Church Street would be narrowed/realigned at its intersection with Bank Street. This would provide a narrower intersection, reduce vehicular speeds and the potential for conflicts, and shorten the pedestrian crossing distance. However, upon review of site conditions and preliminary engineering efforts, a T-intersection along Beecher Street (instead of Church Street), along with the narrowing and realignment of the intersection at Bank Street, may be more feasible (shown in Figure 6). This figure represents Alternative No. 1.

This alternative will create a safer condition for both vehicular and pedestrian mobility, will result in the same overall improvement to traffic operations at a much lower cost, and will not require the acquisition of private property. This approach will reduce the width of the curb cut at Bank Street and create a T-intersection with Beecher Street and Church Street. Currently, there is an informal roadway/access strip for drop-off and pickup in front of the Russian American Citizen Club. This area is within the public right-of-way but is used almost exclusively by the

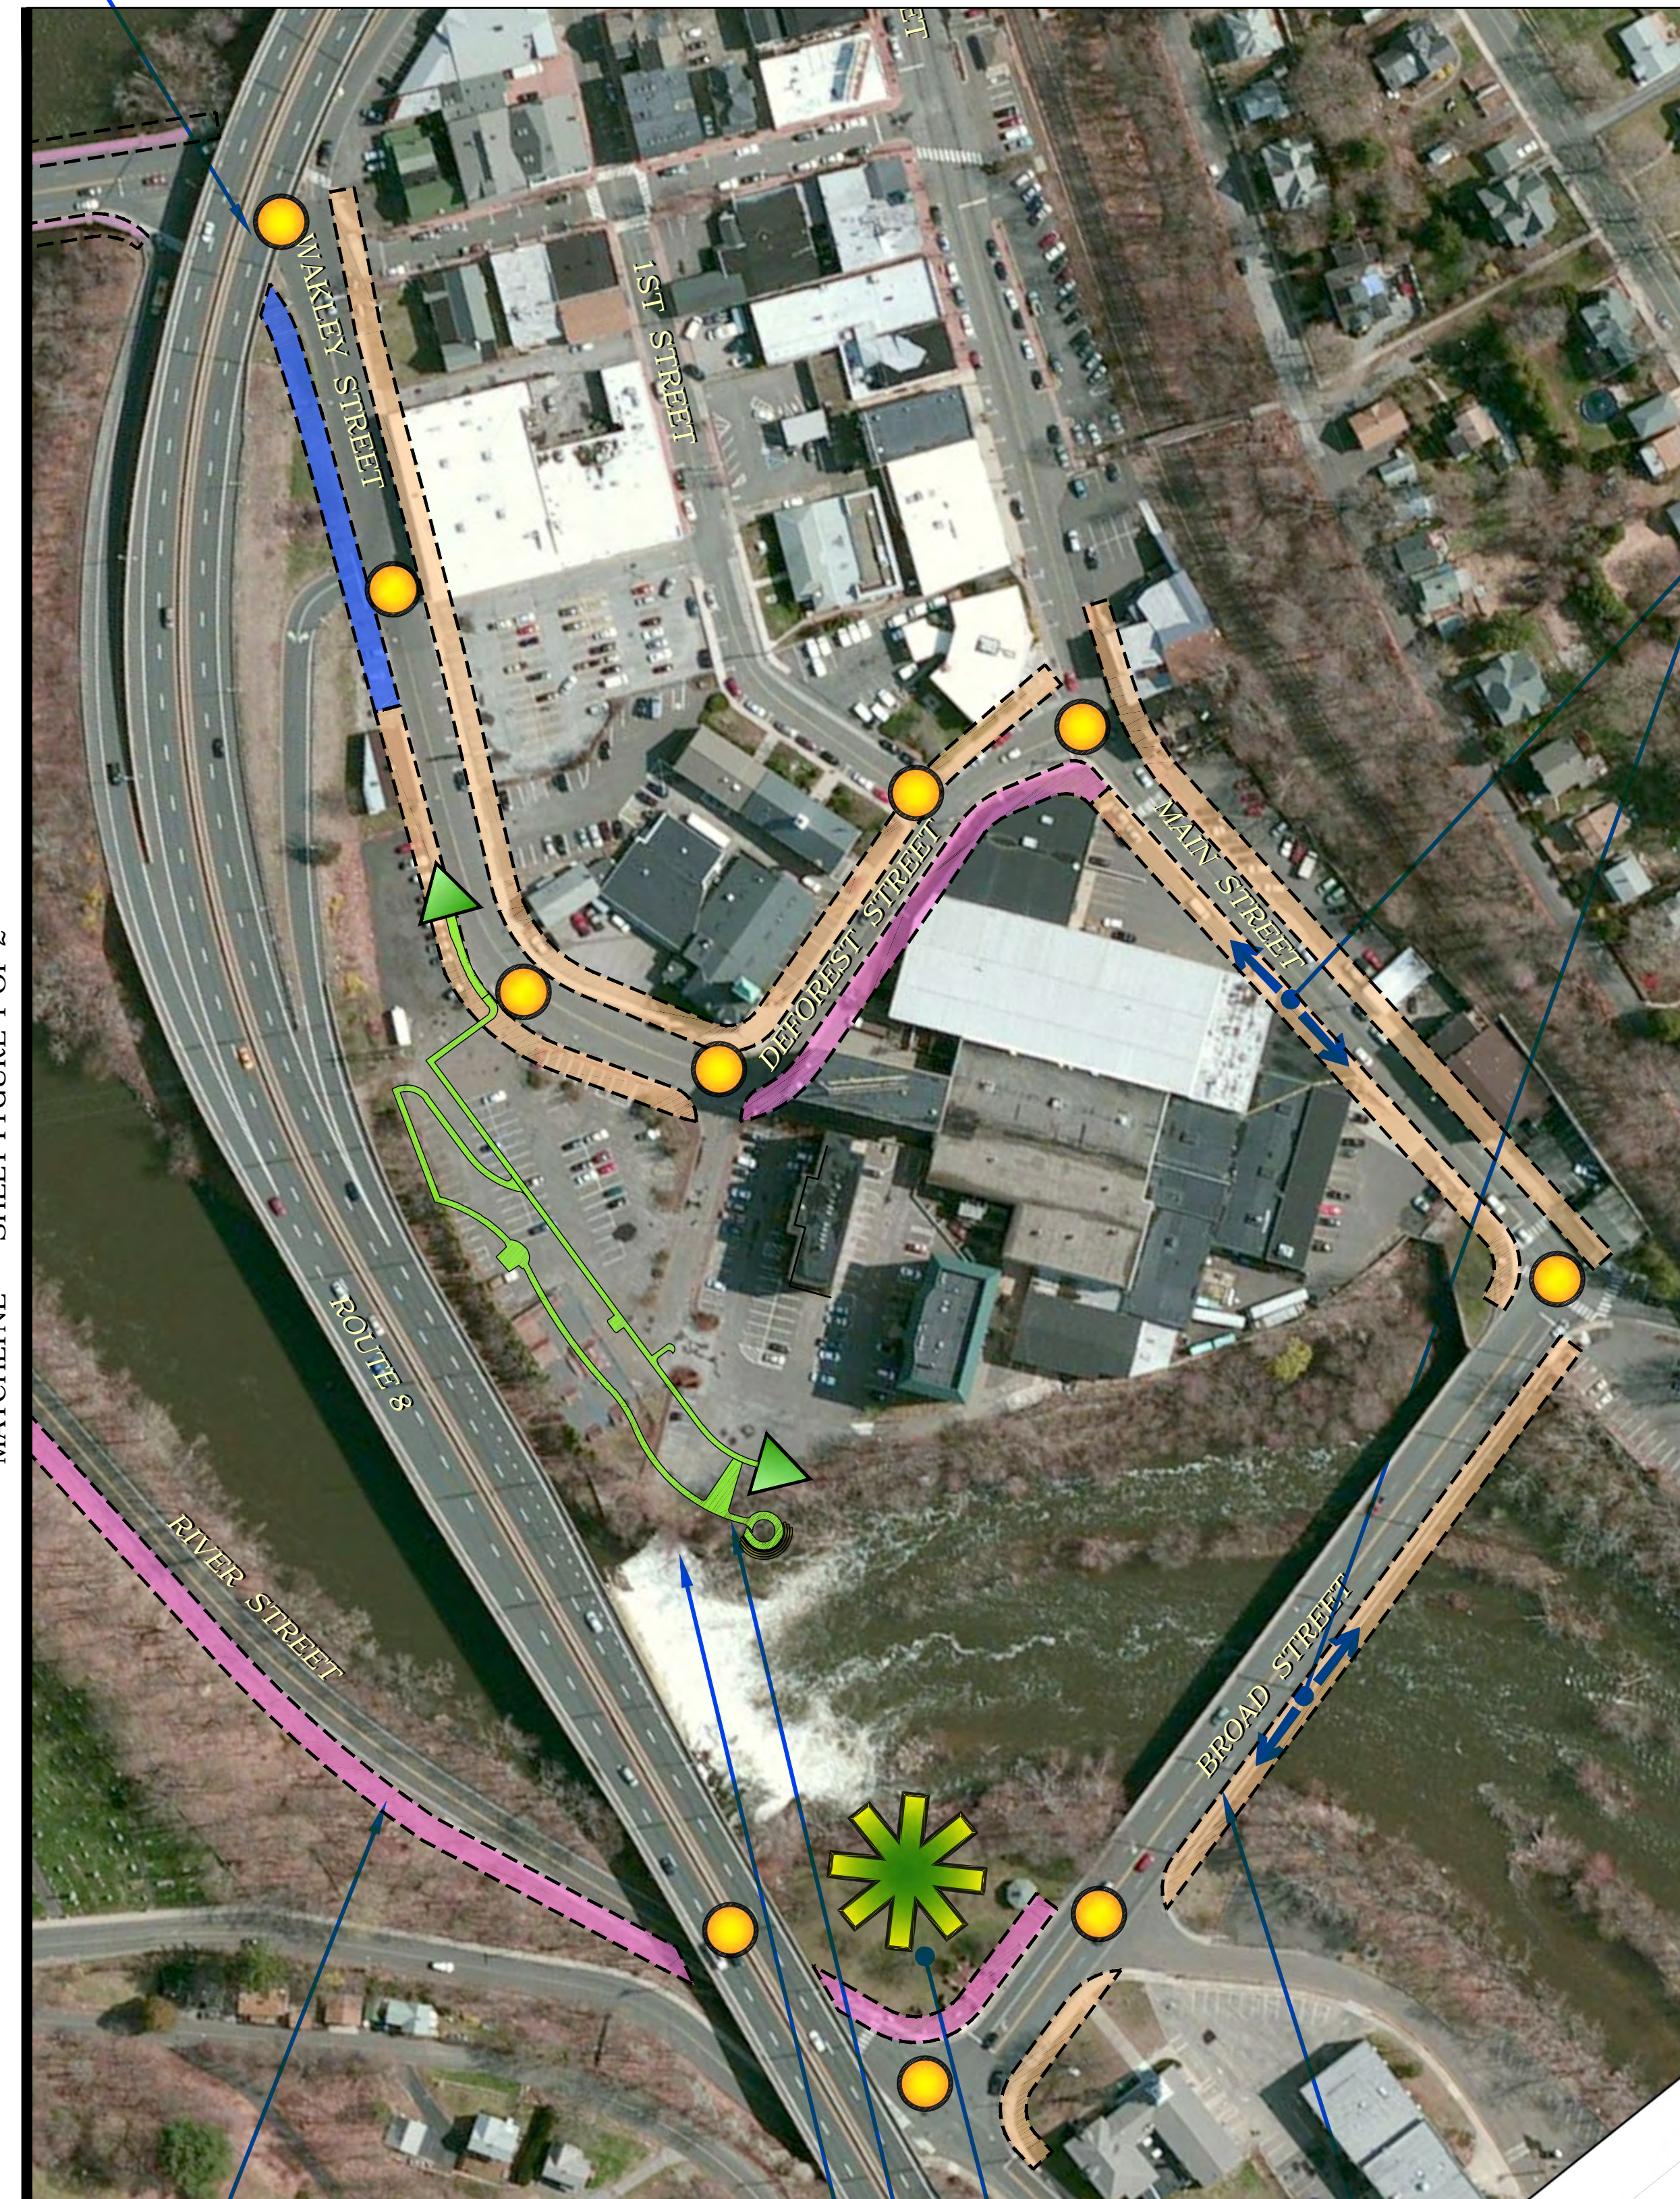
FIGURE 12

Figures 12 and 13 graphically depict the pedestrian circulation gaps and proposed improvements for Bank Street to downtown Seymour. The following summarizes the common issues and opportunities found within the study area.

PROPOSED PEDESTRIAN CIRCULATION - PROJECT CORRIDOR

REPLACE EXISTING SIDEWALK W/10' WIDE MULTI - USE TRAIL &
ADD PROPOSED IMPROVEMENTS, LIGHTS, BENCHES, ETC.

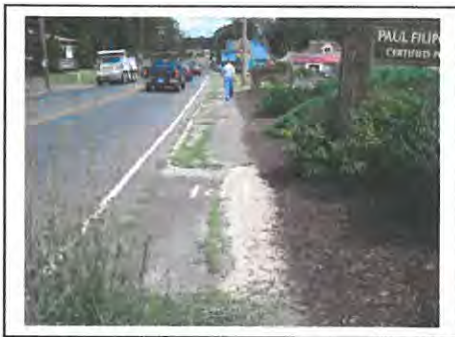
S. Side of Bank Street at Klarides

- Bituminous concrete sidewalks in poor condition and approx. 5' wide
- Curb reveal is less than 6"
- Mulch from adjacent landscape bed is migrating onto walk – need for curb at
- Abandoned curb cut

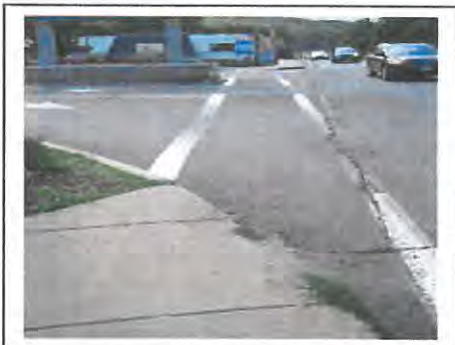
S. Side of Bank Street at Klarides Entrance

- Crosswalk does not meet current standards
- Drop curbs missing ADA tactile warning strips

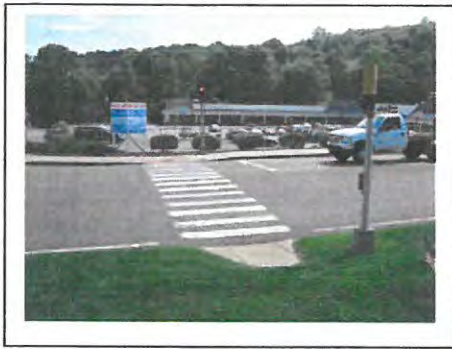
N. Side of Bank Street at Klarides

- No ADA tactile warning strip at crosswalk
- Ped signal, but no sidewalk along north side

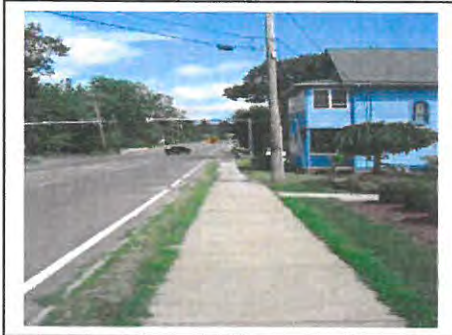
S. Side of Bank Street south of Klarides

- Concrete walk in good condition
- Grass strip at edge of road is maintenance problem
- Consider extending walk to back of curb
- Adequate space for site lighting (minimal overhead conflicts)

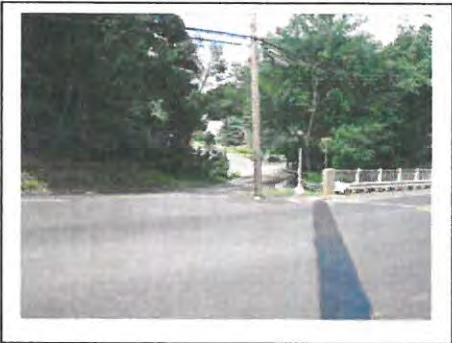
Pedestrian Crossing at Bank and Old Drive

- No dedicated painted crosswalk
- No ADA tactile warning strip on south side of Bank Street
- Note: no sidewalk exists along the north side of Bank Street
- This crossing provides ped. Access to the walk along Old Drive

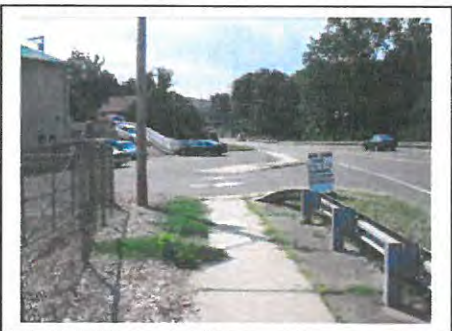
S. Side of Bank Street at Allen's Plumbing Supply

- No painted crosswalk
- Drop curbs missing ADA tactile warning strips

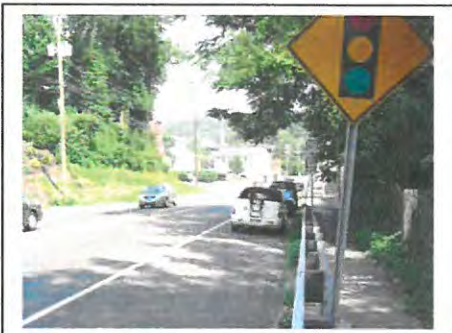
S. Side of Bank Street Adjacent to Little River

- On-street parking is an advantage
- Existing guiderail conflicts with ease of pedestrian movement from the car to the sidewalk (as well as the swing of the car door)
- Narrow bituminous sidewalk in poor condition
- Chain link fence is uninviting – consider optional fence treatment

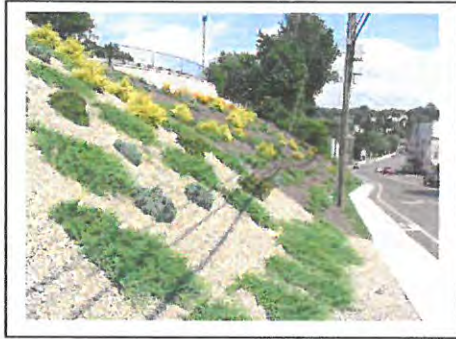
N. Side of Bank Street at Walgreens

- Concrete walk in good condition
- Bank plantings have stabilized slope

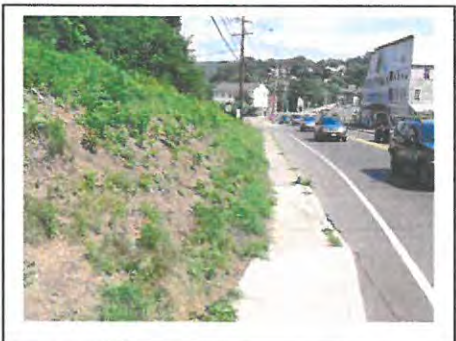
N. Side of Bank Street East of Walgreens

- Slope treatment – low visual appeal and doesn't match treatment at Walgreens.
- Concrete sidewalk in fair condition

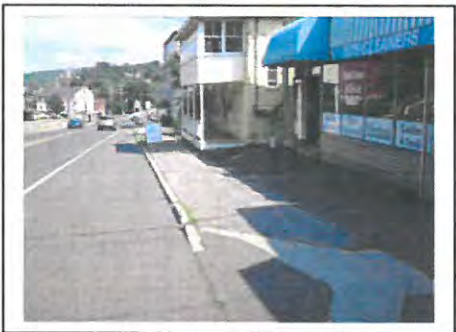
S. Side of Bank Street at Ed's Cleaners

- Curb reveal is less than 6" high
- Bituminous concrete sidewalk in poor condition
- Consider expanding new surface treatments to the building façade
- Opportunity for new bench and trash receptacle

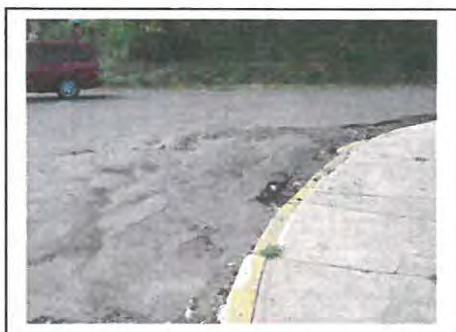
N. Side of Bank St. at Martha St. Intersection

- Concrete and curb in poor condition
- Bituminous concrete road and gutter have failed
- No painted crosswalk or accessible ramps with tactile warning strip

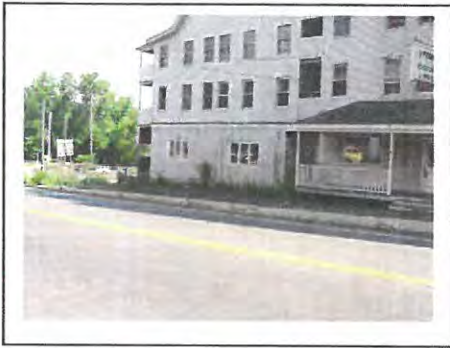
S.Side of Bank Street at Seymour Lumber Co.

- Opportunity to work with developer to enhance streetscape treatments
- Good opportunity to establish streetscape theme here and at the intersection

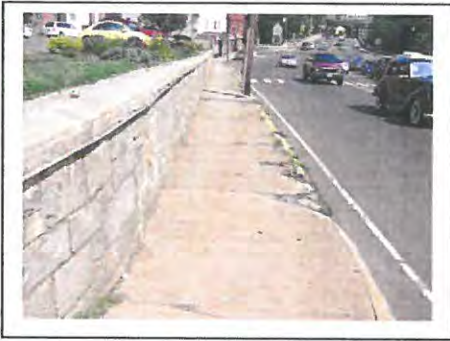
N. Side of Bank Street Approaching RT 313 Intersection

- Concrete sidewalk and curb in poor condition with minimal curb reveal
- Wall in need of repair
- Unsafe mid-block crossing is visible
- No ADA compliant drop curbs/ramps or tactile warning strips

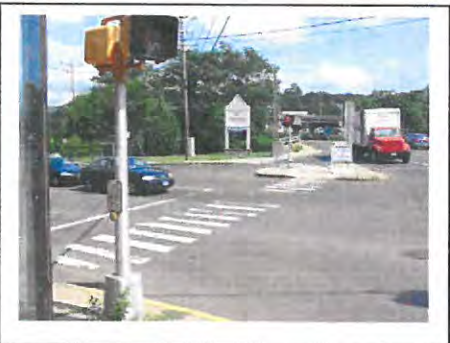
Pedestrian Crossing at Intersection of Bank and Franklin

- Crosswalks are poorly defined
- No ADA drop curb/ramp or tactile warning strips
- Note: no sidewalk exists along the north side of Bank Street
- This crossing provides ped. Access to the walk along Old Drive

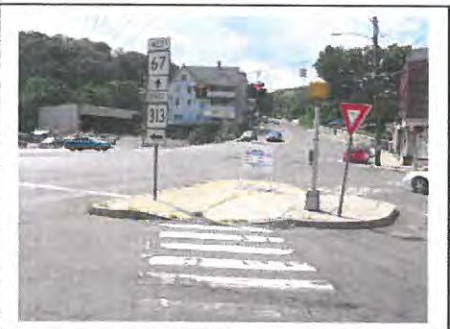
Pedestrian Crossing at Intersection of Bank and Franklin

- Excessively wide street crossing with no area of pedestrian refuge
- Consider bump out at end of on-street parking to shorten distance

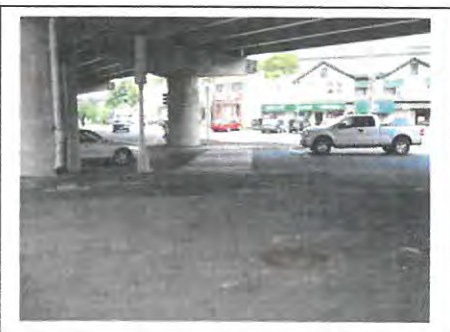
Pedestrian Areas and Crosswalks Below Rt 8

- Area is a sea of pavement and is poorly lit
- Poorly defined pedestrian movements
- Opportunity to introduce new paving treatments and lighting
- Majority of pedestrian crosswalks are lacking ADA compliant tactile warning strips

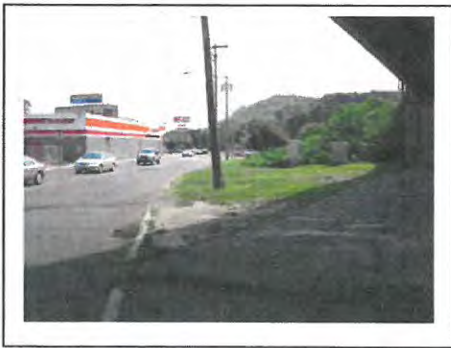
West Side of Wakely Street

- Opportunity for construction of new sidewalks and streetscape enhancements

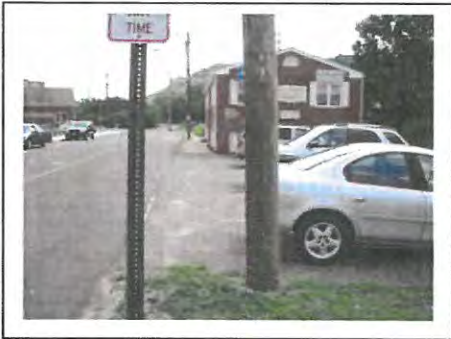
W. Side of Wakely Street at Office Building

- Opportunity to continue dedicated pedestrian walk through parking lot
- Adequate room exists to adjust the limits of paved parking lot to enhance safe pedestrian movement

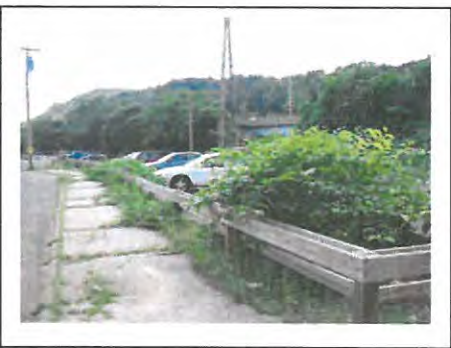
W. Side of Wakely Street at Parking Lot Adjacent to RT 8 and Future Tingue Dam Improvements

- Existing concrete walks and bituminous curb in poor condition
- Establish safe dedicated pedestrian access to waterfront improvements at Tingue Dam

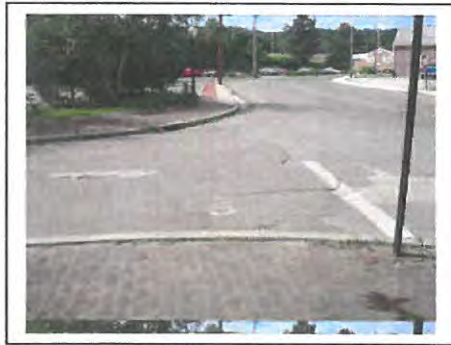
Intersection of Wakely and DeForest Streets

- No painted crosswalk
- No accessible Drop curbs/ramps and missing ADA tactile warning strips
- Existing brick walking surface is uneven, but visually inviting compared to other walks in the area.

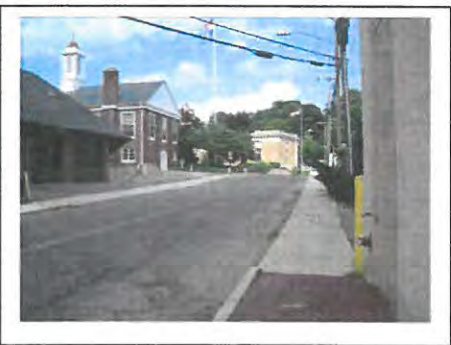
S. Side of DeForest Street

- Limit of brick paver sidewalk
- Concrete in poor condition
- Curb cut appears to be excessively wide and curb reveal is minimal

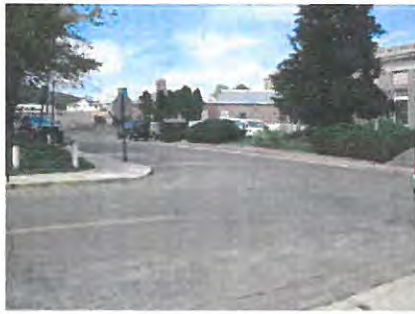
Intersection of DeForest and First Streets.

- No dedicated pedestrian crosswalks, or ADA compliant drop curb/ramp with tactile warning strips.

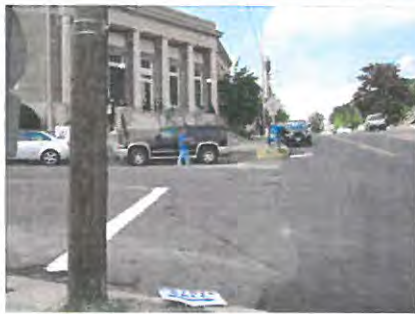
Intersection of DeForest and Main Street

- Lacking dedicated pedestrian crosswalks with accessible drop curb/ramp and tactile warning strips.
- Curb in front of Post Office is excessively high and creates an unsafe condition. Car doors cannot be opened on the sidewalk side of the on-street parking

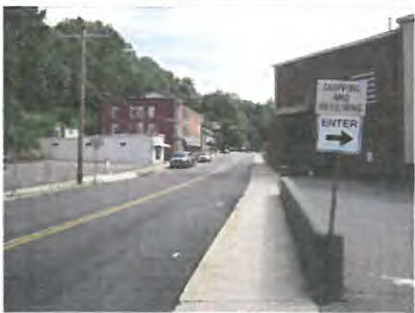
Main Street Sidewalks Looking South

- Concrete walks and curb on west side of street are generally in good to fair condition
- Concrete walks and curb on east side of street are in poor condition
- Opportunity for introduction of pedestrian-level lighting

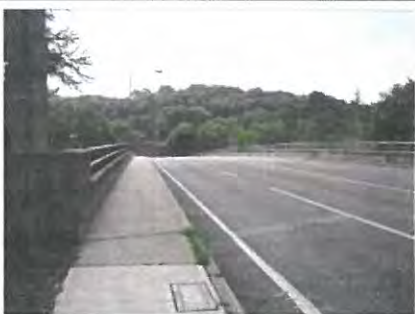
Broad Street Bridge Over Naugatuck River

- Metal Bridge Railing is rusted and would benefit from a new coat of paint
- Consideration should be given to providing pedestrian level lighting, which could be attached to the outside of the concrete rail/wall
- Vehicular speeds are high in this location, with minimal safe walking distance from travelway

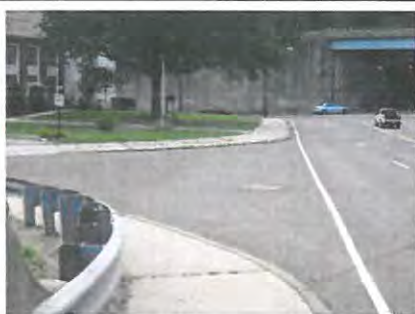
Curb Cut Along South Side of Broad Street

- No dedicated ADA compliant pedestrian crossing

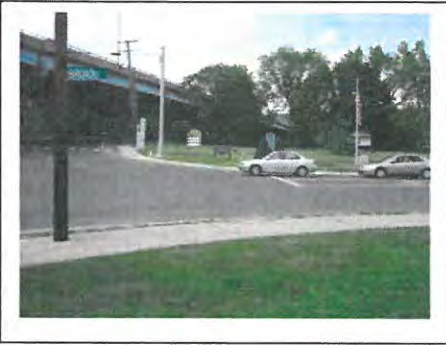
South Side of Broad Street at Route 8 Underpass

- No ADA compliant pedestrian crosswalk here, which denies safe access to the parklet on the north side of the street

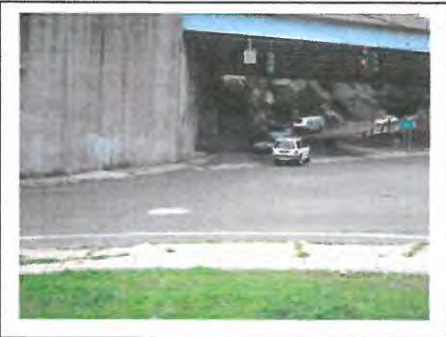
River Street at Bottom of Route 8 Ramp

- No ADA compliant pedestrian crosswalk across River Street or at bottom of ramp.

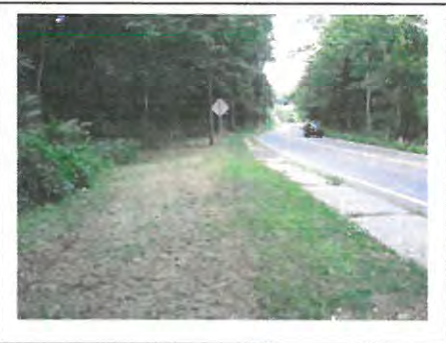
West side of River Street Looking North

- Existing concrete walks and bituminous curb in poor condition
- Wide grass shelf could accommodate wider sidewalks and other amenities, including new landscape treatments
- No sidewalks along east side of road

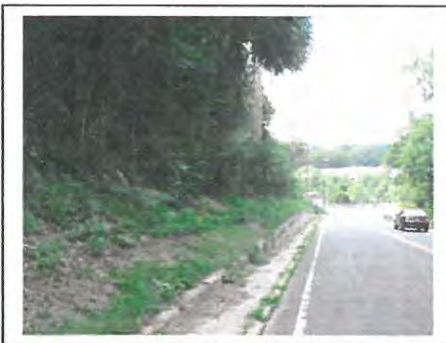
West side of River Street Looking North

- Existing concrete walks and curb in poor condition and very narrow (curb is approx. 2' away from travelway)
- Retaining wall is in very poor condition. Wall ranges in height from approx. 1' to 5'
- Possible horizontal realignment of the road in the direction of the river would permit widening of the walk.

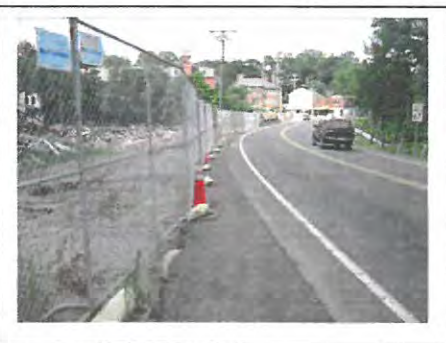
West Side of River Street at Lumber Co.

- Presently no sidewalk exists. It is presumed that this will be corrected as part of the site plan approval process for the new development

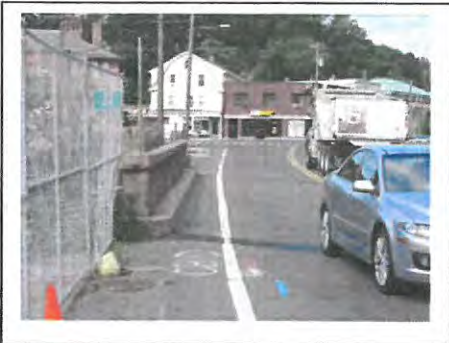
Little River Bridge at West Side of River St.

- No sidewalk at this location
- Consider new prefabricated pedestrian bridge to be located adjacent to the existing concrete bridge
- Existing bridge structure should be evaluated for structural integrity

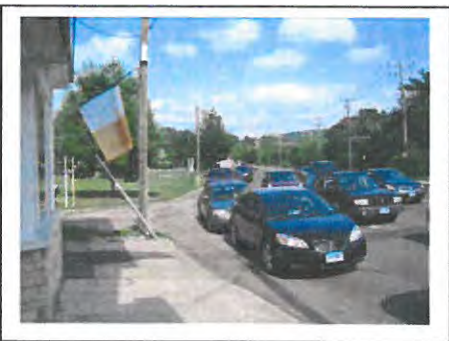
Franklin Street Looking North to Stop n Shop

- Sidewalk along west side of Franklin terminates with no pedestrian linkage to Stop n Shop
- Existing concrete sidewalk in poor condition

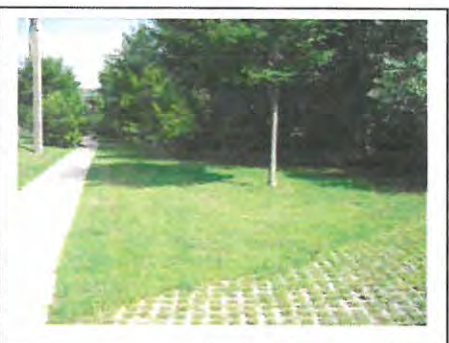
Parklet Along East Side of Franklin

- Existing sidewalk provides a circuitous route to the Stop n Shop
- Area could benefit from pedestrian-level site lighting.

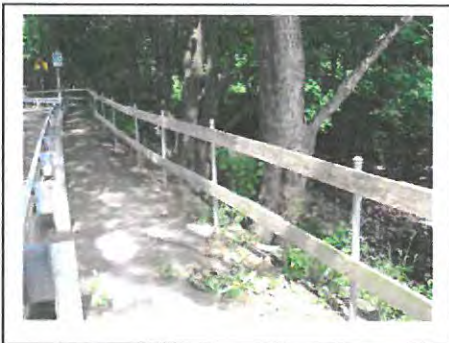
East side of Old Drive Adjacent to Little River

- Existing bituminous sidewalk is narrow and in fair to poor condition
- Timber fence system is not code compliant (based on vertical drop to water, no openings can be greater than 4").
- Existing mature deciduous trees are generally in good condition and provide for an enjoyable, shady walking experience

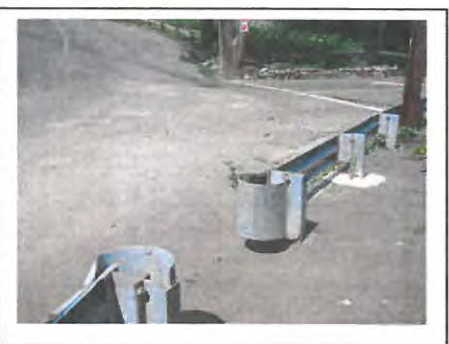
East side of Old Drive Adjacent to Little River

- A single pedestrian opening at the intersection does not provide for safe discharge at the intersection.
- No crosswalks

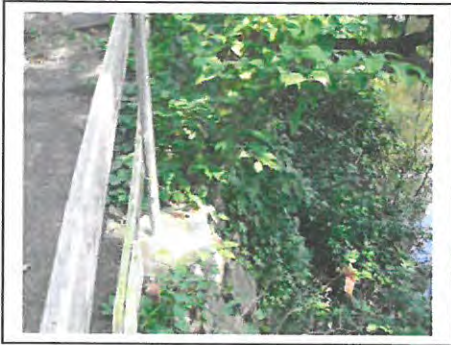
East side of Old Drive Adjacent to Little River

- Vertical drop to river is treacherous
- Structural integrity of the existing cobble wall should be performed

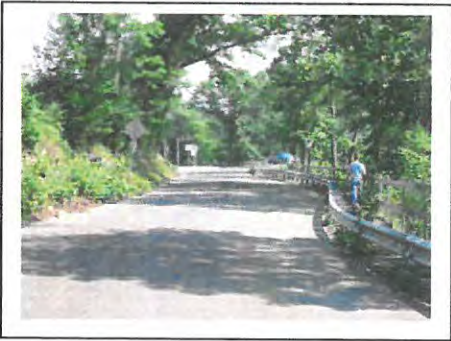
Old Drive Adjacent to Little River Looking East

- One-way vehicular travel
- Road width appears adequately wide to provide for wider, enhanced sidewalks along the water side

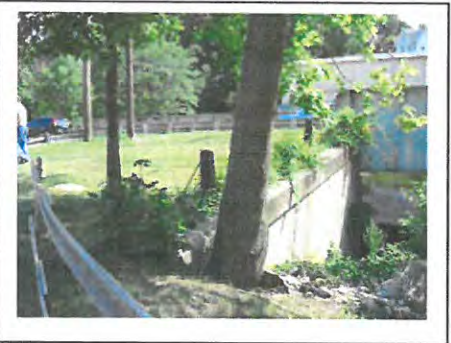
East side of Old Drive Adjacent to Little River

- Small level lawn area at the end of Old Drive provides an opportunity for a small parklet.

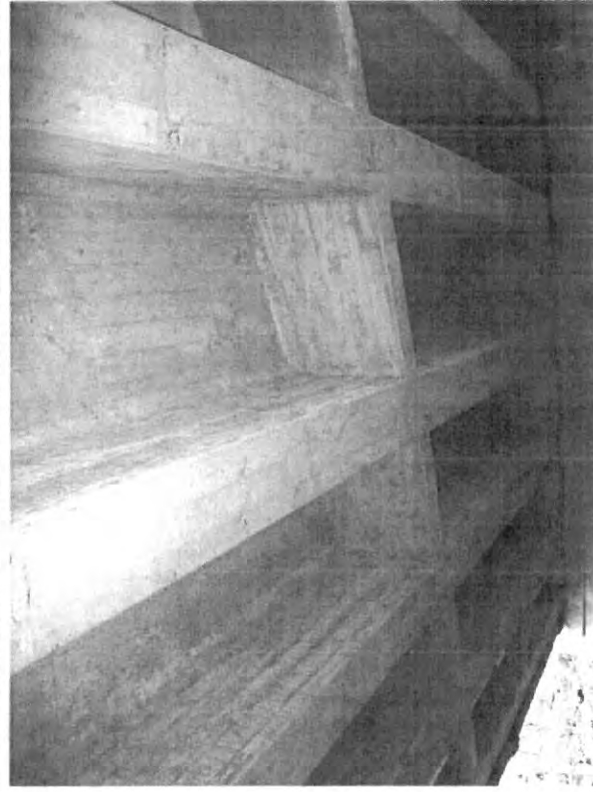
Photo # 15: View of Superstructure Underside.

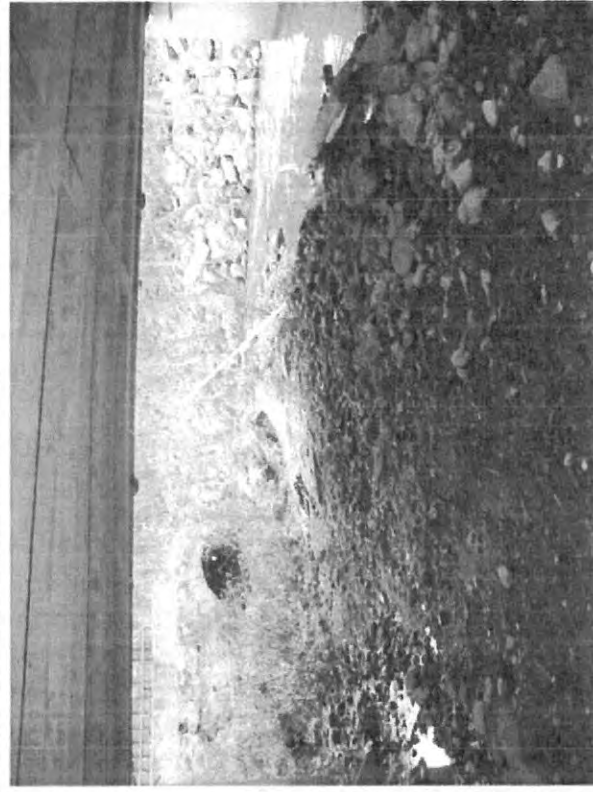
Photo # 16: View of Heavy Silt & Stone Buildup Under Structure.
