### **ENGINEERING EVALUATION**

### OLD TROLLEY BRIDGE OVER BRANCH BROOK WATERTOWN/THOMASTON, CONNECTICUT

March 20, 2017

Lenard Engineering, Inc. 2210 Main Street Glastonbury, Connecticut

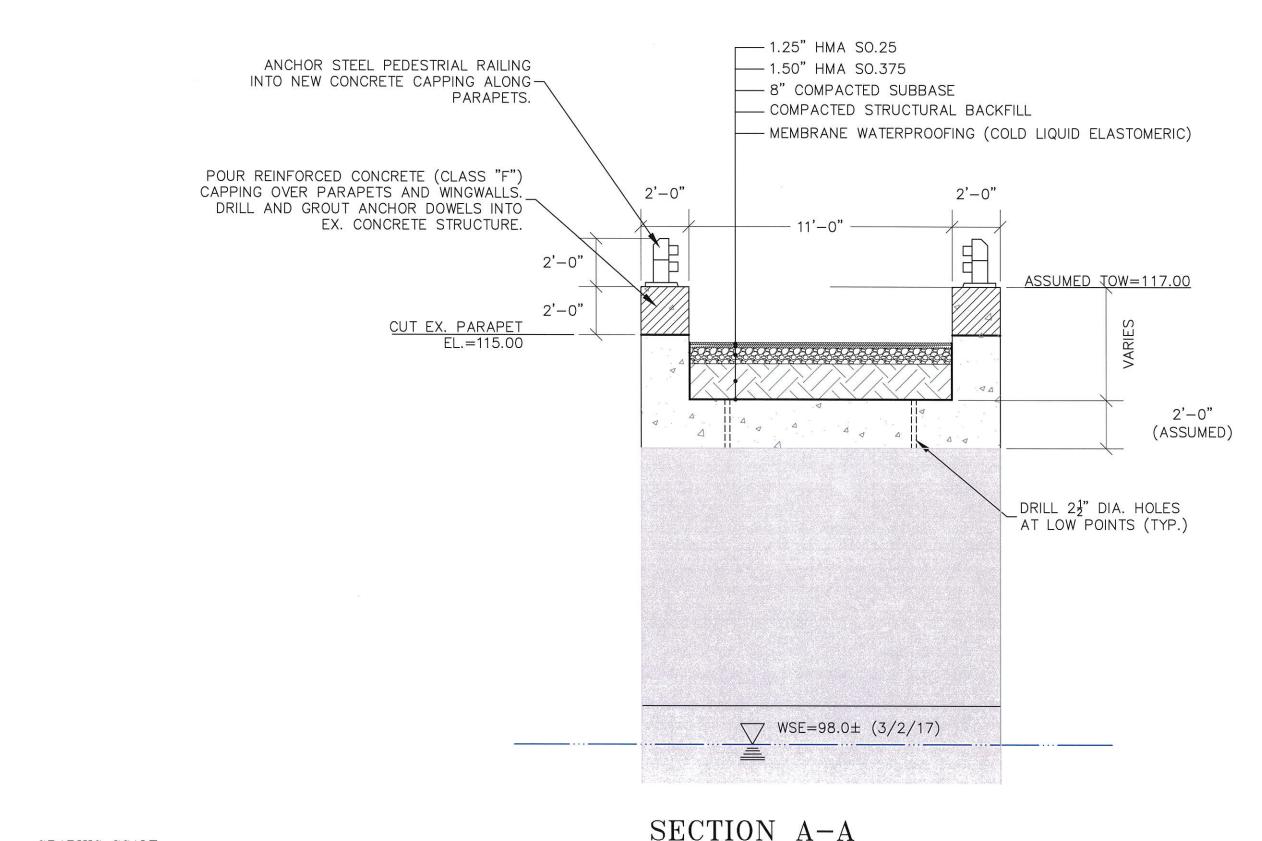
TYPICAL SECTION

The concrete arch is skewed at 39 degrees for improved channel hydraulics. The height of the arch is approximately 15 feet above the deepest point of the channel. The roadway on the bridge is on earth fill over the concrete arch. Assuming that the concrete arch is also 2 feet thick, the thickness of the earth fill varies between approximately 3 feet and 10 feet.

The structure is of either reinforced or unreinforced concrete; the presence of reinforcement in the concrete could not be verified. The geometry of the structure is pictured in *Drawings 1 through 4* in Attachment B.

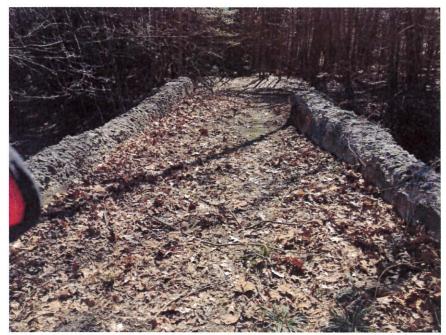
Picture 1 – Roadway on Bridge – Looking South

The structure is a concrete arch of 50 foot span oriented in the north-south direction. The curb-to-curb width of the dirt roadway on the structure is 11 feet with parapets on either side. The northwest and the southeast wingwalls are angled at 160 degrees and are 25 feet and 45 feet long respectively. The northeast and southwest wingwalls are 12 feet and 7 feet long respectively and are perpendicular to the parapets. The parapets and all wingwalls are 2 feet thick. There is no railing on the parapets (see Pictures 1 & 2).

- e) Install pedestrian and/or bicycle railing on the new parapet concrete tops
- f) Place new overburden of pervious structure backfill over the arch
- g) Place subbase and build bituminous roadway over the bridge

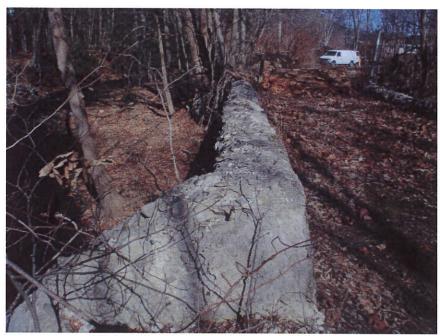
Picture 5 – Southwest Corner of Parapet

The structural concrete is severely deteriorated, and the rate of deterioration seems accelerating. The concrete is disintegrating due to frost/thaw action (see Pictures 5 and 6), and efflorescence can be seen over the entire underside of the arch (see Picture 8). Evidently the structure is not protected against water damage. Vegetation grows over and damaging the wingwalls (see Pictures 3, 4, 5, and 6). Scour related erosion can be observed along the southwest and southeast wingwalls and the south abutment.

- i) Repair (patch and coat) the entire surface of the structure with polymer modified concrete compound

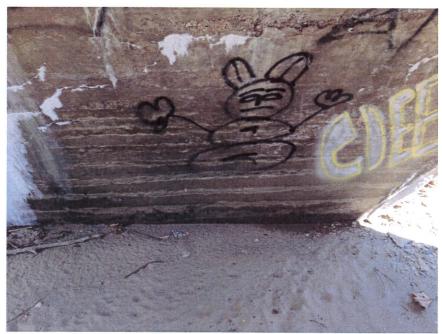
Picture 9 – Underside of Arch – Looking North

We examined the channel for stability and scour. The brook takes a left turn just upstream from the bridge (see the *Location Plan* and the *Structure Layout Plan* in Attachments A and B respectively), and accordingly the right embankment at that location and the south abutment of the bridge are under attack by the flow. The right embankment and the downstream channel appear stable (see Pictures 14, 15, and 16). The south abutment is prone to scour damage. There is no deep scour hole in front of the south abutment, but much of its footing is exposed doe to channel erosion (see Picture 8). The brook is depositing sediment on the opposite embankment, and the north abutment is safe from scour (see Picture 9).

- h) Excavate channel in front of the north abutment. Move channel to the middle of the span. Place standard riprap protection in front of the abutments and wingwalls at the south side
