MEMORANDUM 080513

To: Tracy Fogarty, Connecticut Department of Transportation
cc: Michael Milone, Town Manager, Town of Cheshire
Timothy Slocum, Town Council Chairman, Town of Cheshire
George Noewatne, Director of Public Works, Town of Cheshire
Neil Dryfe, Chief of Police, Town of Cheshire
Edgar Wynkoop, Connecticut Department of Transportation
From: Pat Gallagher, Regional Planner
Subject: Route 10 Signalized Intersection Safety Study

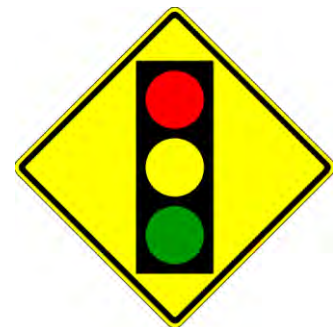
Figure 2. Improvement Option: Channelized Right-Turn on Route 68/70 EB

A short-term option involves improving signage and installing a flashing beacon on the EB leg of Route 68/70. The Manual on Uniform Traffic Control Devices (MUTCD) recommends that a traffic signal with an 85th percentile approach speed of 35 mph should have a minimum sight distance of 325 feet. The Route 68/70 EB approach does not meet the minimum sight distance requirement. MUTCD recommends that signals with inadequate sight distance be supplemented with warning signs and flashing beacons. The flashing beacon may be interconnected with the traffic signal controller to alert road users of a red light or queue ahead. The Crash Modification Factor (CMF) Clearinghouse found that dynamic flashing beacons can reduce rear-end collisions at signalized intersections by over 20%. Additional signage such as chevron signs may also help improve driver awareness around the horizontal curve and reduce speeds.

A long-term improvement option involves adding a channelized right turn to the EB approach of Route 68/70. A channelized right turn would straighten out the approach and dramatically improve traffic signal sight distance (Figure 2). 98% of peak hour vehicles using the EB approach of Route 68/70 turn right onto Route 10 SB. While this improvement option would reduce rear-end collisions, it may encourage motorists to drive faster through the intersection, resulting in higher-speed collisions, and creating a more hazardous environment for crossing pedestrians.
