Re: Kinneytown Hydroelectric Project, No. P-6985-005 and -006

The Naugatuck Valley Council of Governments, Save the Sound, and the Naugatuck River Revival Group (collectively, "Commenters") hereby provide the Commission with an updated assessment of on-site operating conditions at the Kinneytown Hydroelectric Project (the "Project"), owned by Hydroland Omega, LLC ("Hydroland"). Commenters wish to inform the Commission of the specific, ongoing failures by Hydroland to comply with action deadlines set by the Commission, natural resource agencies, or even deadlines self-imposed by Hydroland. This assessment provides the Commission with a factual update following the Commenters' last filed observations (December 8, 2021) and, crucially, informs the Commission of what the Commenters are able to externally observe regarding compliance with the directives contained in the Commission's December 22, 2021 Order and prior communications.

## **Downstream fish passage observations at Kinneytown Dam and Ansonia Bypass**

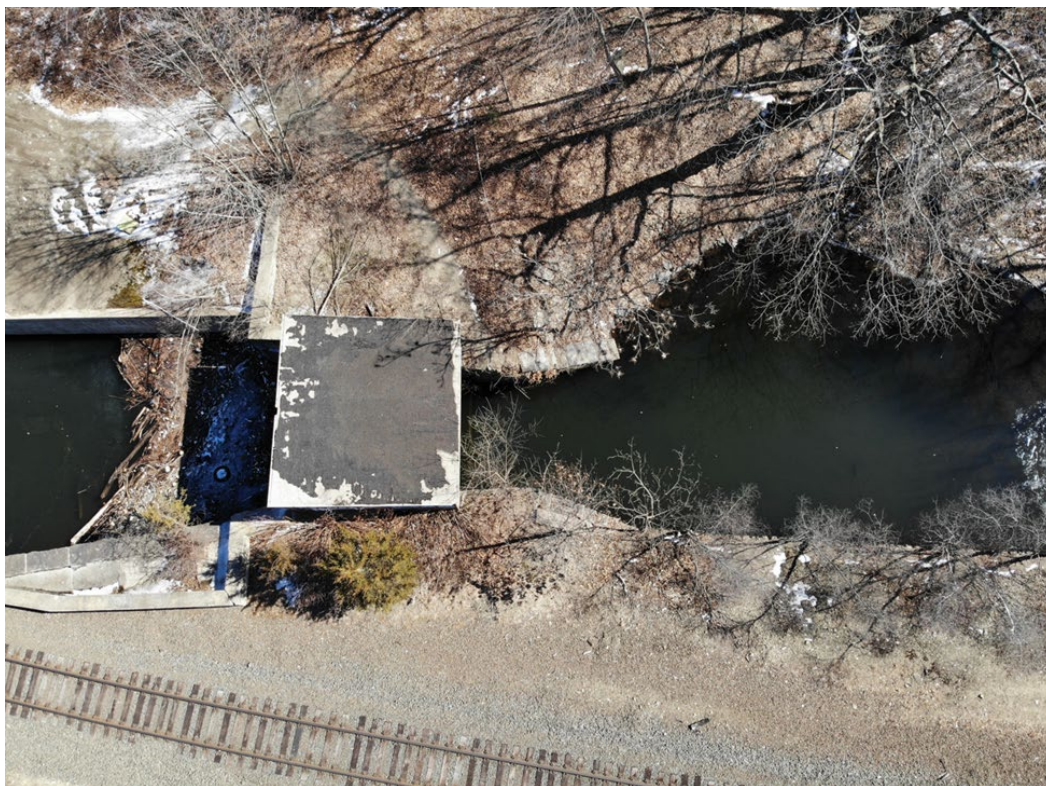
*Figure 6. Gatehouse at entrance to Ansonia Bypass. (Photo: Aaron Budris, March 4, 2022)*

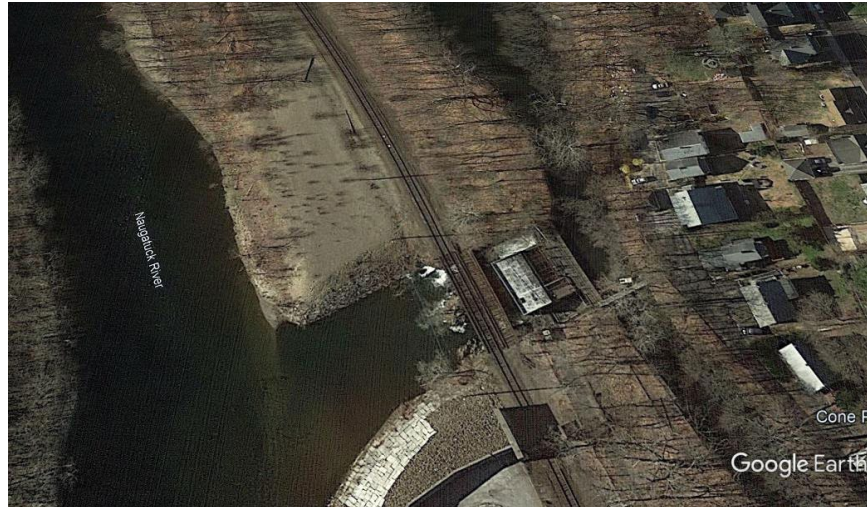
*Figure 10. Location of Ansonia Powerhouse (Unit 2). (Google Earth)*

The canal is essentially acting as a fish trap directing outmigrating diadromous species into a dead-ended backwater. Therefore, the few fish making it up the ineffective fish ladder may be losing what little offspring they produce to the Ansonia canal. Additionally, alewives stocked by CTDEEP upstream could also be redirected into the canal along with any YOY that have been produced. This would help further explain why runs have not been able to establish themselves above the dam. This is a critical issue and should be addressed prior to the 2022 spring fish run.

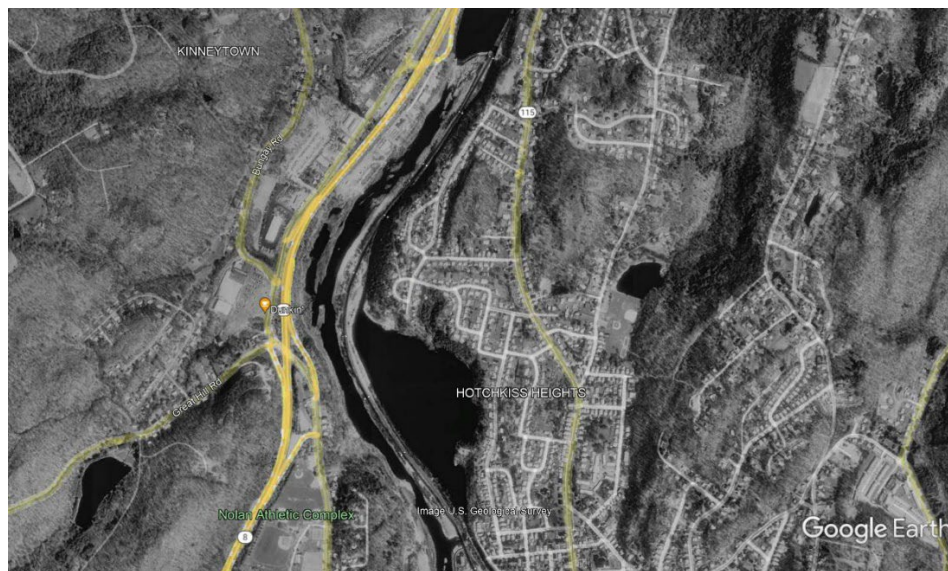
The bypass channel appears not to have been maintained since at least since 2010 when the Ansonia Power House was shutdown. A 1991 image shows a channel free from brush. Current conditions show an accumulation of trash, sediment, brush, and trees. It is likely that, along with the clearing of debris in the channel, any sediment accumulation that has occurred along the channel and into Coe Pond which may require dredging. Given the manufacturing history of the river it is possible, if not probable, that these sediments are contaminated. Any work on the channel to improve hydraulic function could mobilize sediments. Prior to initiating work in the channel, there should be adequate sediment sampling within the pond and channel to characterize any toxics present. Mobilizing accumulated toxins downstream may adversely affect the shell fishing industry at the mouth of the Housatonic River depending on type of contaminant and mobilization characteristics. The following Google Earth time series shows potential accumulation zones.

*Figure 12. Image from 1991 showing a clear run channel and pond. (Google Earth 1991)*
