Ansonia-Derby Temporary Regional School Study Committee Facilities

Facilities: Ansonia and Derby

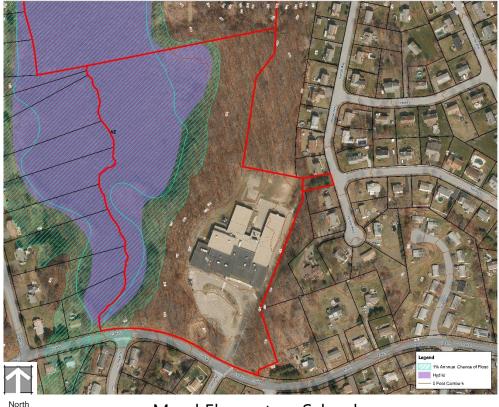
Mead Elementary School

- Significant wetland corridor on the west portion of the site and steep slopes
 - limit parking access and building expansion opportunities
- Limited outdoor play areas
- School bus circulation conflicts with parent/child pick-up

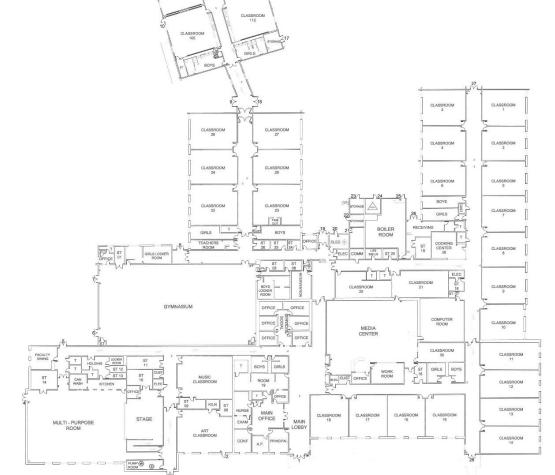
Mead Elementary School

- Built in 1968
- Additions in 1995
- Portables in 2016
- 81,051 square feet

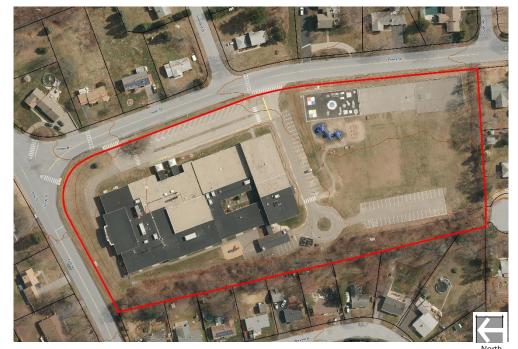
Prendergast Elementary School

- Bus pick-up/drop-off is satisfactory, circulation could be improved
- The site is of adequate size
 - Undeveloped land on the south side of the school may support limited building expansion
 - Opportunities exist to expand parking
 - Outdoor play areas and courts can be redesigned to accommodate additional capacity

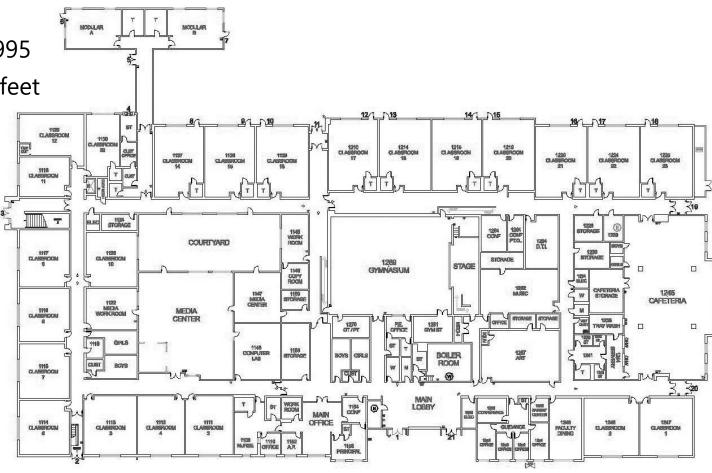
Prendergast Elementary School

Additions in 1995

87,052 square feet

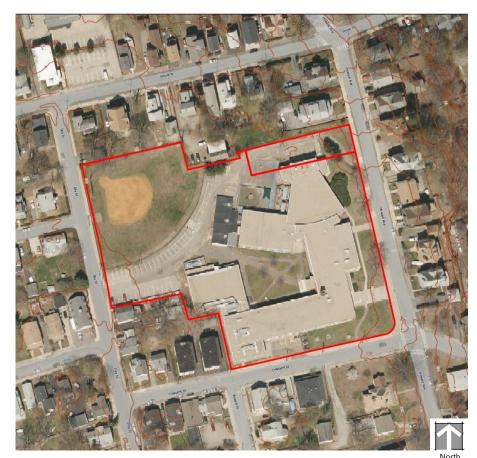
Ansonia Middle School

- The site is undersized with an over-sized facility
 - Inadequate levels of parking on site impact neighborhood traffic
 - Bus drop-off/pick-up do not function well raising safety concerns for students accessing the school site
 - Lack of usable outdoor space although existing PreK play areas are well maintained

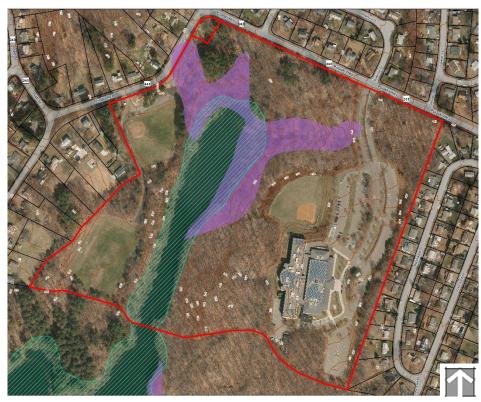
Ansonia High School

- Wetlands and drainage courses are extensive
- Area west of the reservoir holds potential for new development
- The AHS facility is in good condition
 - Walkways are in good condition
 - Parking is adequate
 - Bus drop-off/pick-up functions well

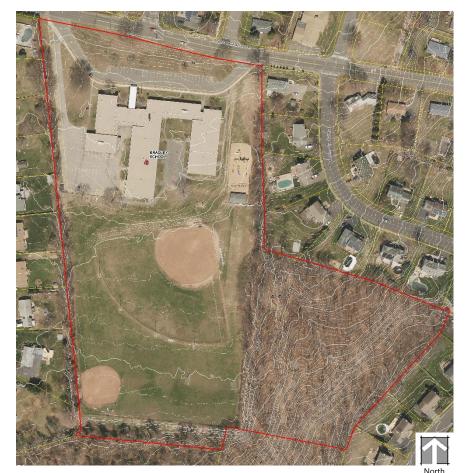
Bradley Elementary

- Bus pick-up/drop-off is satisfactory, parent/child drop off is functional but can be improved
- Parking in the front is adequate but the west (rear) parking area is in poor condition
- Sidewalks are generally satisfactory
- Play areas, courts and athletic fields are all in good condition
- The site is small, limiting opportunities for building expansion

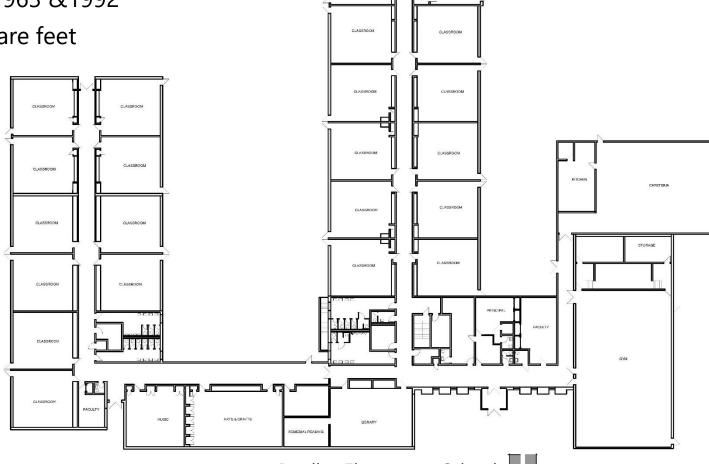
Bradley Elementary School

- Built in 1960
- Additions 1963 &1992
- 45,500 square feet

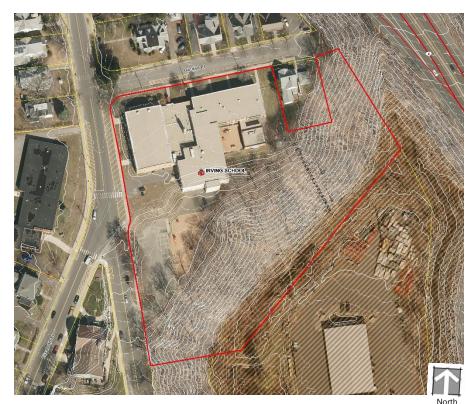
Irving Elementary School

- Site and facility are small
 - Faculty and visitor parking are insufficient
 - Bus parking and parent/child drop off is limited
- Playgrounds are in good condition
 - No turfed lawn or paved play areas available
- Very steep slopes make expansion impractical
