# REGIONAL WASTEWATER TREATMENT CONSOLIDATION STUDY

## Technical Memorandum 2: Condition Assessment

**B&V PROJECT NO. 198910**

**Naugatuck Valley Council of Governments**

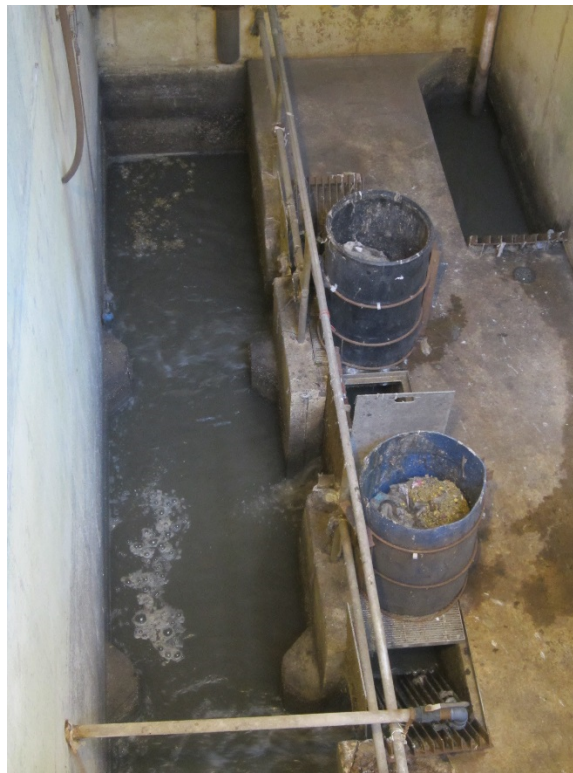
Figure 2-1 Derby Trash Racks

1. **Influent Trash Racks.** Flow enters the plant via two gravity sewer interceptors. Some screenings are captured with trash racks just upstream of the influent pumps on screens that are located several stories below-grade. The racks are cleaned manually and require manned entry into the inlet structure. The screenings are stored in bins within the inlet structure which are reportedly pulled up to grade when full. The inlet trash rack system is in poor condition in terms of process effectiveness, proper ventilation and safety, and should be corrected as a first priority. The lack of proper screens, grinders and grit removal upstream of the influent pumps results in additional wear and operating challenges for the pumps. A proper headworks should be provided upstream of influent pumping. However, lack of conceptual design makes it difficult to assess the footprint required for a properly functioning preliminary screenings facility. During follow-on study and design this should be investigated, along with the optimal (fine to medium) bar spacing that could be accommodated hydraulically.

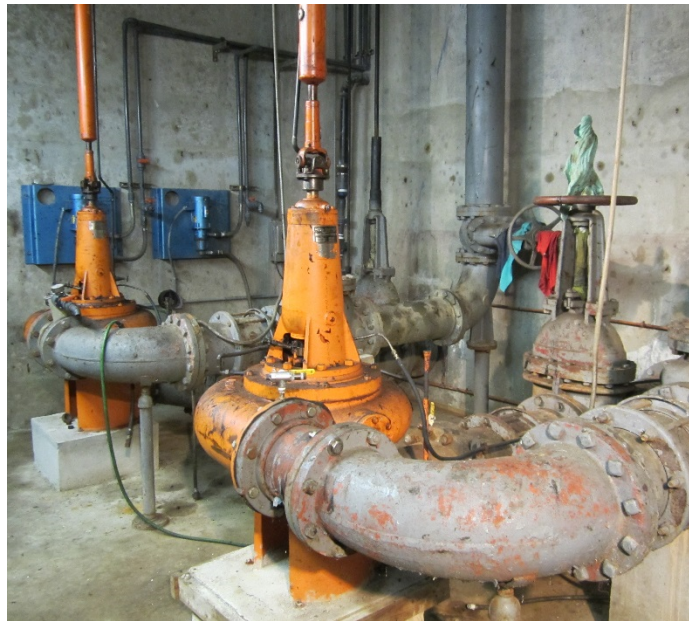
Figure 2-2 Derby Influent Pumps with Extended Shafts

2. **Influent Pump Station.** The influent pump station has two pumps with long, problematic shafts (motors on upper level); and one pump with a close-coupled motor. The newer close-coupled pump is the normal duty unit, because of issues with the other two extended shaft units. Due to age and problems at this facility, the influent pump station is in need of a major upgrade, and perhaps a complete replacement. All pumps, piping, valves and controls need

to be replaced at the influent pump station. This facility also needs to be able to handle peak flows from the collection system.

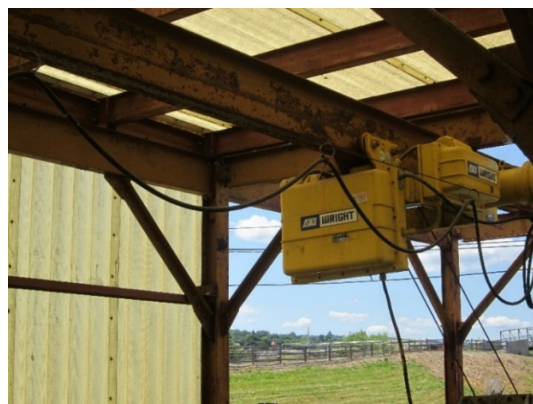
Figure 2-3 Derby Grit Facility Overhead Clamshell Hoist

3. **Aerated Grit Chamber.** Downstream of the pump station is a single aerated grit chamber, with no redundancy. Grit is removed from the tank using a clamshell bucket on an overhead monorail. The grit is discharged into an adjacent grit dumpster. The aerated grit tank is partially covered with a steel frame structure with a fiberglass canopy. Certain grating sections were compromised at the top of this structure. This arrangement is ineffective, difficult to operate and a safety concern as well. Overall, the grit system is in poor condition and needs to be completely replaced with an appropriate system that provides at a minimum, capability to bypass the grit removal system when extensive maintenance is required.

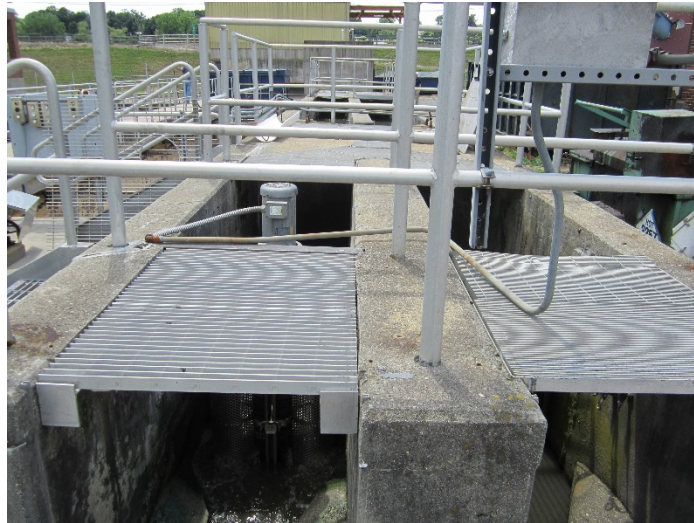
Figure 2-4 Derby Comminutor Channel

comminutors would no longer be required and therefore should be removed. This will allow for redundant channels to primary treatment.

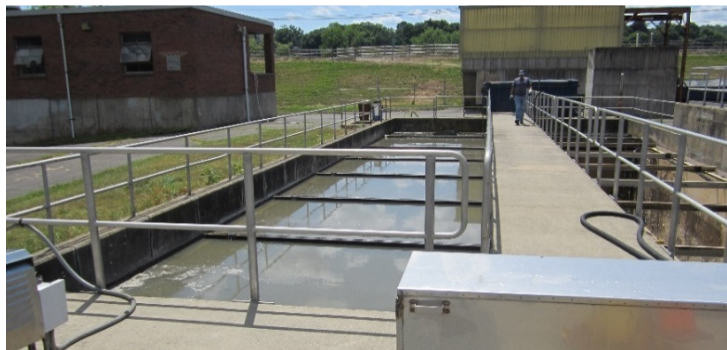
Figure 2-5 Derby Primary Clarifiers

5. **Primary Clarifiers.** The WPCF has two 90 ft. x 16 ft. x 10.5 ft. side water depth (SWD) rectangular primary settling tanks, which include chain-and-flight sludge collectors and tipping weir scum troughs. Due to the lack of proper headworks facilities, grit tends to collect in these clarifiers and cause operations challenges. It appears the plant has adequate primary clarifier capacity, at least under normal flows. One of the primary clarifiers was down for repair at the time of the site visit; the focus of the repair appeared to be the internal mechanism. Both clarifiers were constructed in 1964, and show some structural cracks due to their age and settlement. Complete replacement of the mechanisms at both clarifiers is recommended. These structures also need to be studied to determine the extent of repairs required.

Two plunger pumps located in the operations building convey primary sludge to storage.

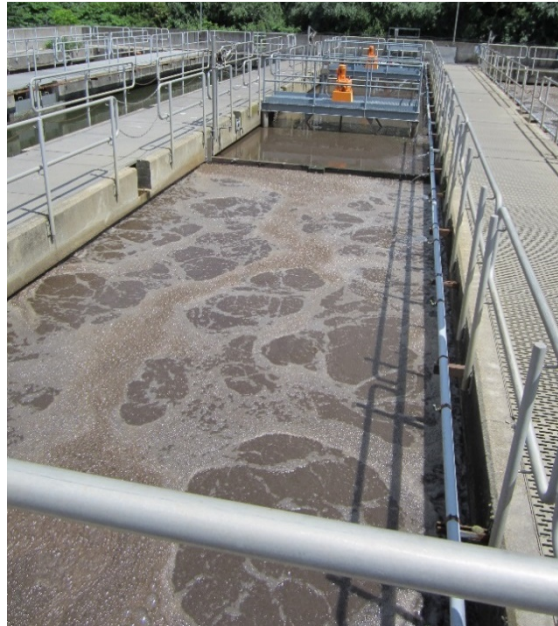
Figure 2-6 Derby MLE Basins

Basins No. 2 and 3 were modified in the 1998 upgrade to operate in an MLE process configuration for nitrogen removal (with the first two-thirds of the first pass in each train being converted to an anoxic zone). The third basin, Basin No. 1, was left unmodified. Operations staff report that the two modified basins have provided sufficient capacity for plant wastewater flows. Based on issues discussed in the Facilities Plan, the aeration basin diffuser and blower system should be upgraded to improve overall energy efficiency, and for better DO control to optimize nitrogen removal. Additional investigation is required to confirm whether the existing off-line aeration basin needs to be upgraded.

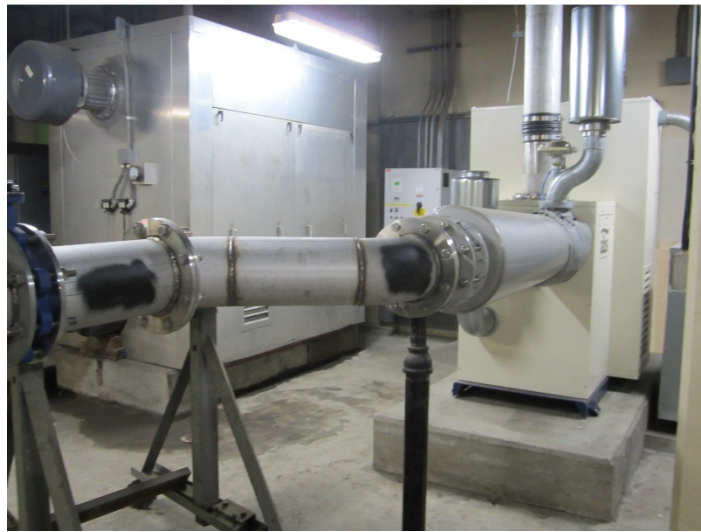
Figure 2-7 Derby Aeration Blowers

Most of the blower system piping is outdated, and is leaking in several locations. The blower system should be updated at the same time that work in the aeration basins is being done in order to replace the aeration piping and to provide redundant blowers that are energy efficient. The blowers may need to be relocated to another building or in a new building if ventilation at the existing location cannot be positively corrected.

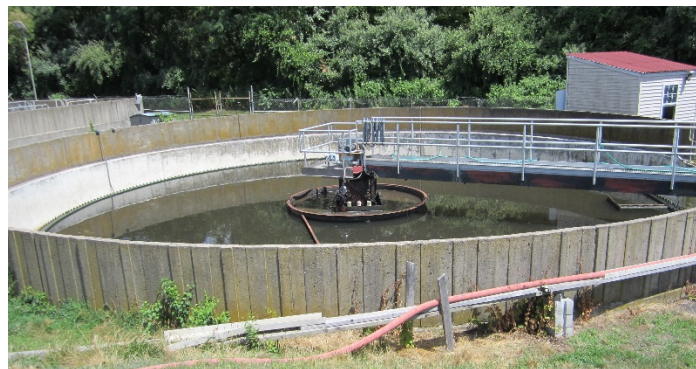
Figure 2-8 Derby Secondary Clarifier

8. **Secondary Clarifiers.** Secondary settling is accomplished in two 60 ft. dia. x 10 ft. SWD secondary clarifiers with draft tube type sludge removal mechanisms. With only two clarifiers there is no redundancy if one unit is out of service. Also, the flow split between the two is uneven. New mechanisms and improved internal baffling are recommended for both secondary clarifiers, as well as hydraulic modifications upstream to improve flow splitting upstream of the clarifiers. The operations and performance should be reviewed after these modifications are implemented, to assess whether additional capital improvements will be required. The secondary clarifiers are served by three variable-speed centrifugal RAS pumps, all located in a dry pit.

10. The secondary clarifier mechanisms and internal baffles need to be replaced. Surface loading rates are high at current and future peak day and peak hour hydraulic loading rates, and the relatively shallow depths of the clarifiers (10 ft SWD) do not provide a great deal of operating cushion to protect the sludge blanket from being scoured during peak flows. It may be possible to mitigate this without adding a third clarifier by implementing other modifications, for example by adding sludge blanket baffles within the clarifiers. This will need to be confirmed with additional study of the clarifiers.

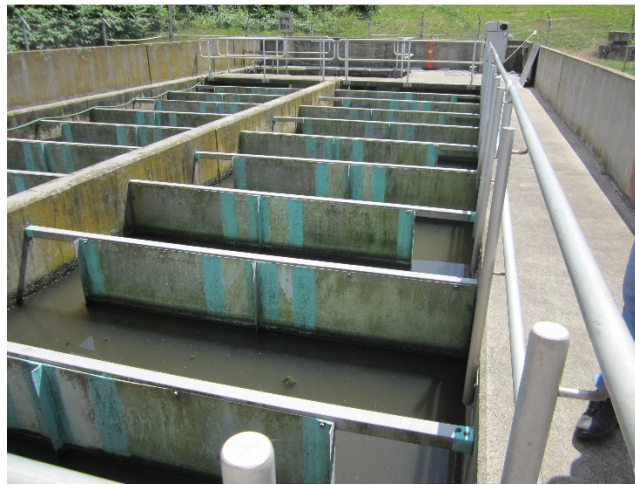
Figure 2-9 Derby Chlorine Contact Basins

9. **Disinfection.** The Derby WPCF provides seasonal disinfection (May-September) with sodium hypochlorite, fed via peristaltic metering pumps. There are two parallel chlorine contact basins. The Facilities Planning Study noted that this system has been functioning properly overall, but recommended modifications to improve operational flexibility and to optimize the chemical dose. Dechlorination is accomplished by feeding sodium bisulfite. Since the chlorination system was installed over 20 years ago, plans for its renewal should be included as part of the overall plant upgrade.

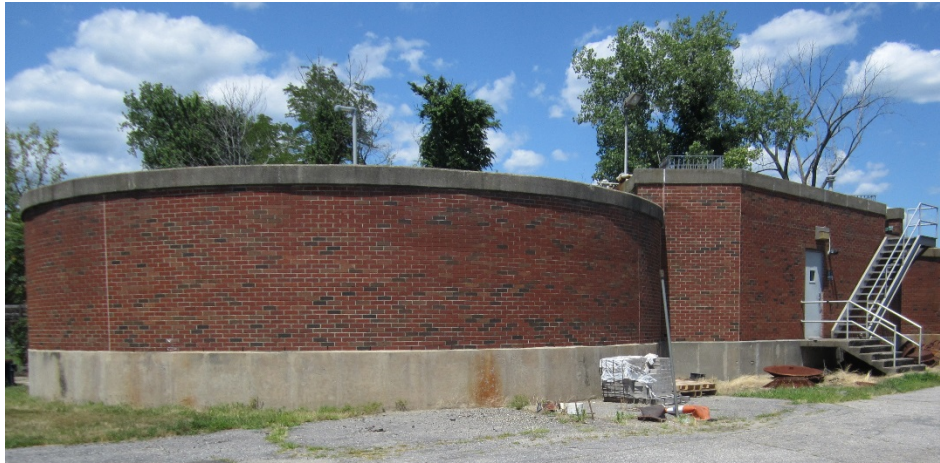
Figure 2-10 Derby Former Anaerobic Digesters

10. **Sludge Processing and Disposal.** Primary sludge is pumped manually to a sludge holding pit in front of the aerobic digesters. There are two rectangular aerobic digesters with coarse bubble diffusers, built in 1972 and located in a fiberglass enclosure with inadequate ventilation. Waste activated sludge (WAS) is thickened in a rotary drum thickener, located in the secondary control building. Thickened WAS is mixed with the primary sludge, and the mixed sludge is dewatered on a 1.5-meter gravity belt filter press, then trucked offsite by Synagro for further treatment and incineration.

The two circular anaerobic digesters at the plant were built in 1964 and no longer function as digesters, but have been used for sludge storage. There are also two rectangular aerobic digesters at the plant with coarse bubble diffusers, built in 1972 and located in a fiberglass enclosure with inadequate ventilation.

The Facilities Plan noted that the sludge processing equipment is over 30 years old, having served beyond the end of its useful life. That Plan recommended a complete upgrade of the sludge processing system, including rehabilitation of the old digesters and providing new sludge dewatering facilities, including a sludge cake storage area. However, Black & Veatch believes that the size of this plant is too small to justify this level of capital expenditure for solids processing. Average annual flow for 2015-2017 was only 1.3 MGD. For a plant of this size, we believe a more appropriate solution (one we expect will be lower in life cycle cost and easier to operate) would be to store thickened liquid sludge onsite without dewatering, and to haul it offsite in liquid form, in tanker trucks.

The approach we recommend would eliminate the need for: anaerobic digesters, aerobic digesters, sludge dewatering systems, sludge cake conveyance, and sludge cake storage and handling. Instead, all that would be required is WAS thickening, primary sludge thickening, thickened liquid sludge pumping, thickened liquid sludge storage and tanker truck loading facilities. The liquid sludge storage facility would require mixing and the ability to decant.

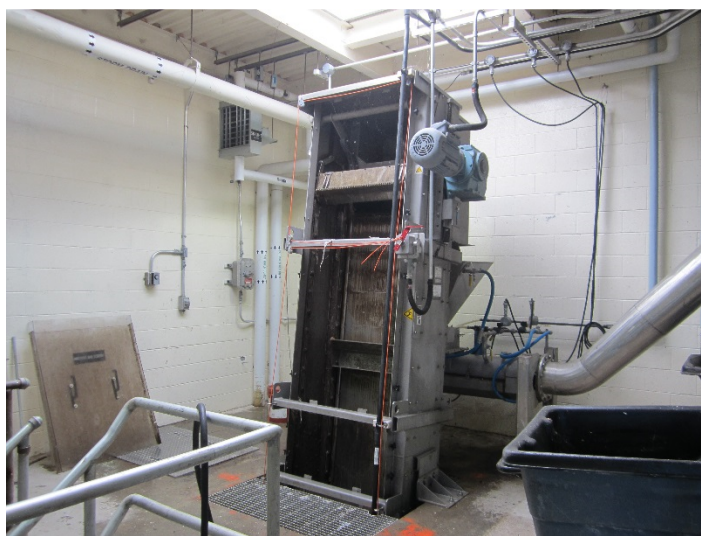
Figure 3-1 Ansonia Mechanical Bar Screen

1. **Mechanical screening.** The plant has only one mechanical bar screen, which was installed as part of the 2011 plant upgrade, along with the associated screenings process equipment. This is upstream of the influent pump station. There is also a second (manual) bar screen located at the lower level, which is more difficult to access.

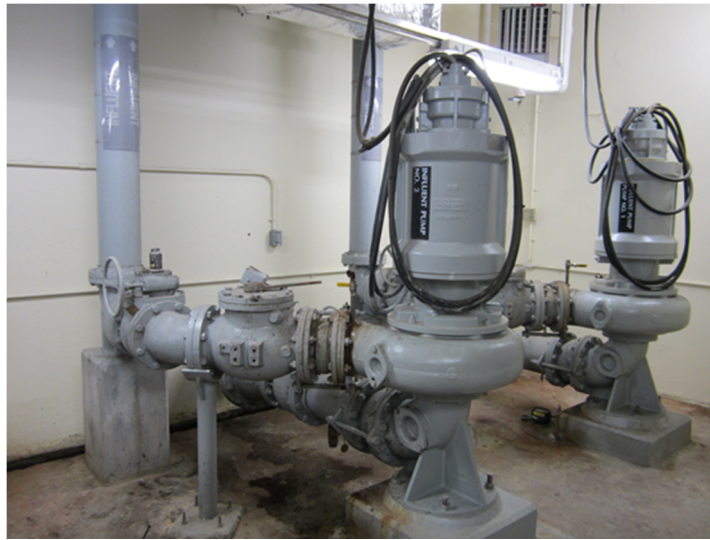
Figure 3-2 Ansonia Influent Pumps

2. **Influent Pump Station.** The plant's influent pumping station has two smaller and two larger centrifugal pumps in a dry pit. All four pumps are new from the 2011 plant upgrade.

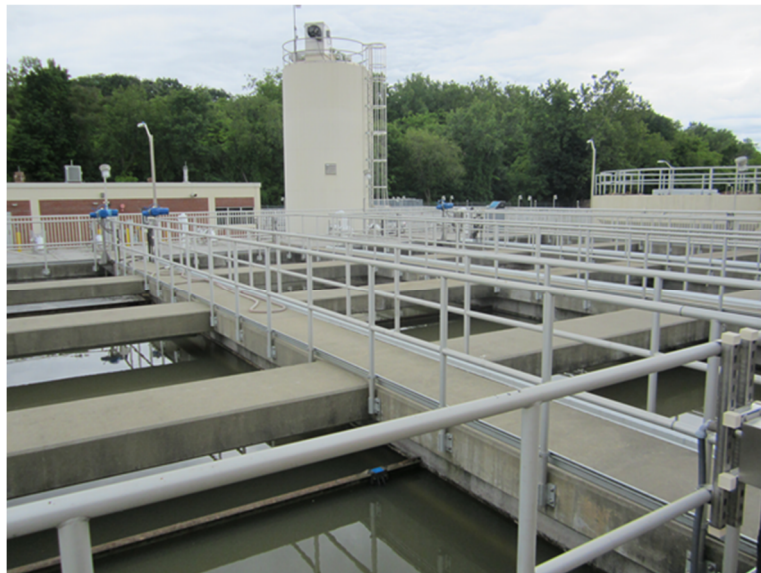
3. **Vortex Grit Separation.** The plant has a new covered vortex grit chamber and grit system, also from the 2011 plant upgrade. There are provisions to bypass flow around the grit chamber when maintenance is required.
4. **Primary Clarifiers.** The chains and flights in the existing primary clarifiers were replaced during the 2011 upgrade. The clarifiers were full at the time of the visit, but appear to be in satisfactory condition based on staff input.

Figure 3-3 Ansonia Primary Clarifiers

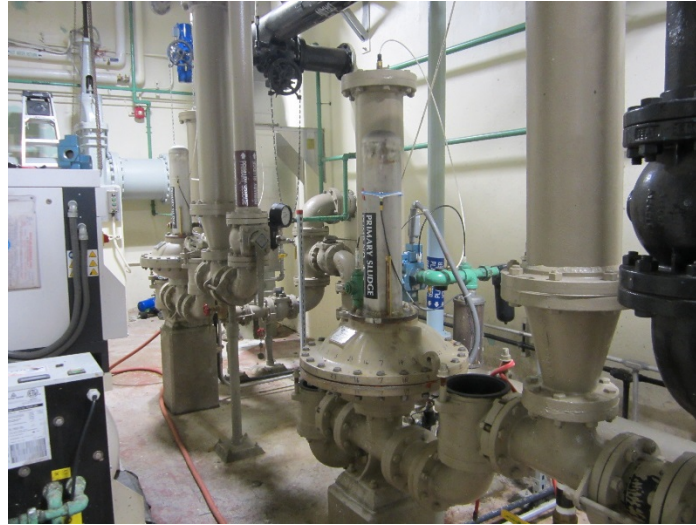
Figure 3-4 Ansonia Sludge Pumps

and minerals industries, rather than for domestic wastewater sludge. It was reported that these are high-maintenance items, and that the ball checks need to be replaced relatively frequently. Without a high amount of maintenance for this system, these pumps would be unreliable. Ansonia is considering replacing these pumps with a pump more commonly used in primary sludge pumping applications.

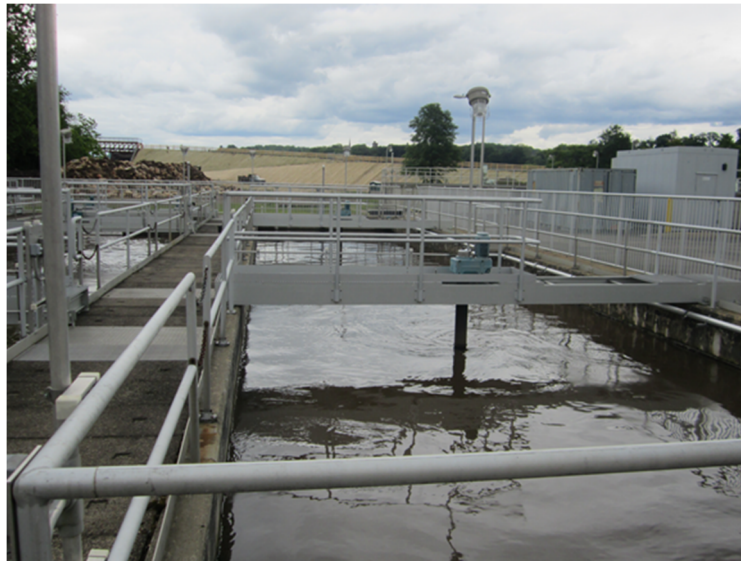
Figure 3-5 Ansonia Converted Anoxic Basins

Former rectangular secondary clarifiers were modified to become second stage aeration and second stage anoxic basins. New blowers and diffusers were installed for the second stage aeration system.

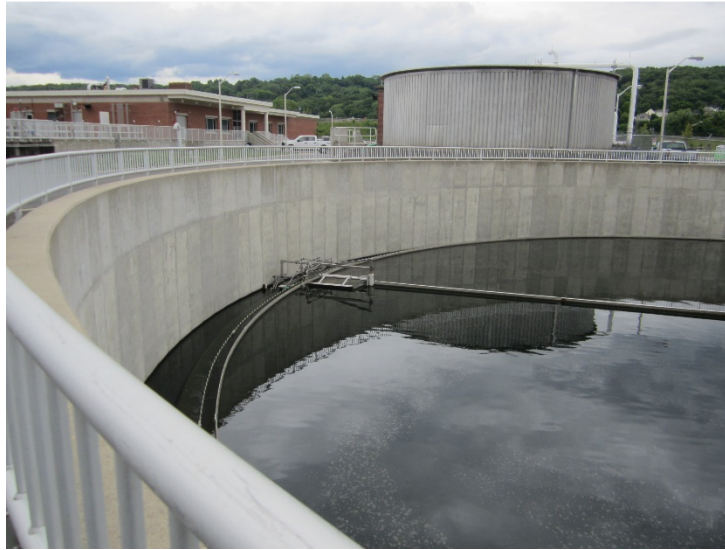
Figure 3-7 Ansonia Secondary Clarifier

7. **Secondary Clarifiers.** New circular secondary clarifiers were installed during the 2011 plant upgrade, along with new RAS and WAS pumping systems. Ansonia is adding alum ahead of the secondary clarifiers for phosphorus removal. Ansonia operations staff report that the phosphorus removal system is working well, and they have been meeting permit requirements for effluent phosphorus.

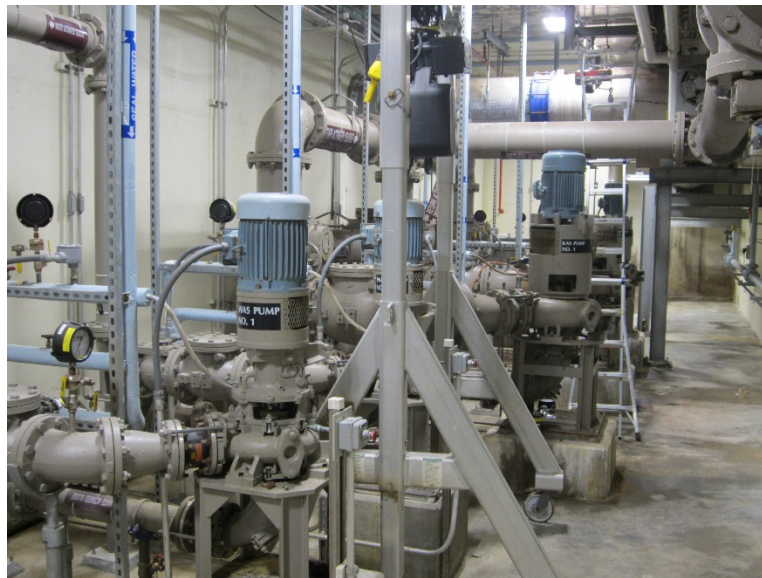
Figure 3-8 Ansonia RAS and WAS Pumps

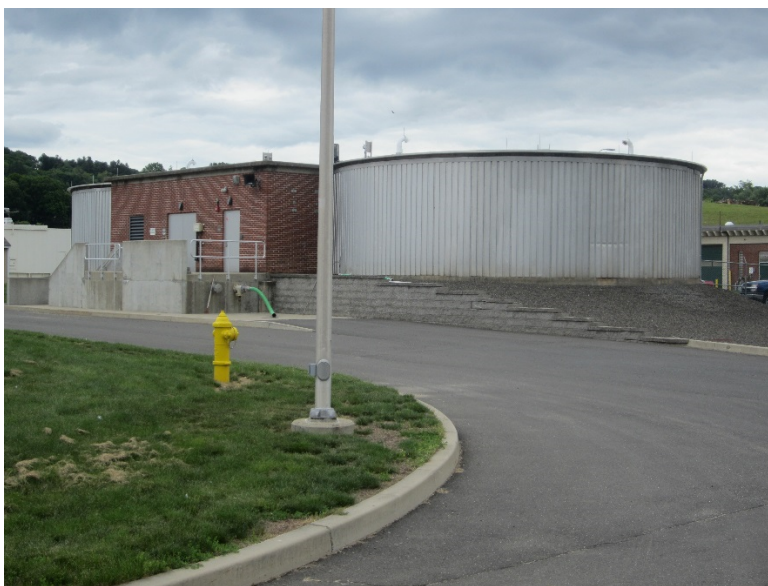
Figure 3-9 Ansonia Former Digesters Used for Sludge Storage

The sludge storage tanks do not have decanting ports. The City reports that having the ability to decant from the storage tanks would reduce the amount of water hauled off by the tanker trucks, thereby extending storage capability and reducing hauling costs.

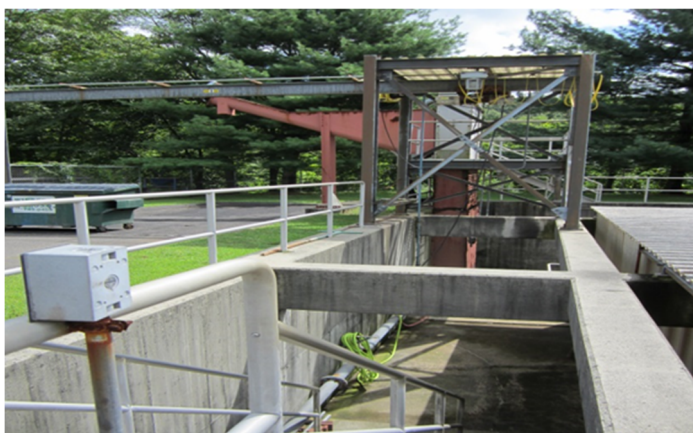
Figure 4-1 Seymour Headworks Area

1. **Influent Screening.** After Parshall flume flow measurement, the incoming wastewater flows through a coarse manual bar rake with 1.5-inch spacing. The flow then travels through a single mechanical bar screen located in a three feet wide channel. Bar spacing on the screen is 0.75 inches. A bypass channel allows for uninterrupted flow-through during times when the mechanical screen is down for maintenance. Captured screenings are lifted by a bucket elevator system to a dumpster at grade. The mechanical bar screen equipment and screenings handling system dates to the 1990s plant upgrade, and needs to be replaced with new equipment. This entire facility is located outdoors which makes operations and maintenance difficult, especially during the cold seasons.

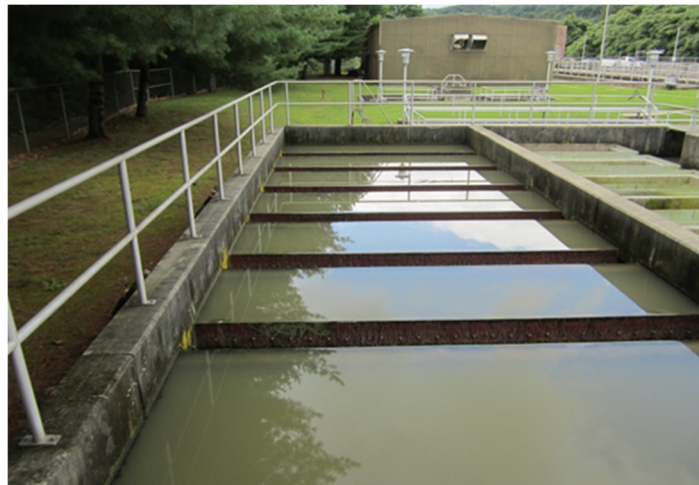
Figure 4-2 Seymour Primary Clarifiers

4. **Primary Settling Tanks.** The plant has four rectangular primary settling tanks. Two of the tanks date back to the original construction of the 1970s; the other two were constructed as part of the upgrade done in the early 1990s. The tanks include longitudinal sludge collectors with surface scum skimming. Effluent from the primary settling tanks flows to the secondary treatment influent box. Scum collected from the primary settling tanks is discharged to the primary scum reactor. The mechanisms on two of the four primary settling tanks require replacement. Metal within the tanks will require either replacement or sand blasting and recoating, depending on actual condition.

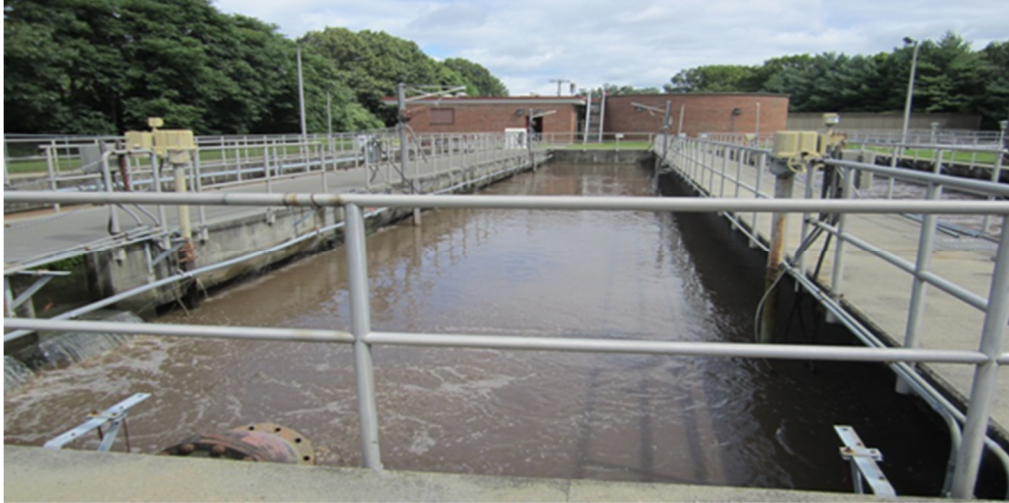
Figure 4-3 Seymour MLE Basin

effluent weirs which allow mixed liquor flow to the final clarifiers. Based on the age of the equipment, it is recommended that the aeration diffuser system in the aeration basins be programmed for replacement.

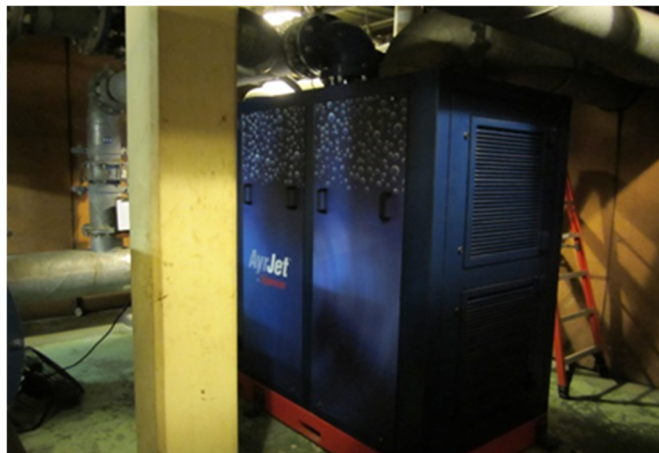
Figure 4-4 Seymour Blower

6. **Aeration Blowers.** The aeration blowers include a newer magnetic bearing turbo blower unit which serves as the duty unit and two older style multistage centrifugal blowers. It is recommended that a new turbo blower be provided to match the operating conditions of the existing turbo blower. This will provide for more efficient operations and reliable back-up to the existing turbo blower. The older multi-stage blowers should be decommissioned. It is noted that the blowers are located within the same general space as sludge pumps. Turbo blowers have sensitive electronics that make them vulnerable to harsh environments, including sludge gasses that are prevalent at a wastewater treatment plant. The ventilation in the blower room space needs to be reviewed and modified accordingly such that the air supply to the blowers, including the space they occupy, is noncorrosive and conducive to their overall reliability. Relocating the blowers may be required if the ventilation system problem is not corrected.

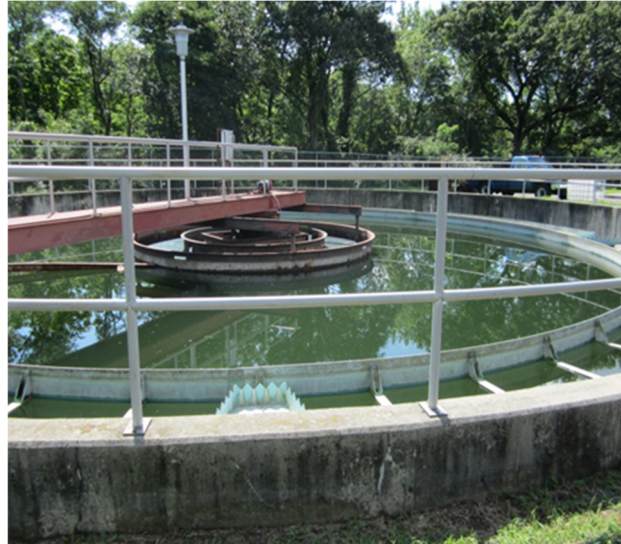
Figure 4-5 Seymour Final Clarifier

7. **Final Clarifiers.** The two final clarifiers are 65-foot diameter, with 13-foot side water depth. The clarifiers are equipped with rotating suction type sludge collectors. The clarifiers were part of the early 1990s upgrade. Due to their age, the internal mechanisms in these tanks need to be replaced with new equipment. A detailed condition assessment of this equipment may show that sand blasting and recoating of all metal parts could be done as part of the upgrade.

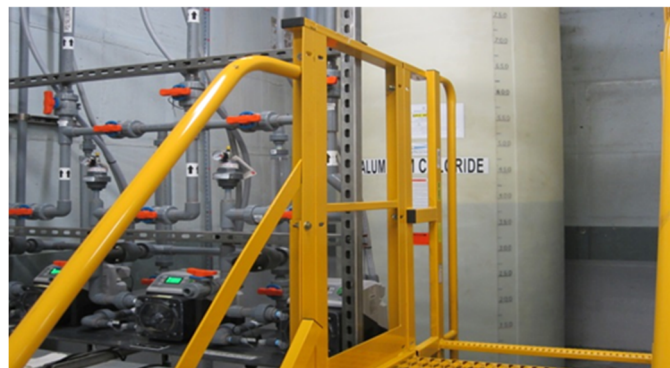
Figure 4-6 Seymour Alum Feed System for P Removal

8. **Phosphorous Removal System.** The Town recently installed and commissioned a chemical phosphorous removal system at the plant. The system utilizes alum, which is introduced into the process at the aeration basins effluent.

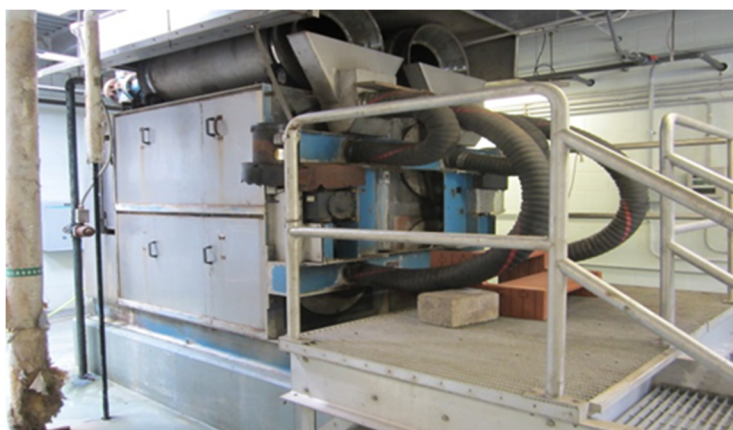
Figure 4-7 Seymour Rotary Drum Thickener

The RDT has reached the end of its useful life and needs to be replaced. The BFP has also reached the end of its useful life. From experience gained from working at other small plants, we believe that sludge processing should end with thickening at Seymour. The thickened sludge would then be hauled off-site for additional treatment at the merchant incineration facility. The two sludges should also be handled separately, and not combined; this is to minimize release of odorous compounds and to minimize corrosion of steel and concrete. This should be investigated further in lieu of proceeding with new sludge dewatering equipment.

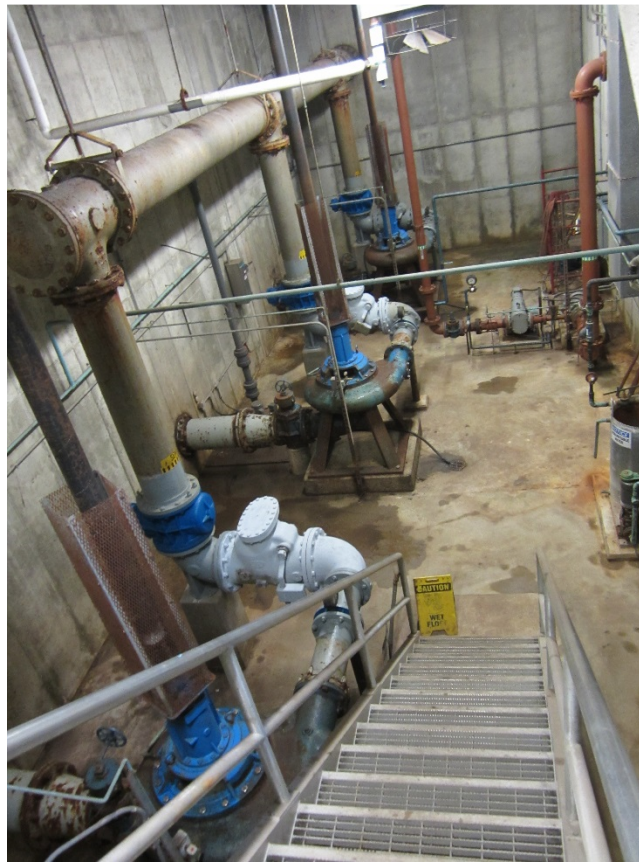
Figure 5-1 Beacon Falls Influent Pump Station

1. **Influent Pump Station.** The plant influent pump station features three constant speed centrifugal pumps in a wet pit/dry pit configuration. Based on the age and condition of the equipment, it appears that this pump station is structurally sound overall, but is due for a mechanical upgrade.

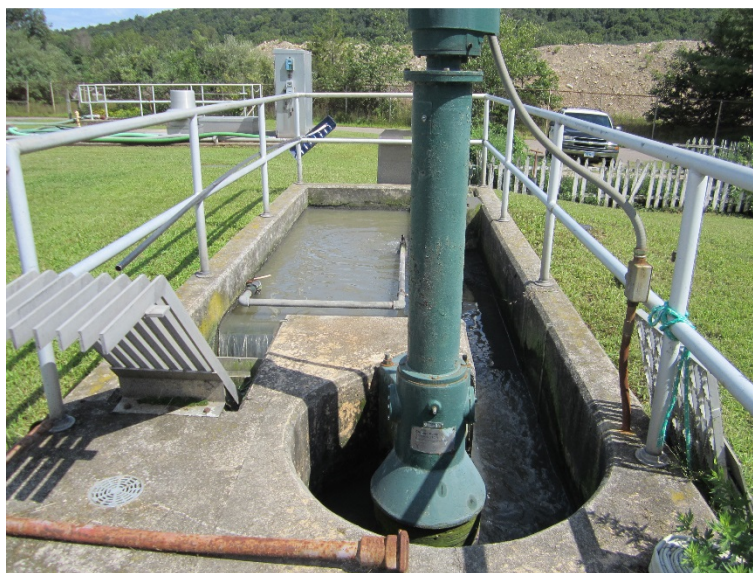
Figure 5-2 Beacon Falls Comminutor and Bar Screen

2. **Headworks.** The headworks, which is located downstream of the influent pump station, features a comminutor in parallel with a manually cleaned bar screen in the bypass channel. The equipment is at the end of its useful life and should be replaced.

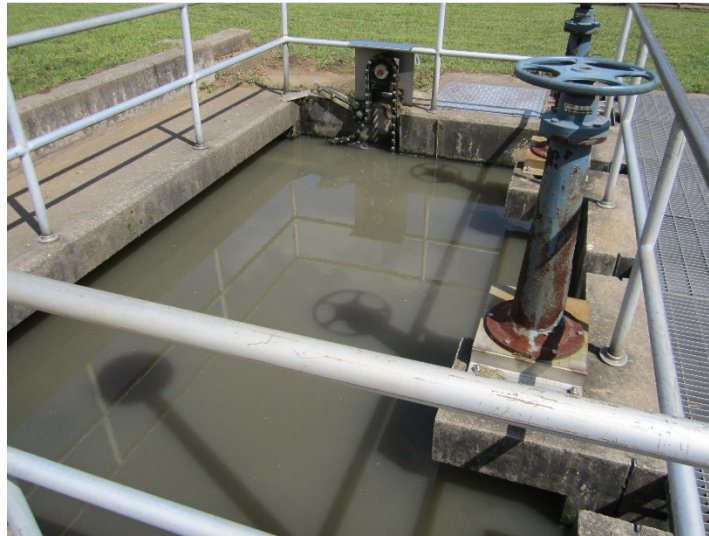
Figure 5-3 Beacon Falls Rectangular Primary Clarifier

3. **Primary Settling Tank.** There is only one primary settling tank at the plant, a rectangular basin mostly below grade, which dates back to the early 1970's. With the tank in service and most of it out of view, it was not possible to assess its condition. A condition assessment needs to be undertaken to determine whether structural repairs are needed. It was not clear whether this tank can be bypassed.

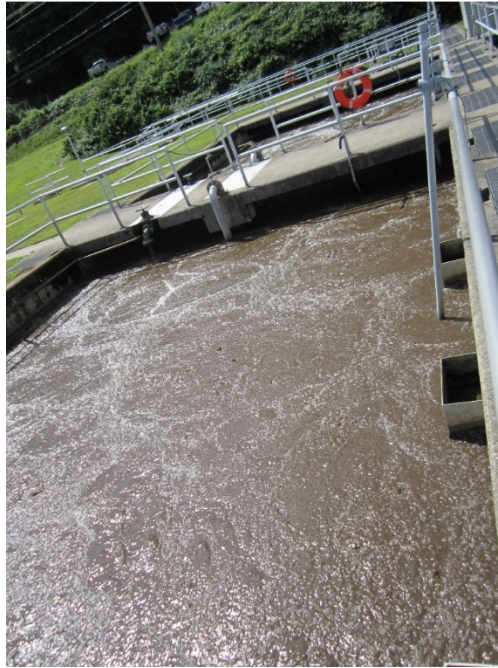
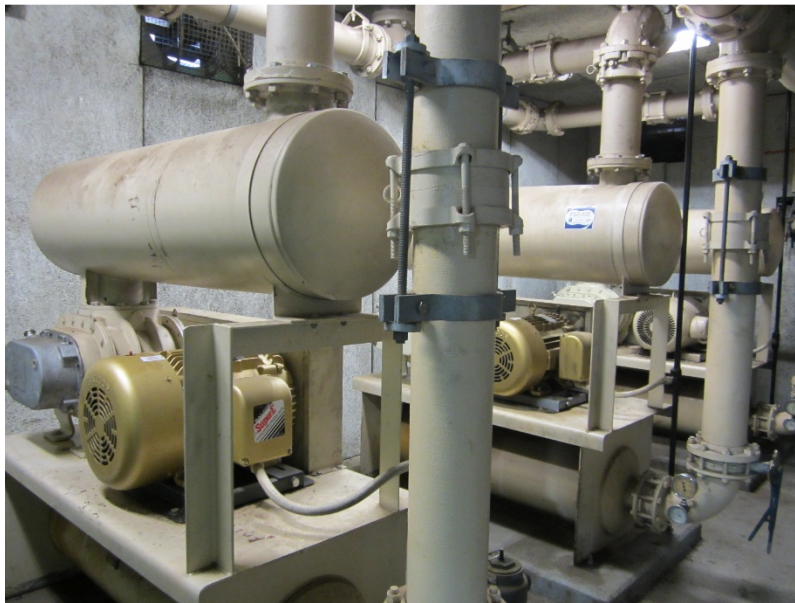
4. **Aeration Basins and Blowers.** The secondary treatment system is activated sludge basins, with a grid of diffusers. These were installed during the 1994 upgrade, along with the three small conventional aeration blowers which are located in the basement of the Operations Building. Based on the age of these units, they should be replaced with more energy-efficient modern blowers. The aeration basins need to be modified as well, to improve nitrification and denitrification capability.

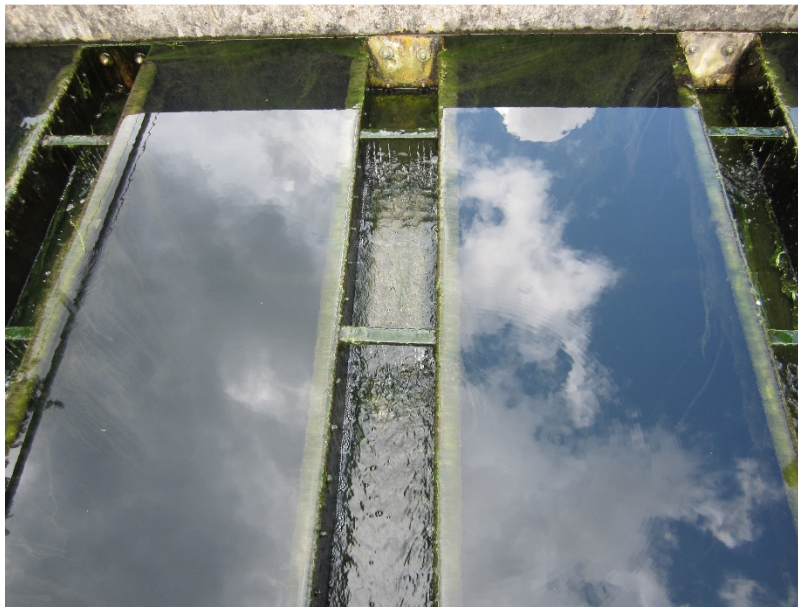
Figure 5-6 Beacon Falls Secondary Clarifier Effluent Weirs

5. **Secondary Clarifiers.** The Seymour plant has two rectangular concrete secondary settling tanks. The older, original clarifier is relatively shallow (8-foot depth); the second clarifier, added during the 1994 upgrade, is 12 feet deep. It was reported that a retrofit at the inlet to these tanks is required to optimize flow split and overall treatment performance.

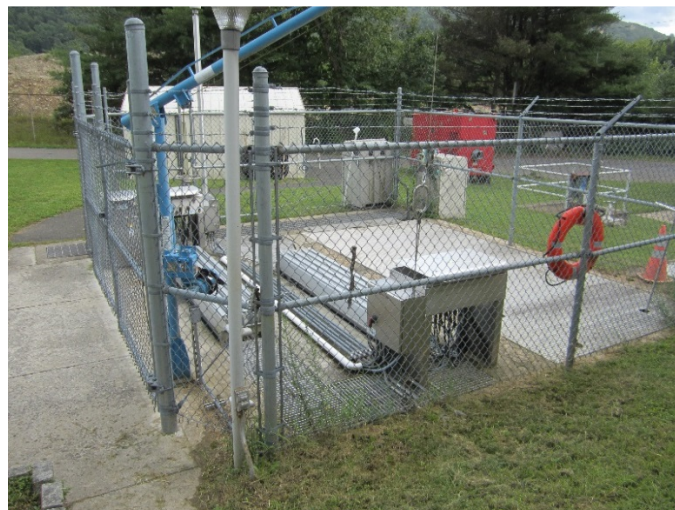
Figure 5-7 Beacon Falls UV Disinfection System

6. **Ultraviolet Disinfection.** A new two-bank outdoor ultraviolet disinfection system, installed in 2006, is reported to be in good working condition.

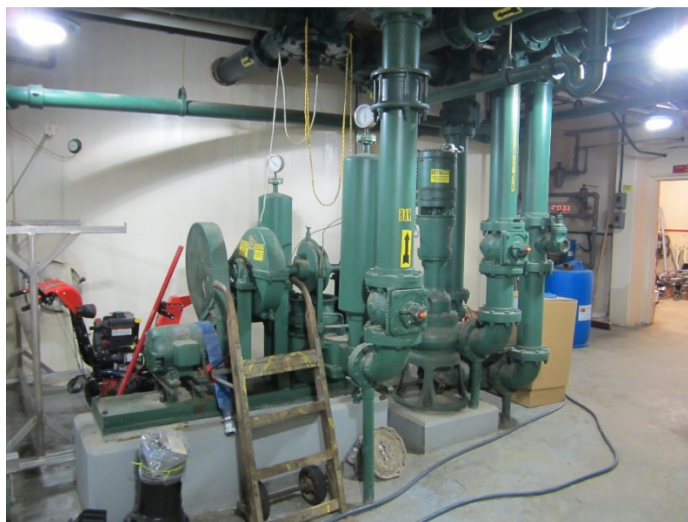
Figure 5-8 Beacon Falls Plunger Pumps for Sludge

anaerobic digester no longer functions as a digester, and is used for sludge storage. There is an abandoned sludge centrifuge onsite. Mechanical thickening should be provided to decrease sludge disposal costs.

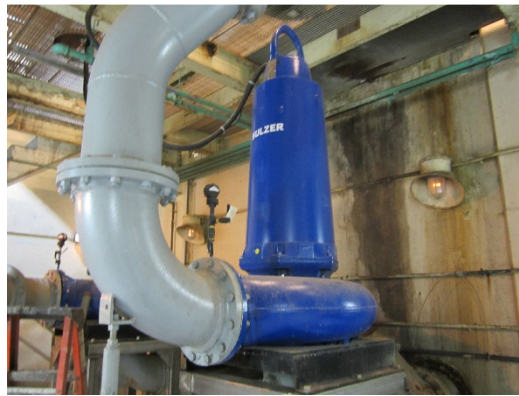
Figure 6-1 Naugatuck New Sulzer Influent Pump

1. **Influent Pump Station.** The plant influent pump station consists of four pumps in a dry pit/ wet pit arrangement. There is no headworks upstream of the influent pump station; consequently, the influent pumps are subject to maintenance challenges related to both grit and screenings. Three of the four influent pumps were recently replaced with new Sulzer centrifugal pumps.

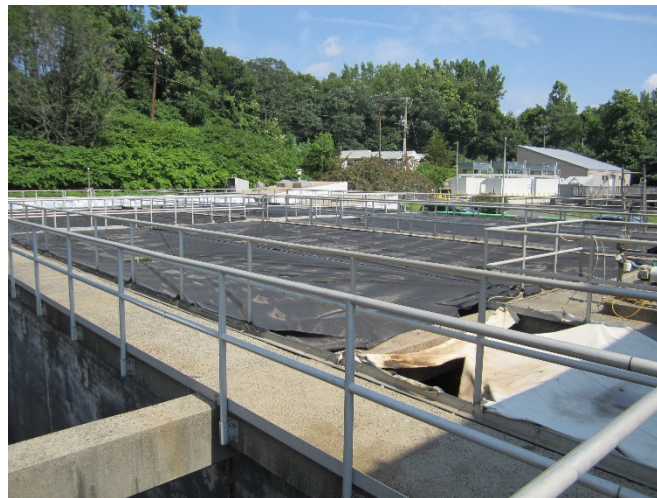
Figure 6-2 Naugatuck Primary Settling Tanks, Covered for Odor Control

2. **Primary Settling Tanks.** The plant has two operable rectangular primary settling tanks, each 120 ft x 30 ft x 12 ft SWD. Each tank has two parallel sections, with chain and flight sludge collectors and cross-collectors. The tanks are covered with fabric covers, for odor control. The scum collection system has not worked for several years.

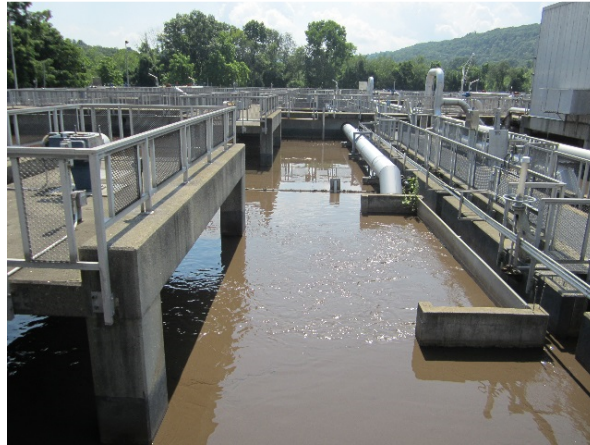
Figure 6-3 Naugatuck Anoxic Basins, in Modified 4-Stage Bardenpho Process

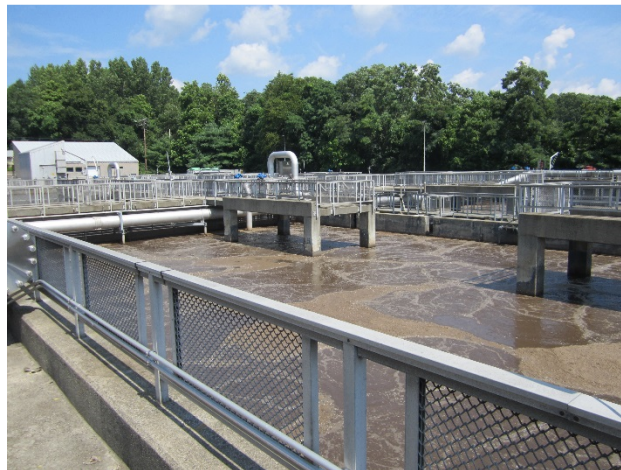
Figure 6-4 Naugatuck Activated Sludge Aeration Basin

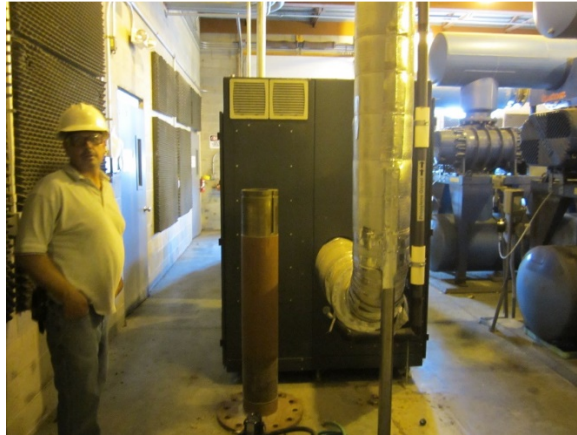
Figure 6-5 Naugatuck Piller Turbo Blower, for Aeration System

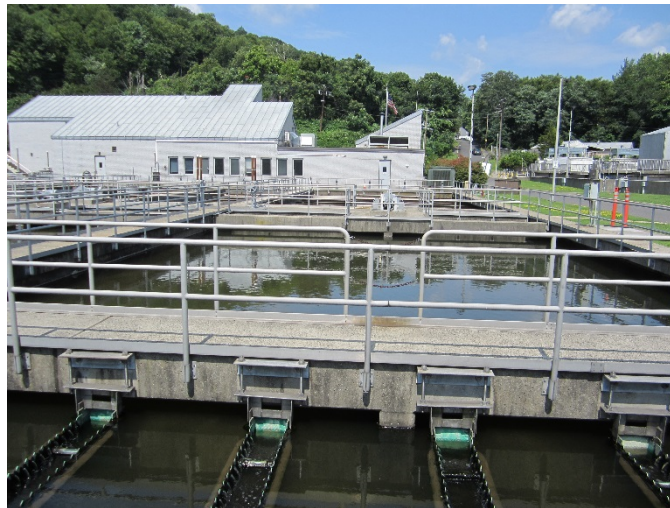
Figure 6-6 Naugatuck Secondary Clarifiers

4. **Secondary Clarifiers.** The Naugatuck WPCF has three rectangular secondary clarifiers, each 150 ft x 40 ft x 12 ft SWD. Much of the mechanical equipment, including the collector drives, RAS pumps and WAS pumps, is from the 1970's and needs to be replaced. Flow from these three clarifiers is sent to a fourth polishing clarifier downstream of the other three.

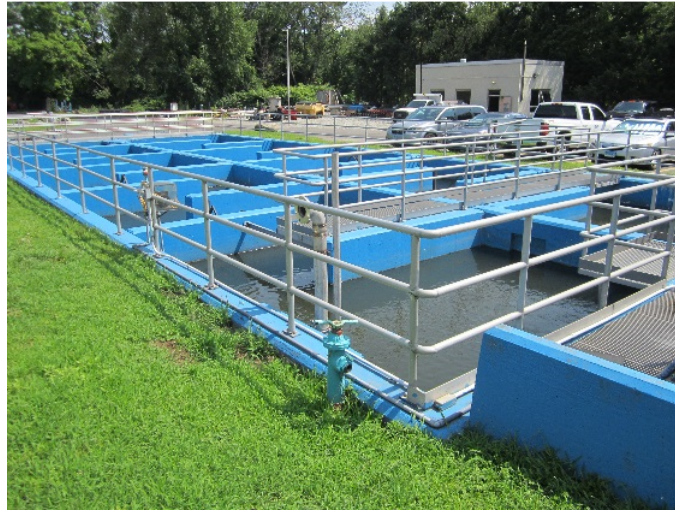
Figure 6-7 Naugatuck Chlorine Contact Basins

5. **Disinfection System.** Disinfection, which is provided by hypochlorite addition, is followed by bisulfite dechlorination. Since a significant portion of the plant's secondary effluent is used by the sludge incinerators, only a portion of the secondary effluent is disinfected and discharged to the Naugatuck River. The condition of the chlorine contact tanks is considered fair.

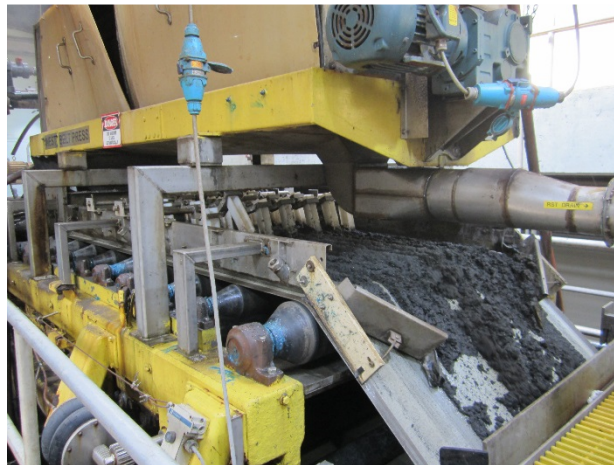
Figure 6-8 Naugatuck Belt Filter Press

6. **Sludge Thickening and Dewatering.** Primary sludge and WAS are co-thickened in a gravity thickener. There are four covered gravity thickeners at the WPCF. Thickened sludge is stored in multiple sludge storage tanks onsite. Sludge dewatering is accomplished with two centrifuges (installed 2002) and two belt filter presses (installed in the 1970's). Due to the large amount of sludge being processed from other plants at the incineration facility, sludge dewatering generally takes place on a 24/7 basis.

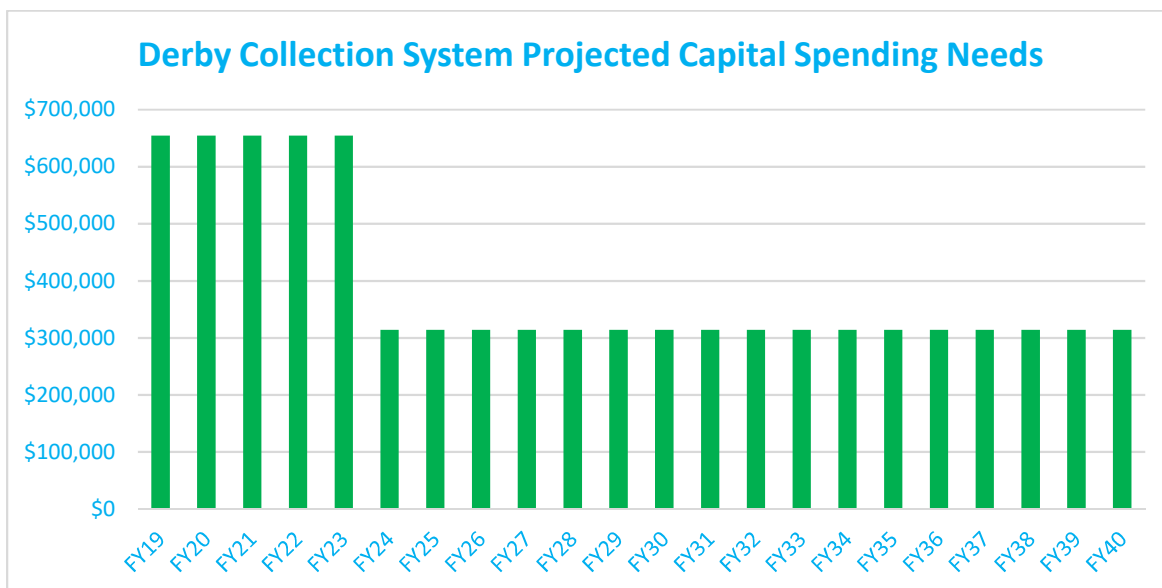
Figure A-1 Derby Collection System Projected Capital Spending Needs (2019 \$)

- Based on age and condition of the collection system (very old, approximately 70% VC pipe, high infiltration and inflow) system renewal costs were based on replacing 2.5% of the collection system per year during the first five years of a “catch up” period, followed by a sustained investment thereafter of replacing 1.2% of the system annually. Based on an overall collection system length of 41.2 miles of sewers, at an average 2019 replacement cost of \$120/LF, this would require approximately \$654,000/year for the first five years, and \$314,000/year thereafter, as shown on Figure A-1.

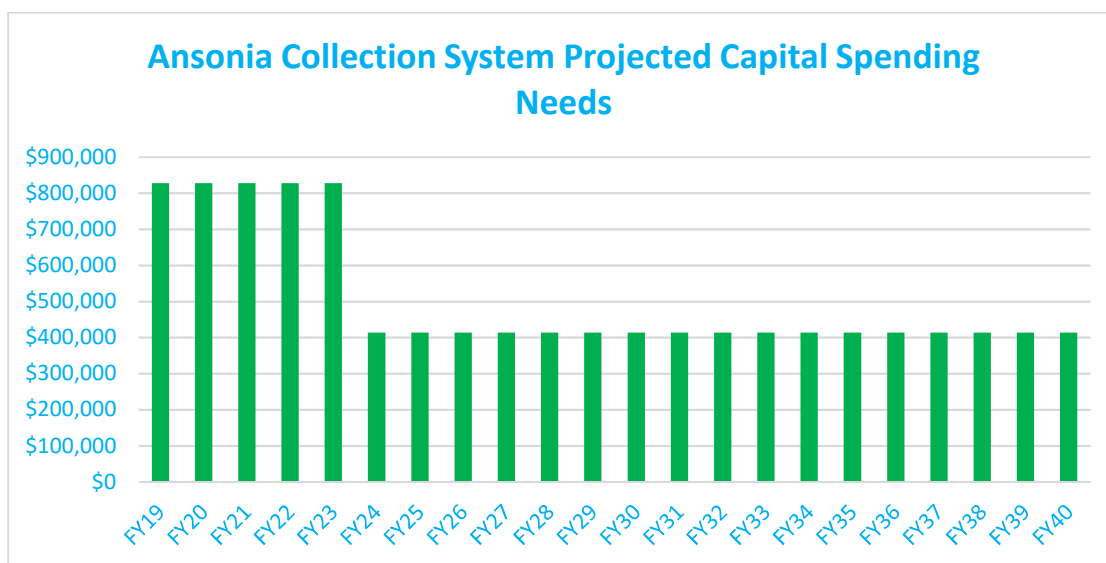
Figure A-2 Ansonia Collection System Projected Capital Spending Needs (2019 \$)

- The Ansonia collection system is old and much of it is VC pipe. While there has been some I/I work done in the past, significant investment is still required. A higher system-wide renewal rate is recommended for the first five years for catch-up. Therefore, system renewal costs were based on replacing 2.0% of the collection system per year during the first five years of a “catch up” period, followed by a sustained investment thereafter of replacing 1.0% of the system annually. Based on an overall collection system length of 65.3 miles of sewers, at an average (2019) unit cost of \$120/LF (to cover average lining or replacement costs, manhole rehabilitation, related inspection and SSES activities), this would require an investment of approximately \$828,000/year for the first five years, and \$414,000/year thereafter, as shown on Figure A-2.
