# REGIONAL WASTEWATER TREATMENT CONSOLIDATION STUDY

## Technical Memorandum 2: Condition Assessment

**B&V PROJECT NO. 198910**

**Naugatuck Valley Council of Governments**

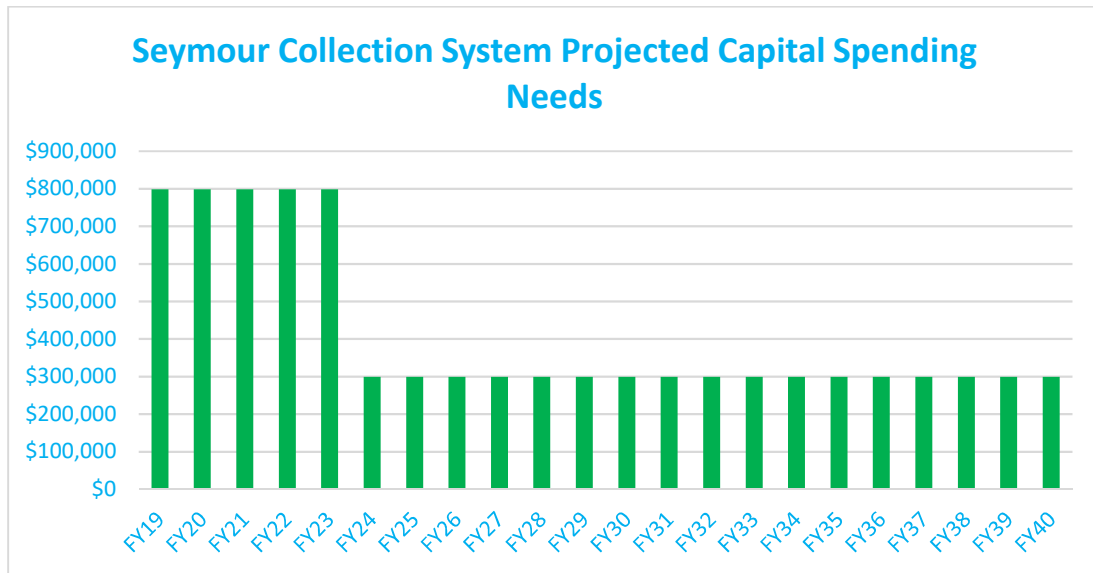
Figure A-3 Seymour Collection System Projected Capital Spending Needs (2019 \$)

- Significant investment will be required for sewer replacement and repairs, based on age and anticipated poor condition of the system. Projected system renewal costs were based on replacing 2.0% of the collection system per year during the first five years of a “catch up” period, followed by a sustained investment thereafter of replacing 0.75% of the system annually. Based on an overall collection system length of 63 miles of sewers, at an average (2019) unit cost of \$120/LF (to cover average lining or replacement costs as well related inspection and SSES activities), this would require an investment of approximately \$798,000/year for the first five years, and \$299,000/year thereafter, as shown on Figure A-3.

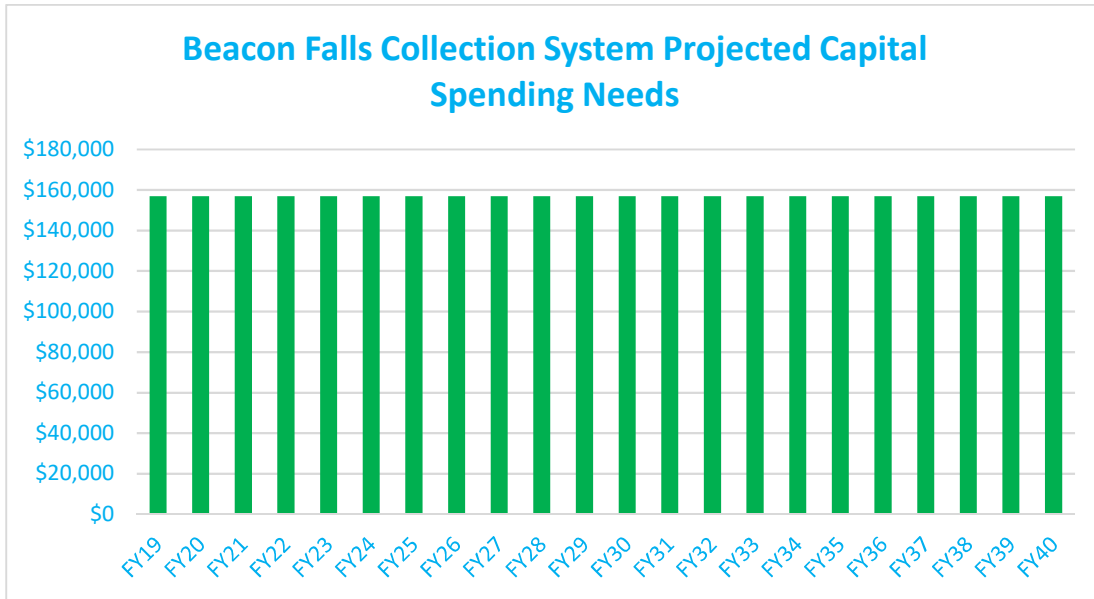
- Approximately two-thirds of the Beacon Falls collection system sewer piping was installed within the past 20 years. However, no detailed engineering investigations have been done on the collection system in the recent past. Based on this being a relatively new sewer system, it is presumed that the system as a whole is good condition. Therefore, a relatively low annual investment should be required compared to other the communities in this study. Projected system renewal costs were based on replacing 0.75% of the collection system per year, throughout the 20-year planning period. Based on an overall collection system length of 33 miles of sewers, at an average (2019) unit cost of \$120/LF (to cover average lining or replacement costs as well related inspection and SSES activities), this would require an investment of approximately \$157,000/year throughout the planning period, as shown on Figure A-4.

Figure A-4 Beacon Falls Collection System Projected Capital Spending Needs (2019 \$)

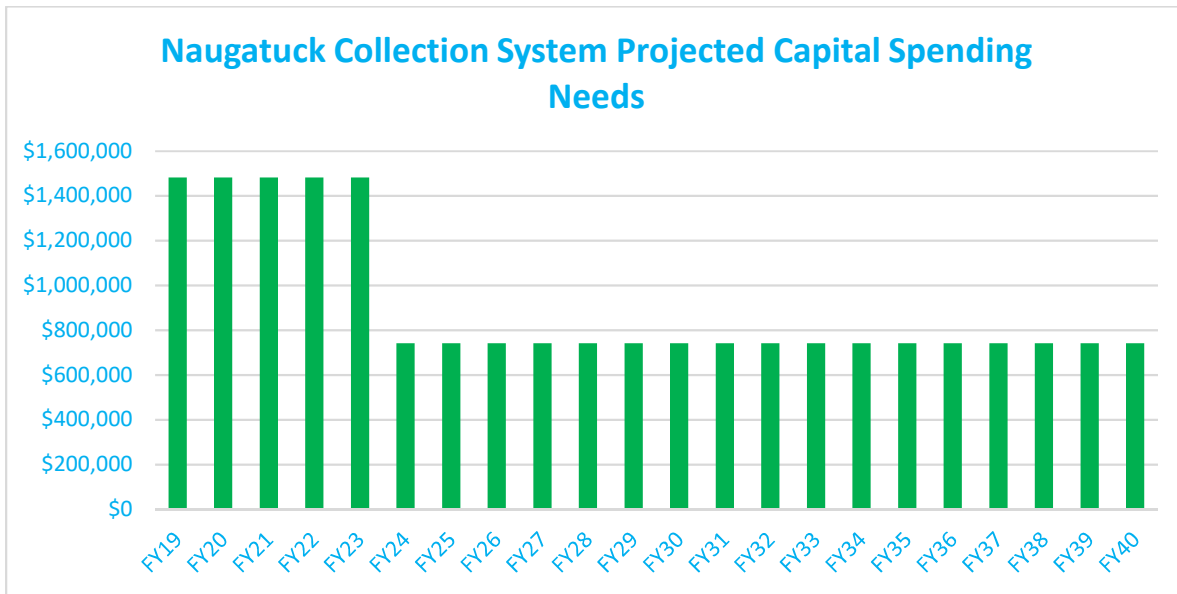
- The Naugatuck collection system is old and much of it is VC pipe. Significant investment will be required for sewer replacement and repairs, based on age and anticipated poor condition of the system. Projected system renewal costs were based on replacing 1.5% of the collection system per year during the first five years of a “catch up” period, followed by a sustained investment thereafter of replacing 0.75% of the system annually. Based on an overall collection system length of 156 miles of sewers, at an average (2019) unit cost of \$120/LF (to cover average lining or replacement costs as well related inspection and SSES activities), this would require an investment of approximately \$1,480,000/year for the first five years, and \$741,000/year thereafter, as shown on Figure A-5.

Figure A-5 Naugatuck Collection System Projected Capital Spending Needs (2019 \$)
