Re: Kinneytown Hydroelectric Project, Nos. P-6985-005 and -006;  
Failure to meet deadlines for Project compliance.

## APPENDIX I

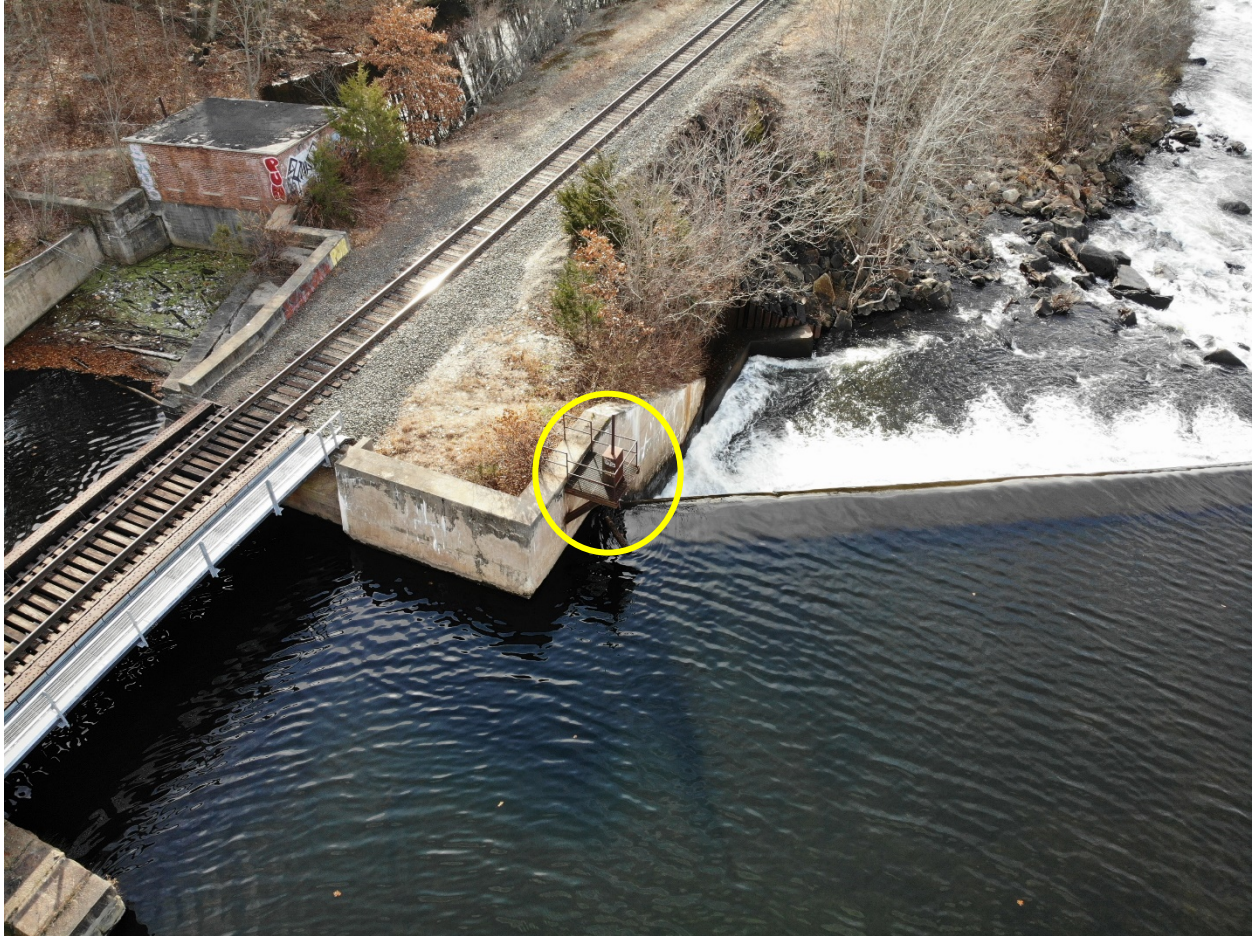
Photo 1: No warning signage approaching dam (A. Budris, 12/1/21)

Current status: See Appendix I, Photos 1-2, 7. While some general clean-up of the site has been completed (such as vegetation management), no tasks relevant to protecting the public from the hazards of the hydroelectric facilities and the dam itself have apparently been conducted: there are no signs alerting approaching river users of the dam and there are no functioning lights surrounding the facilities.

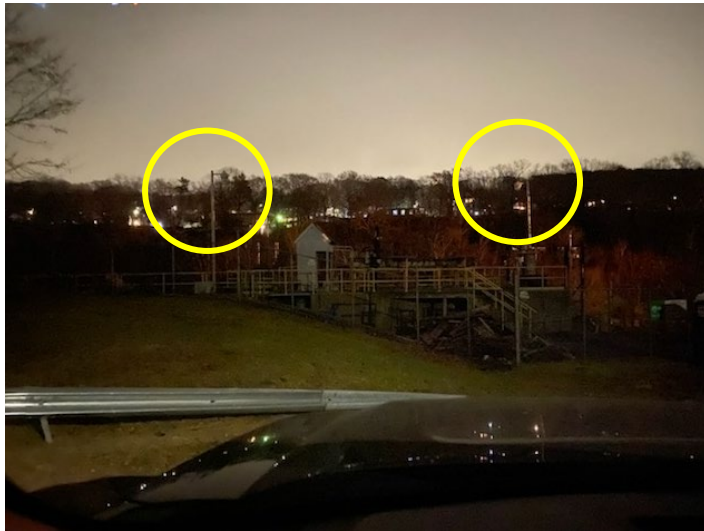
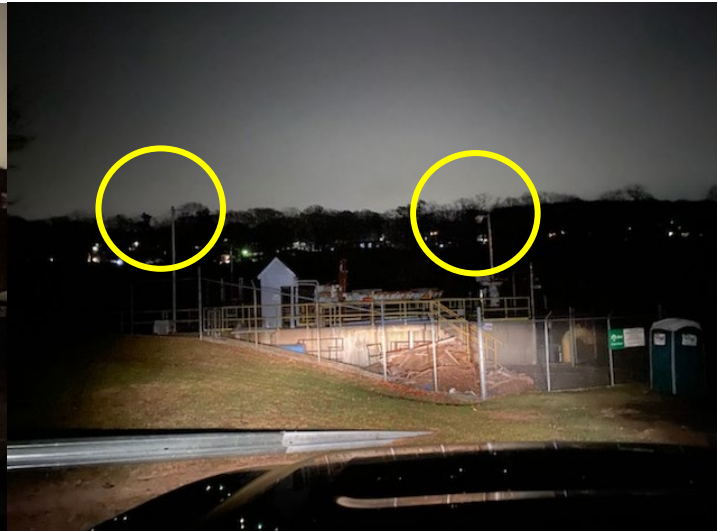
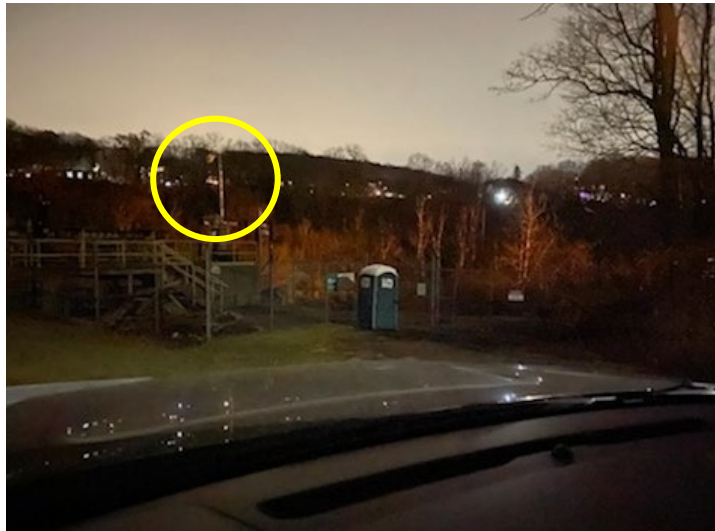
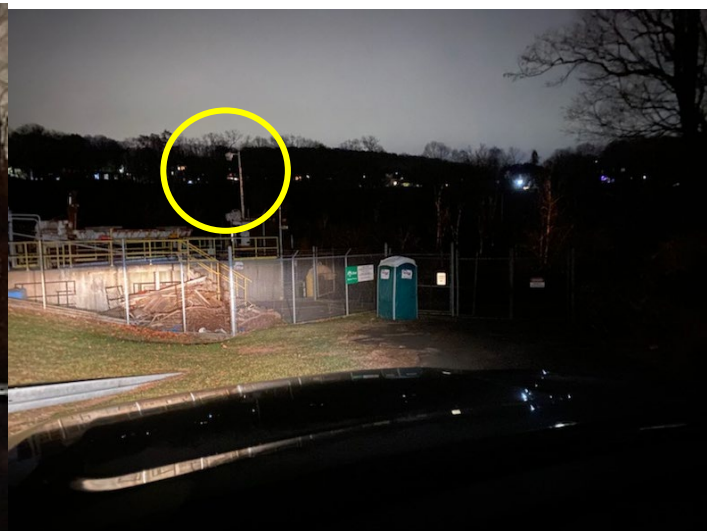
Photo 2: no safety lights at dam (K. Zak, 12/1/21)

8. I returned to the site around 10:00 p.m. on December 1, 2021 to inspect the lights surrounding Unit 1. I took several pictures with an iPhone of Unit 1 from a public parking area

off of Derby Avenue in Seymour, Connecticut. These photos, taken with and without vehicle headlights illuminating the facility, show that there are no functioning safety lights around Unit

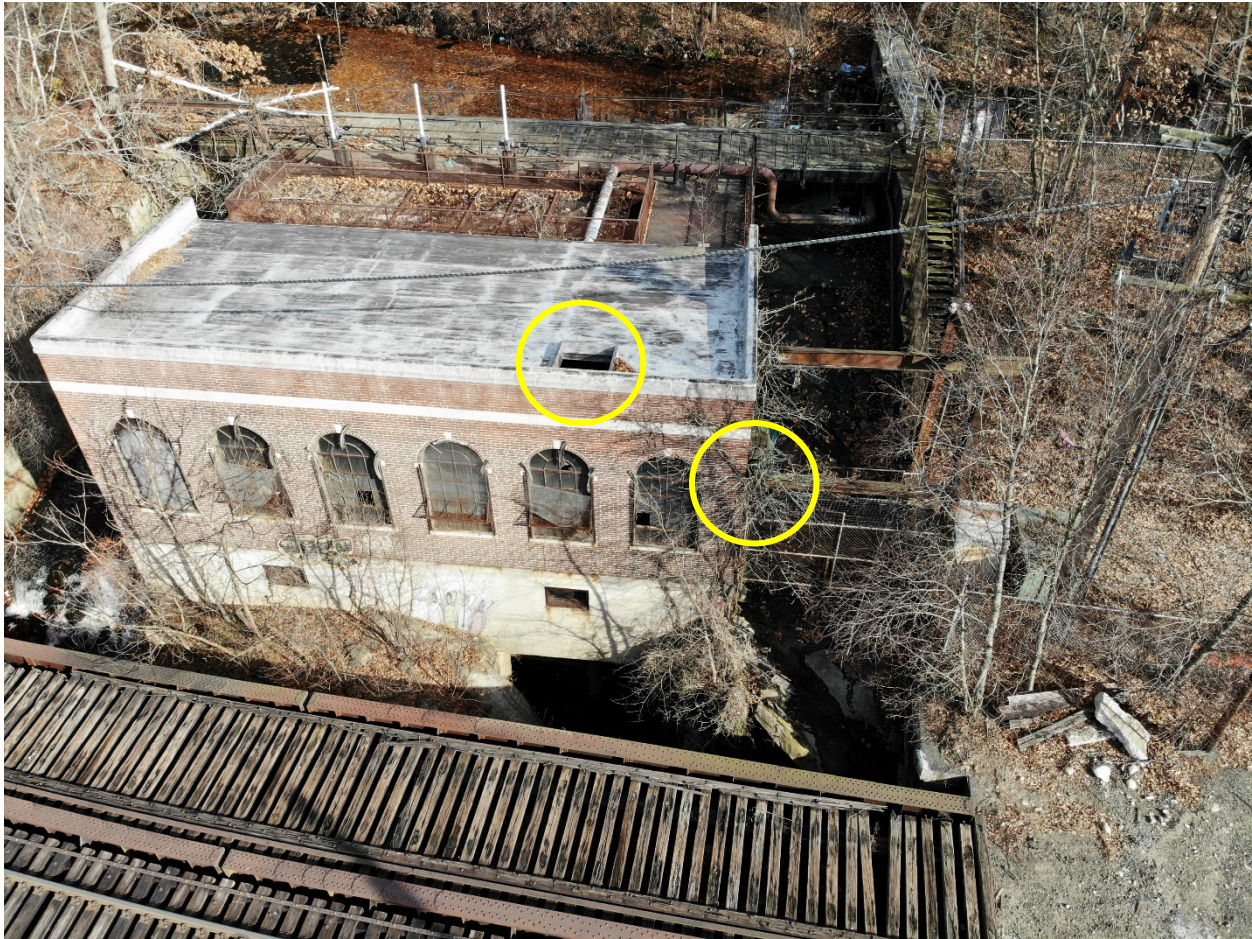
Photo 3: Unit 2 unsecured, skylight and door open (A. Budris, 12/1/21)

Current status: See Appendix I, Photos 3-5. Hydroland has not restricted access by the public to the hydropower facilities. The conditions existing when Hydroland made this promise of repair to the Commission appear to remain unchanged, namely: the gatehouse remains unlocked; Unit 2 remains unlocked and open, including an open skylight; and there are significant gaps in the fencing surrounding the Unit 2 property. Unit 2 is of particular concern, given that the property abuts a residential neighborhood.

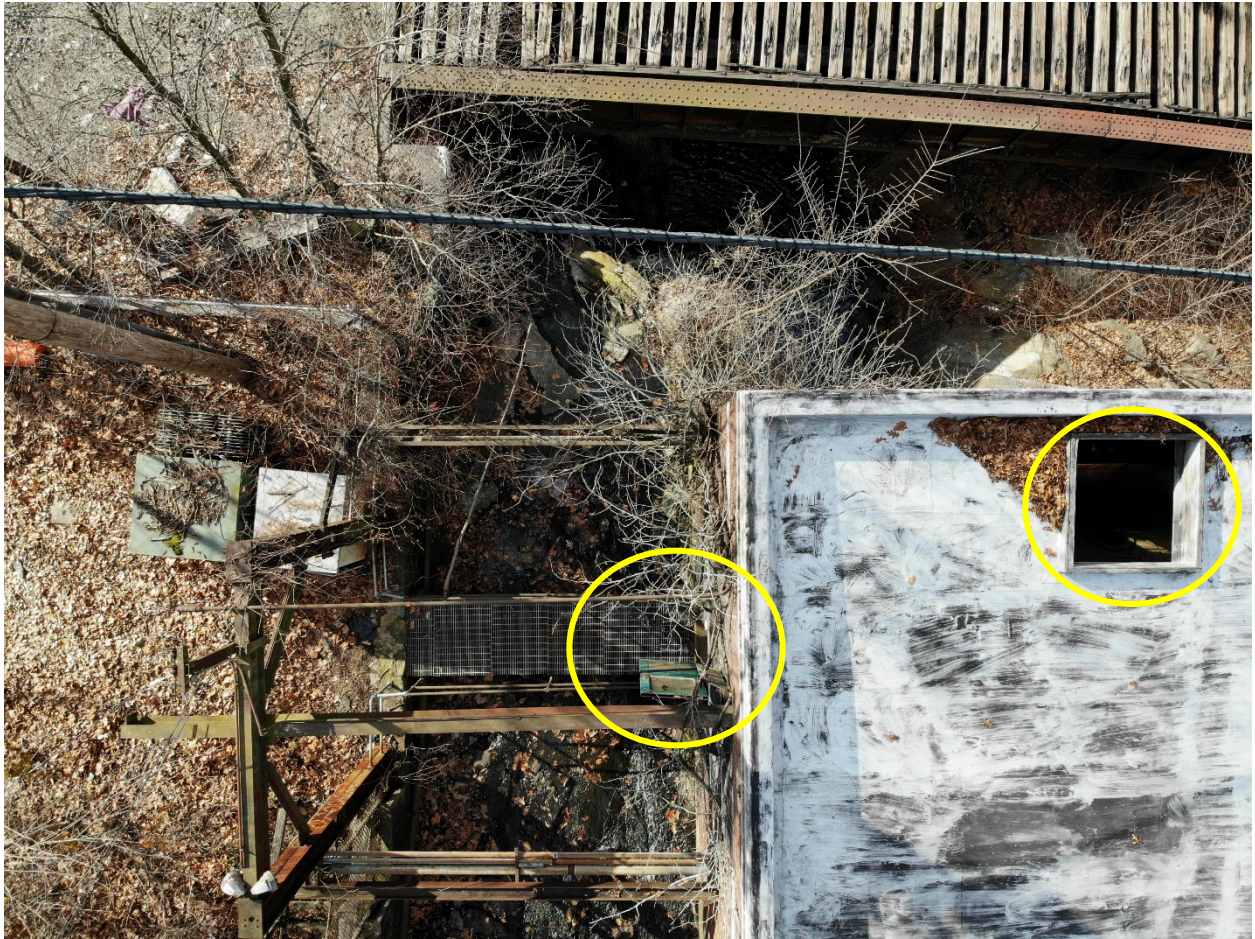
Photo 4: Unit 2 unsecured, skylight and door open (A. Budris, 12/1/21)

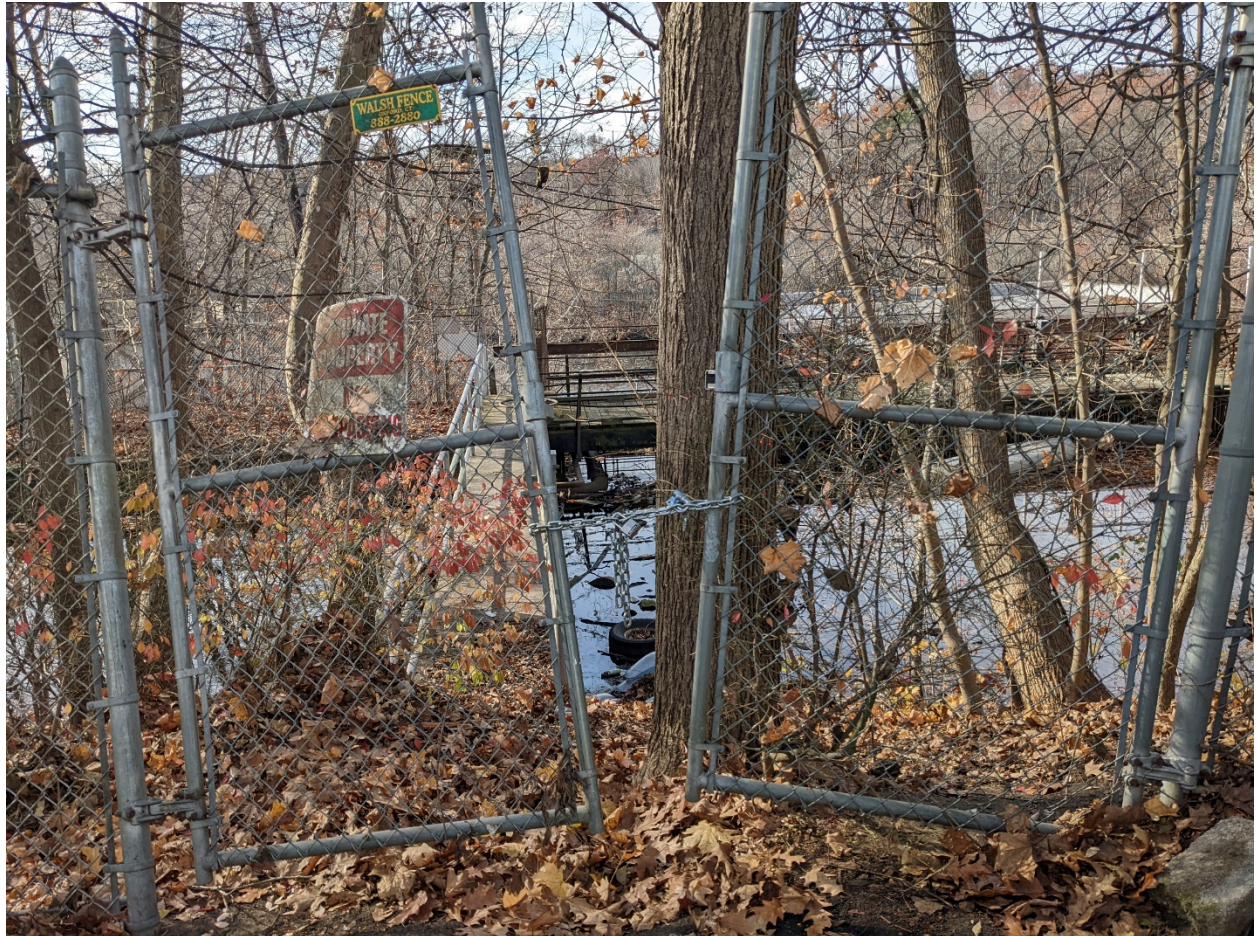
Photo 5: Unit 2 unsecured, easy access from adjacent neighborhood (A. Budris,  
12/1/21)

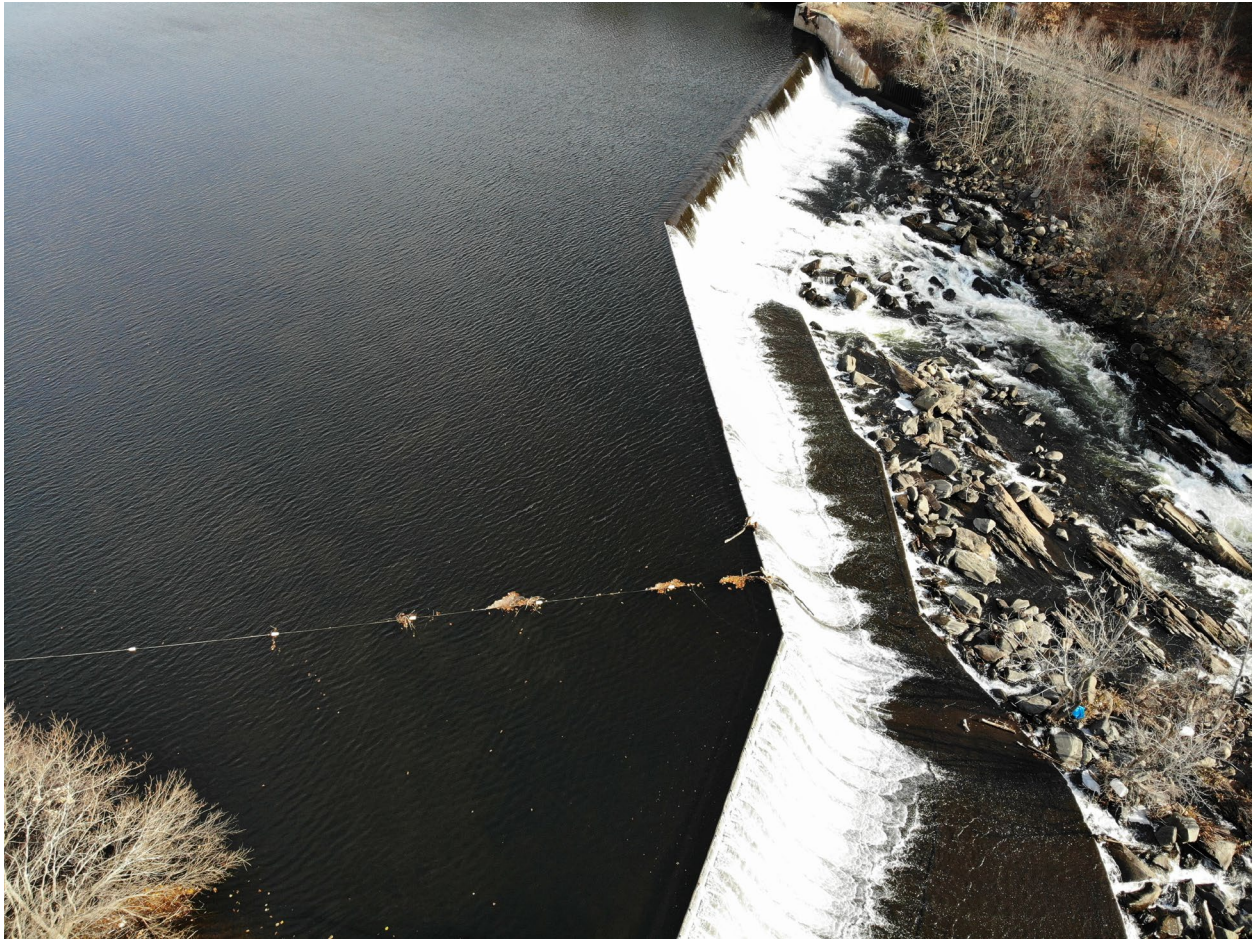
Current status: The boat barrier remains draped over the face of the dam, continuing to leave boaters at risk. See Appendix I, Photos 6-7.

Photo 6: boat barrier draped over face of dam (A. Budris, 12/1/21)

Deadline: In its July 2019 inspection report, the Commission determined that the boat boom was not in place and required that it be replaced.<sup>12</sup> Hydroland stated that the boat barrier would be replaced by April 2022.<sup>13</sup> Commenters contend that waiting until April 2022 is a dangerously delayed response, as this task is not resource intensive, and urgent to protect public safety.

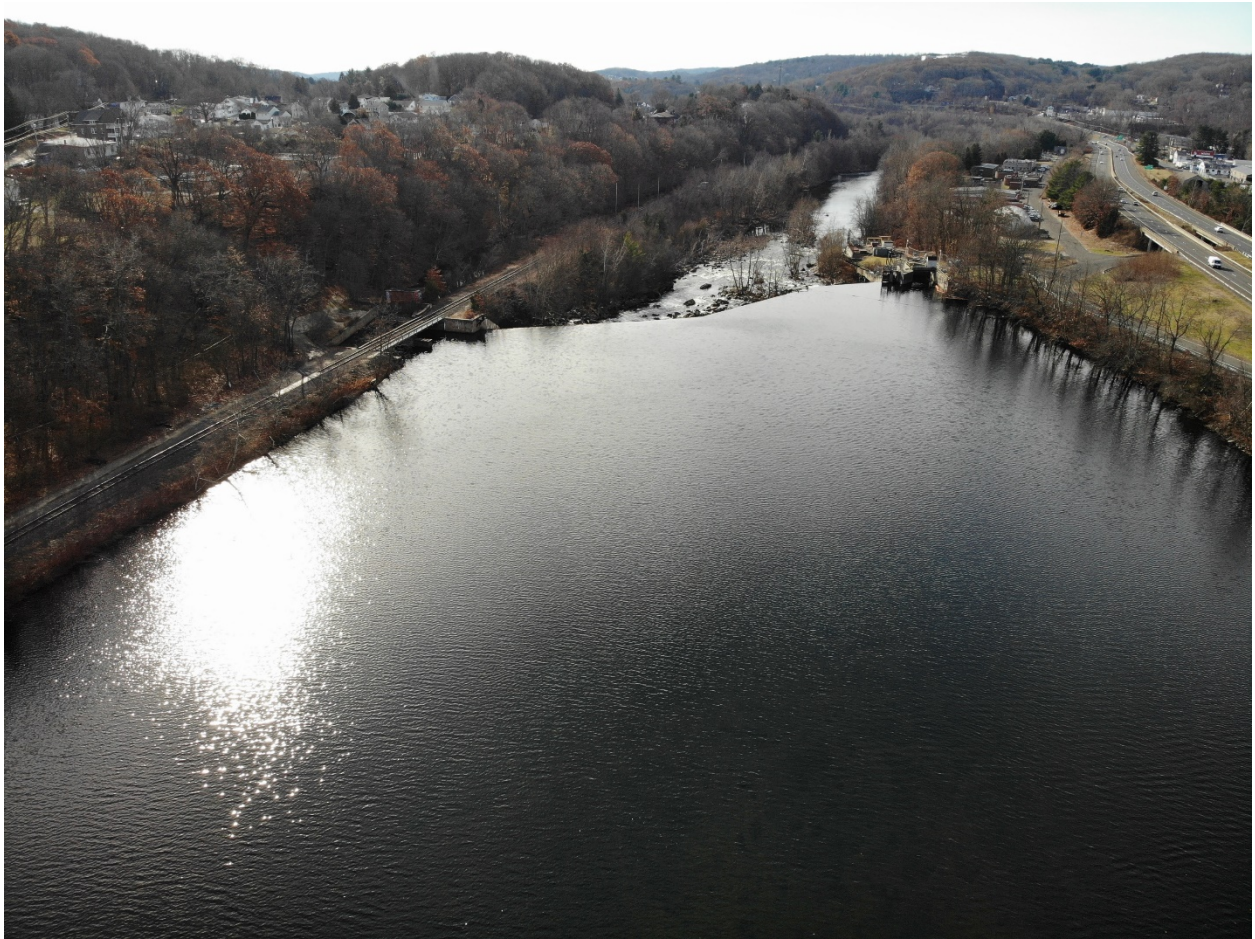
Photo 7: no warning signs, no boat barrier (A. Budris, 12/1/21)

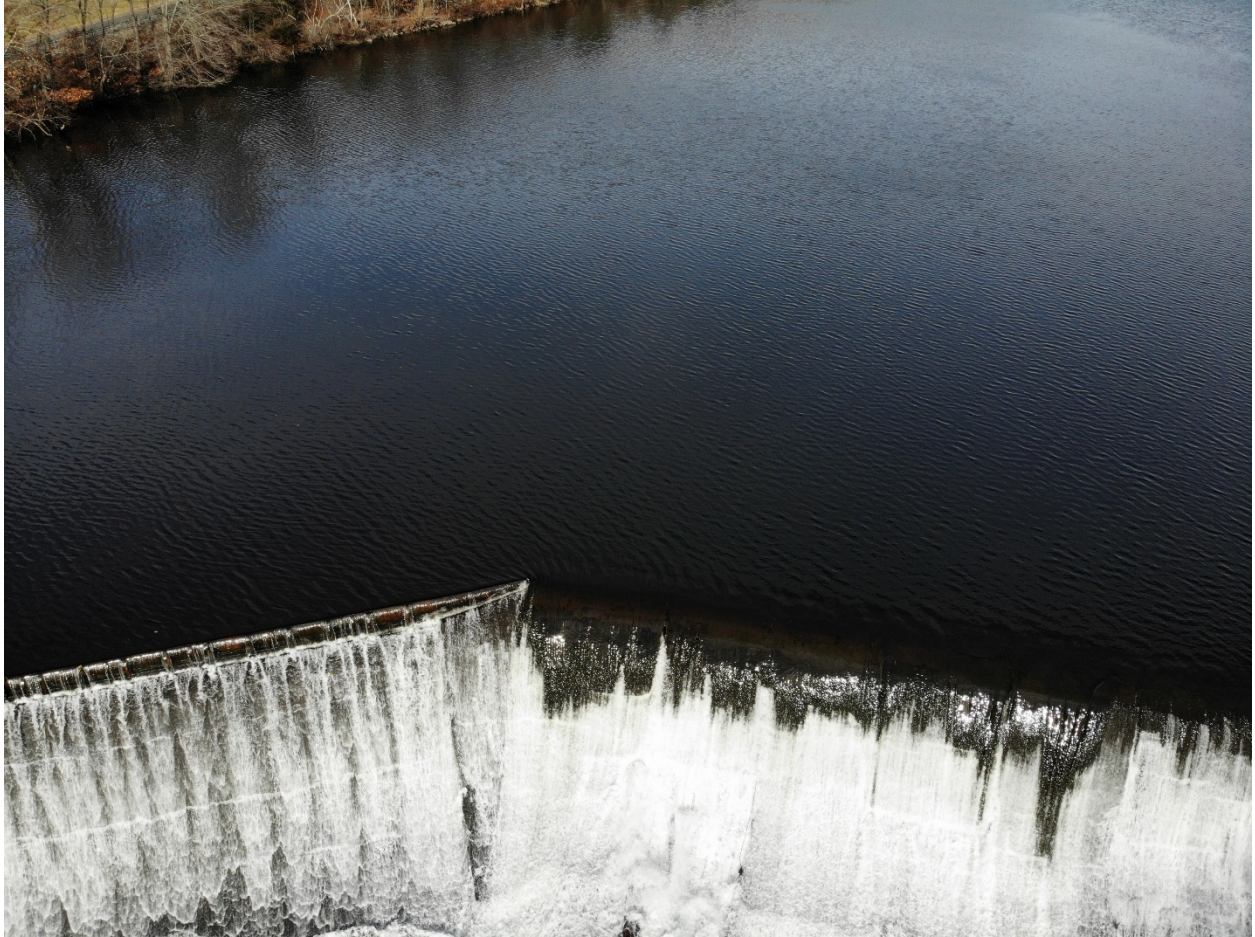
Current status: See Appendix I, Photo 8. There are still no flashboards on the east side of the dam. This task would bring the dam height to a uniform elevation, which is one of the many tasks necessary to provide the proper flow regimes for fish passage, as it would limit the spill that results in false attraction.

Photo 8: no crestboards on east side of dam (A. Budris, 12/1/21)

Deadline: This task was to be completed by November 30, 2021, according to Hydroland and FWS deadlines.<sup>14</sup> FERC previously ordered the installation or repair of these flashboards/crestboards by April 15, 2021.<sup>15</sup>

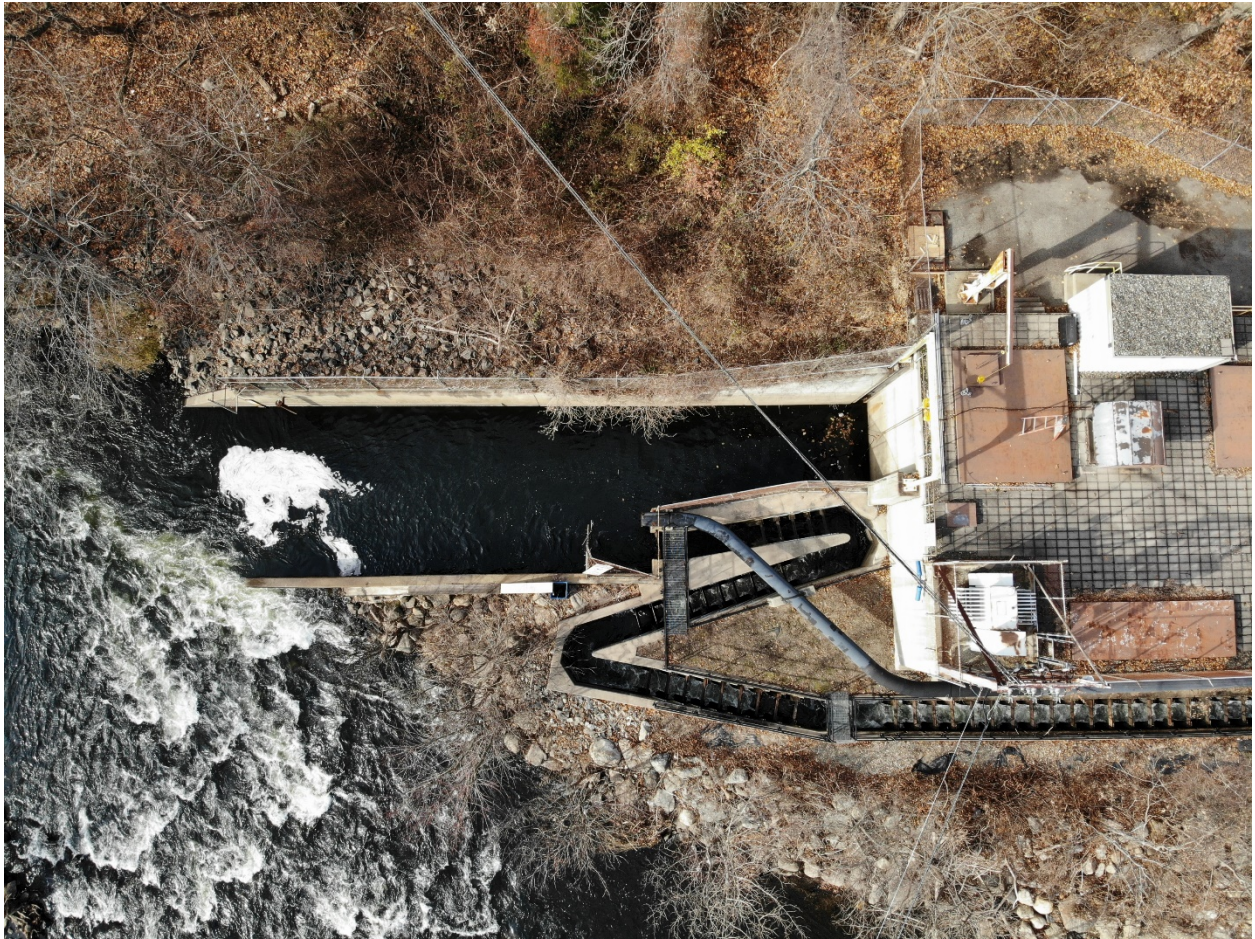
Current status: Hydroland has not notified the Commission that Unit 1 is now operating, nor has it provided any subsequent updates regarding any reason for a delay if indeed it is still offline. It is our understanding from site observations and river flow conditions that Unit 1 is still not in operation: no flow was observed exiting Unit 1, and all flow appeared to be spilling over the face of the dam. See Appendix I, Photo 9. A status update regarding Unit 1 should be immediately provided to the Commission and natural resource agencies. Operation of Unit 1 is required under the conditions of the

Photo 9: no flow from Unit 1 outfall (A. Budris, 12/1/21)

Deadline: Hydroland has provided various deadlines for returning Unit 1 to service, most recently stating that it would be back in operation “ASAP,”<sup>16</sup> in the “near future,”<sup>17</sup> or “with[in] a few days.”<sup>18</sup> FERC previously ordered that Unit 1 return to operation by April 15, 2021.<sup>19</sup>
