Coe Pond Dam Inspection Findings

Kinneytown Hydroelectric Project (FERC No. 6985)

MARCH 2024

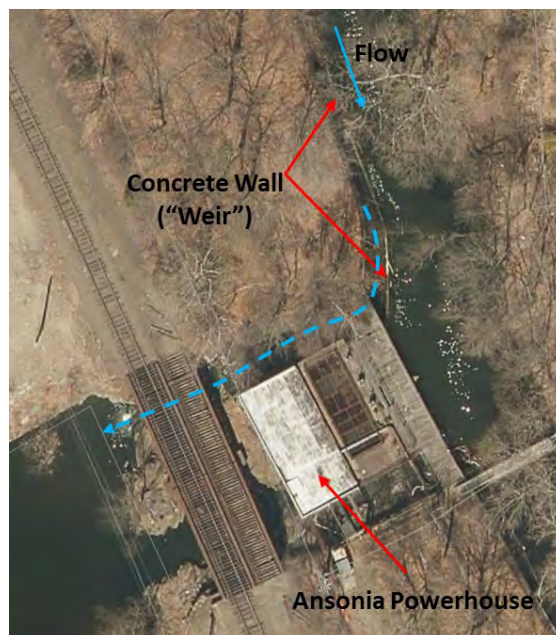
While FERC included several issues needing to be addressed, we prioritized the issues based on public safety. Given the threat to public safety should the earthen dam breach, the top priority and highest level of urgency is lowering the water level in Coe Pond to reduce pressure on the earthen dam, reduce the potential for overtopping, and reduce the volume of water in Coe Pond. It is recommended that this work be completed as soon as conditions permit, but not later than the end of April 2024. Based on the site inspection, the best alternative to lowering Coe Pond water level is purposely removing a portion of a 65-foot-long northern weir north of the Ansonia Powerhouse (see inset). If Coe Pond water level rises above the northern weir, water flows into a separate channel and is discharged below the Ansonia Powerhouse and into the Naugatuck River as shown by the dotted blue line on the inset.

A photograph showing the approximate location to breach the northern weir is shown in [Figure 6.1-1](#). The removal will lower the weir crest to be within 6 inches of the concrete base slab (sizing of the weir breach is discussed below). This removal will result in lowering the normal water level in Coe Pond and Coe Pond by

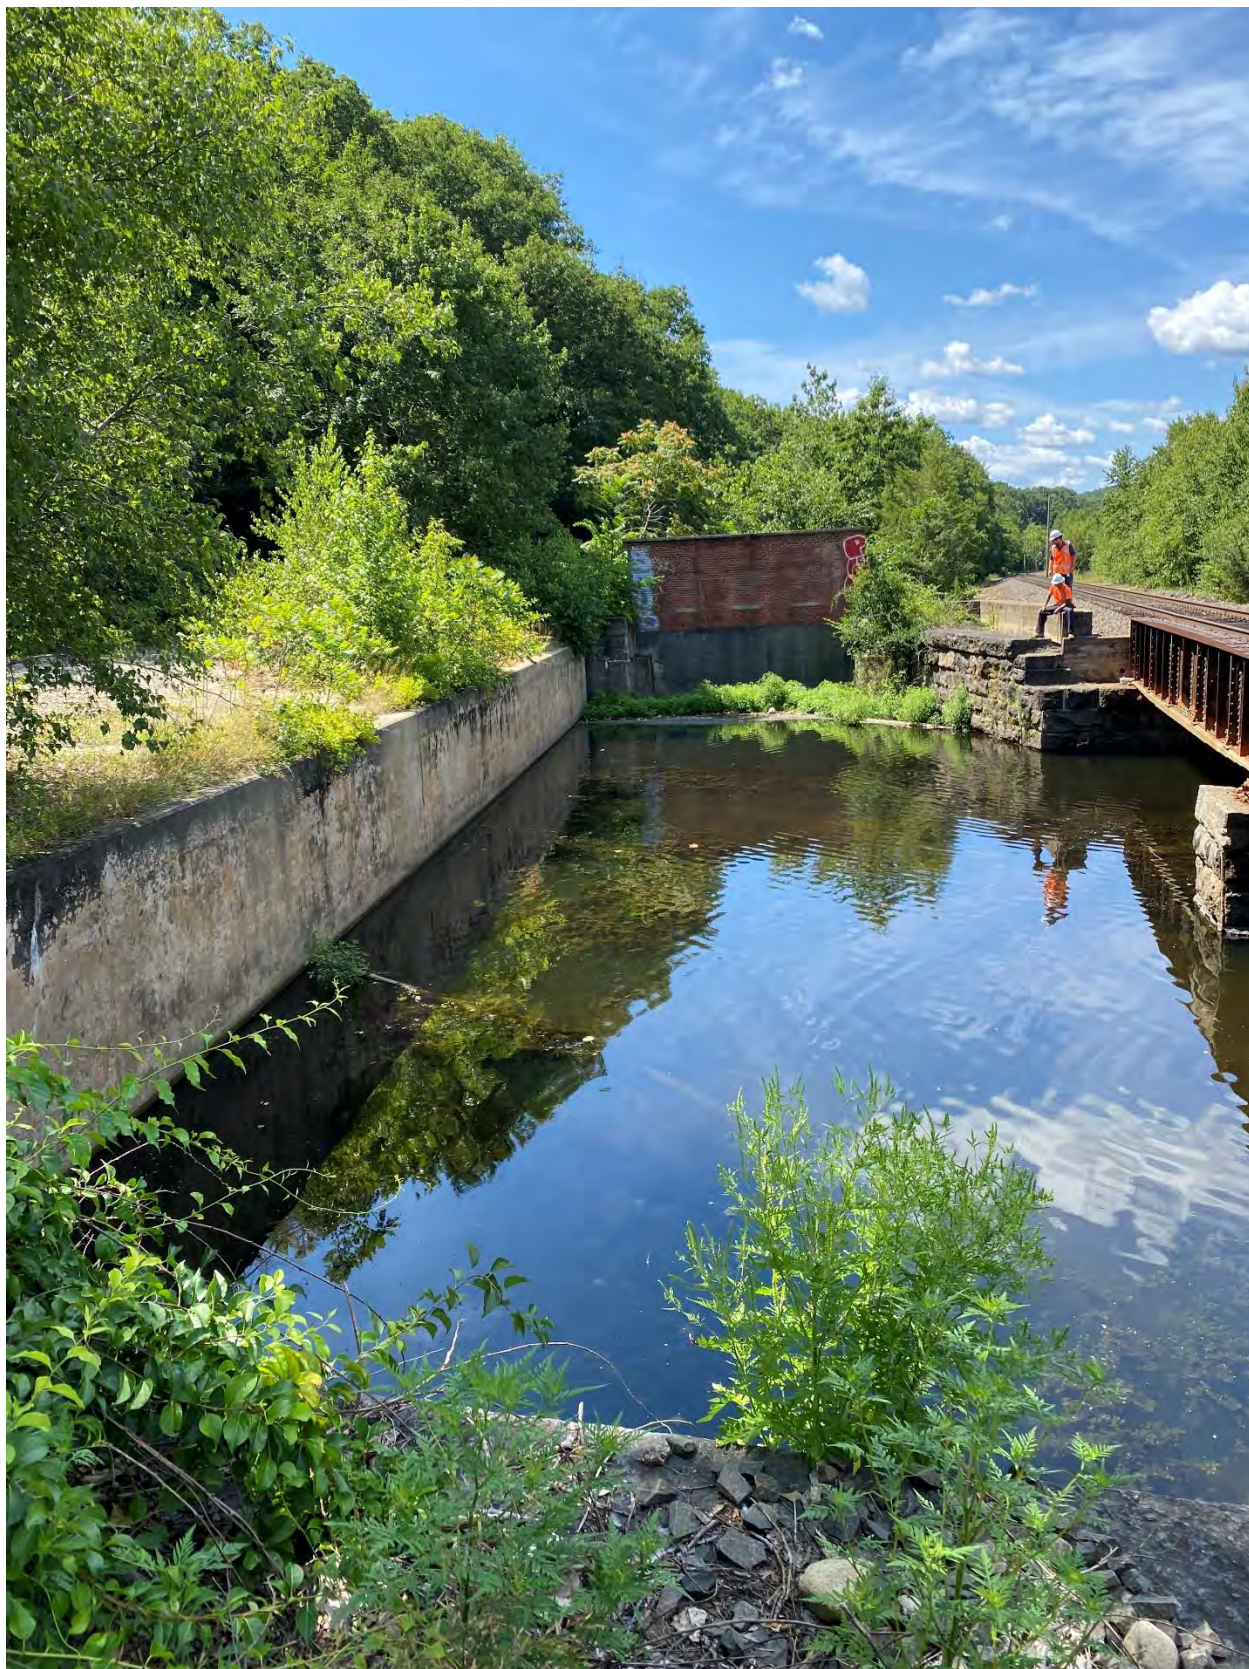
Photo 4-Gate House, adjacent to Kinneytown Dam- Right abutment.

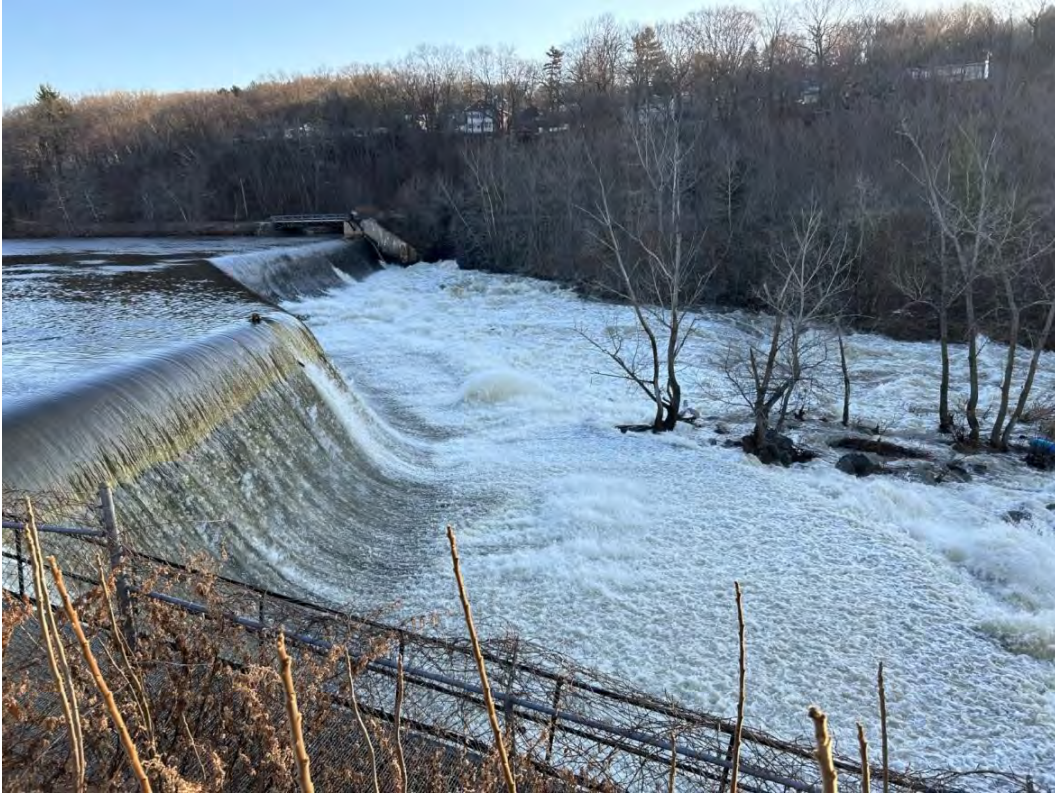
Photo 1. View of Kinneytown Dam from Right Abutment

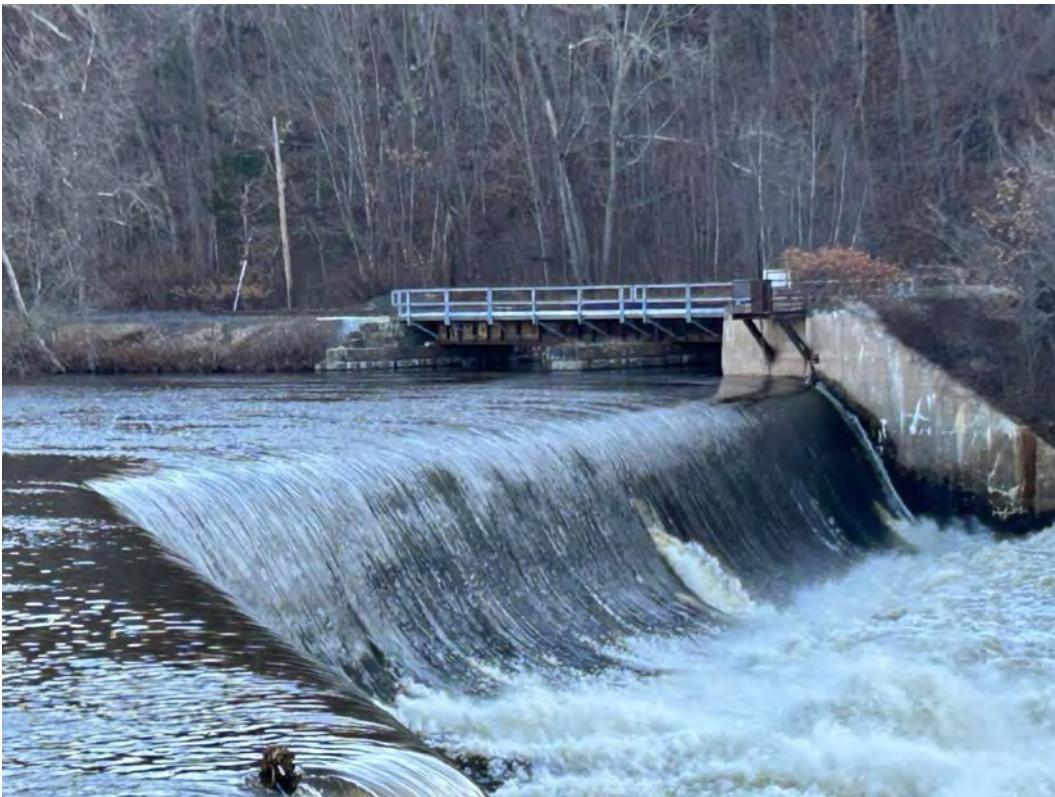
Photo 2. View of Left Spillway at Kinneytown Dam. Note Canal Intake in Background

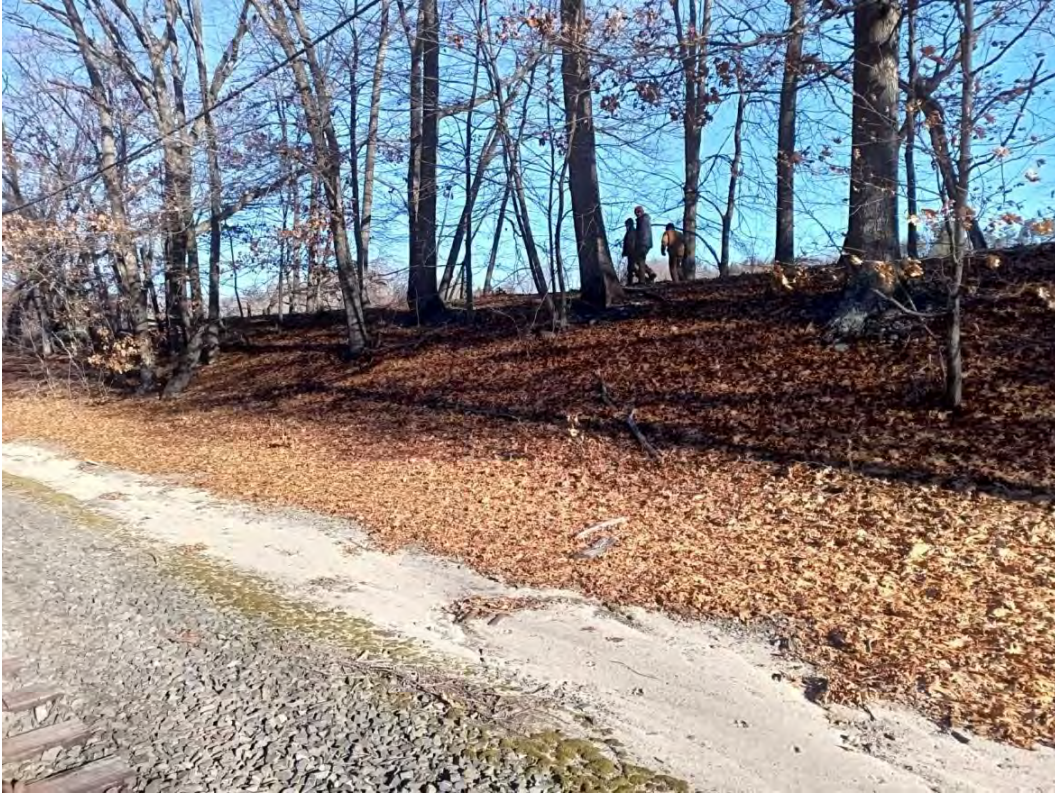
Photo 18. View of Outboard Slope of Embankment

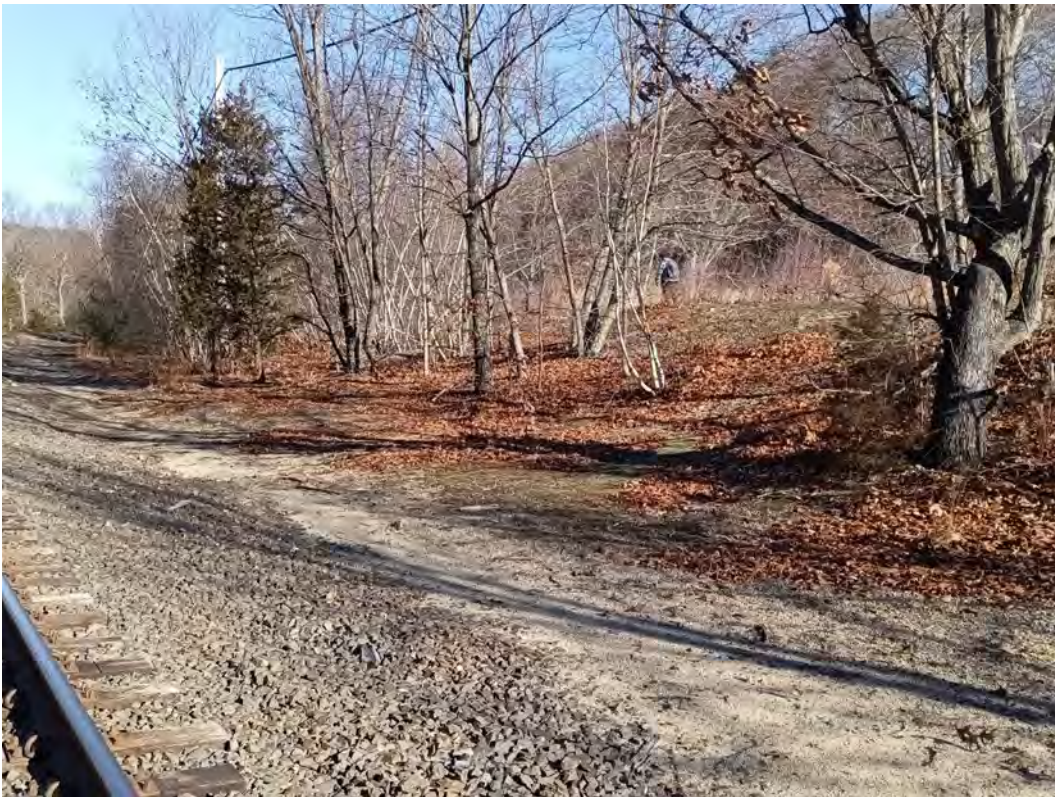
Photo 19. View of Outboard Slope of Embankment

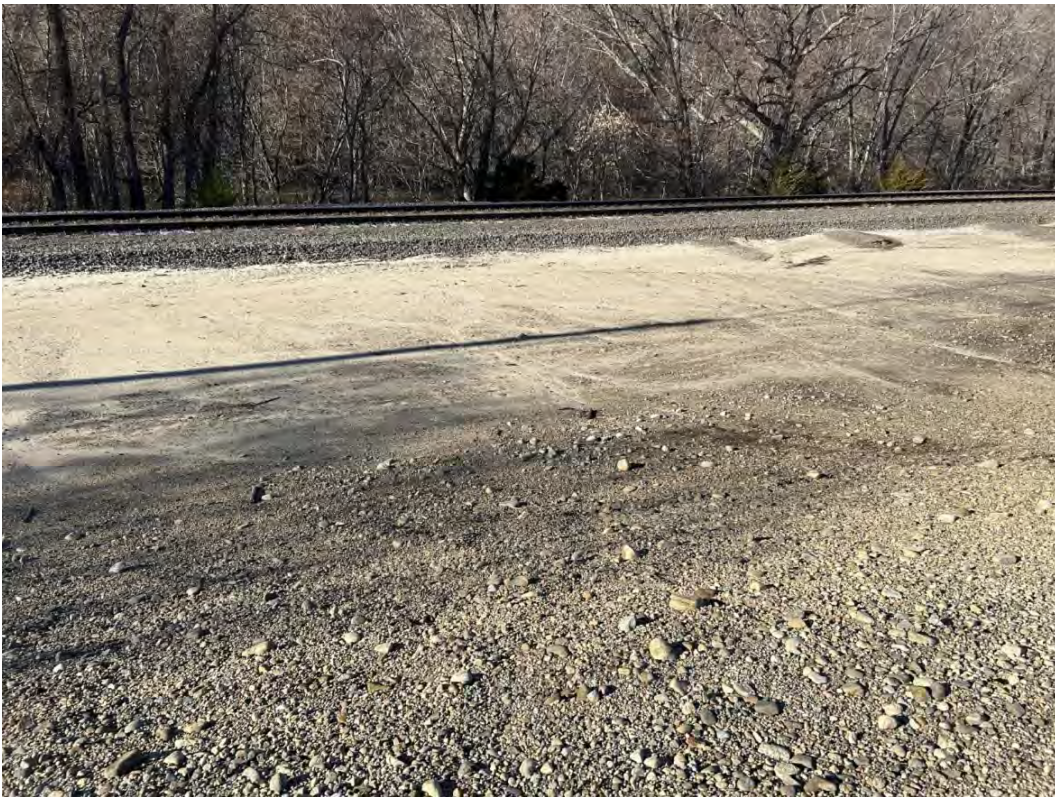
Photo 25. View of Outboard Slope of Embankment

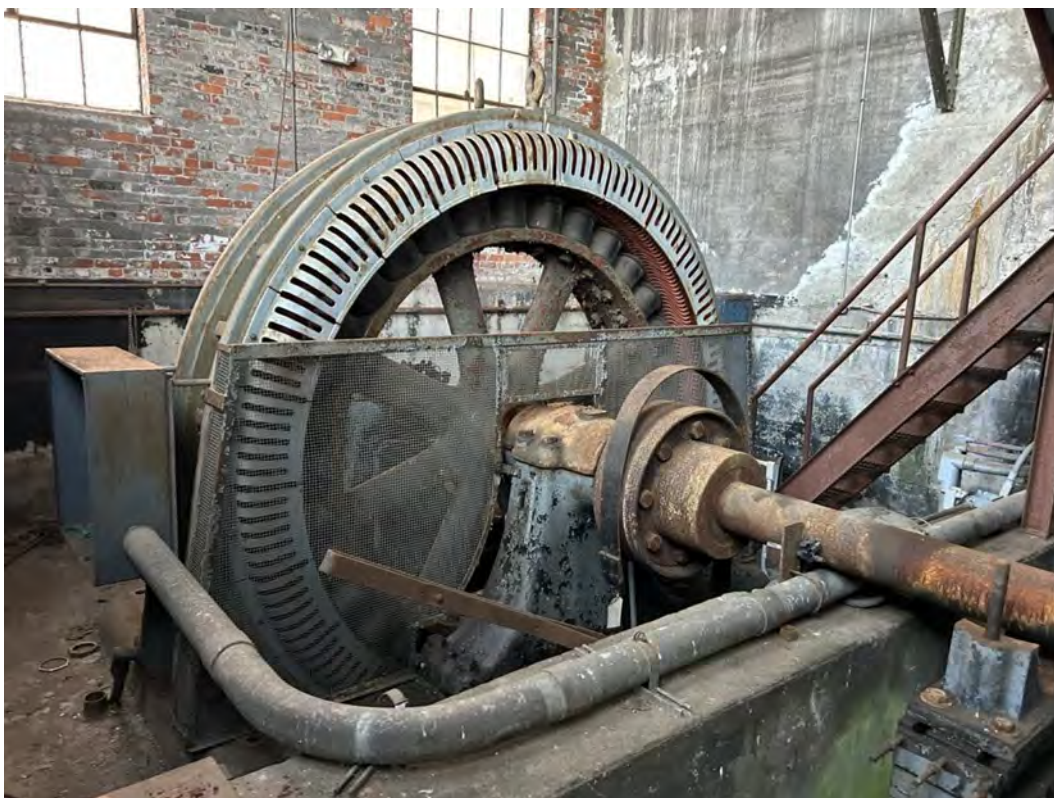
Photo 27. View of Ansonia Powerhouse Interior (Generator)

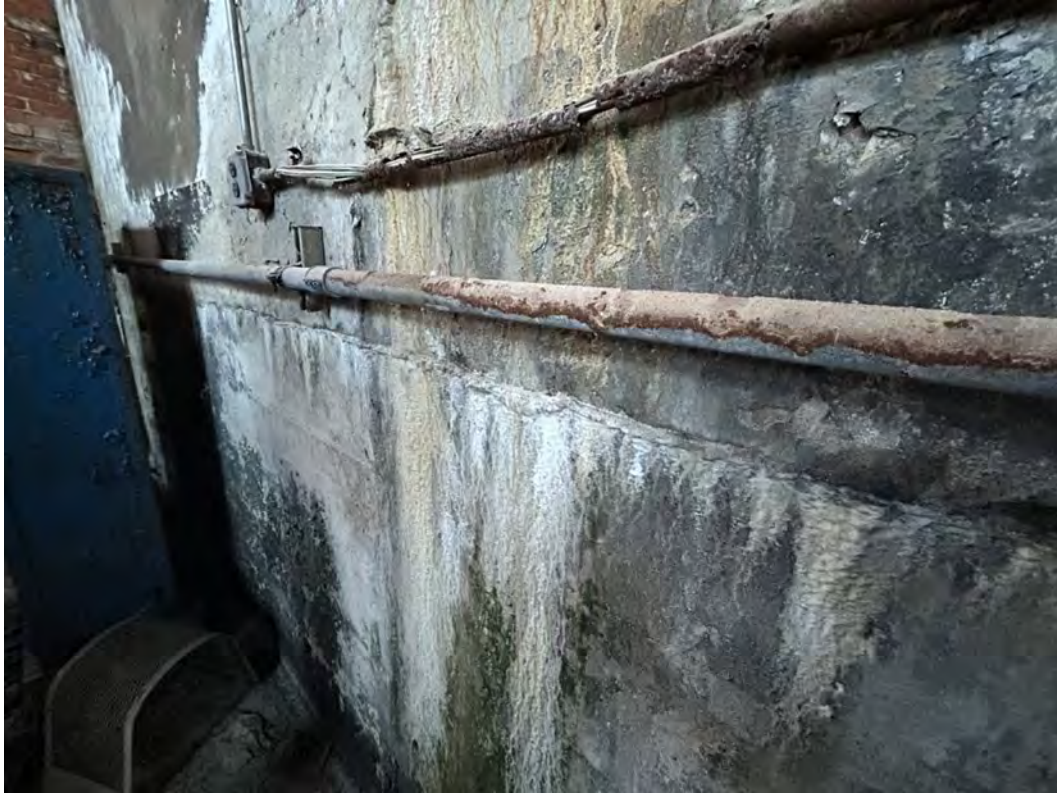
Photo 28. View of Ansonia Powerhouse Interior Wall and Electrical Conduit

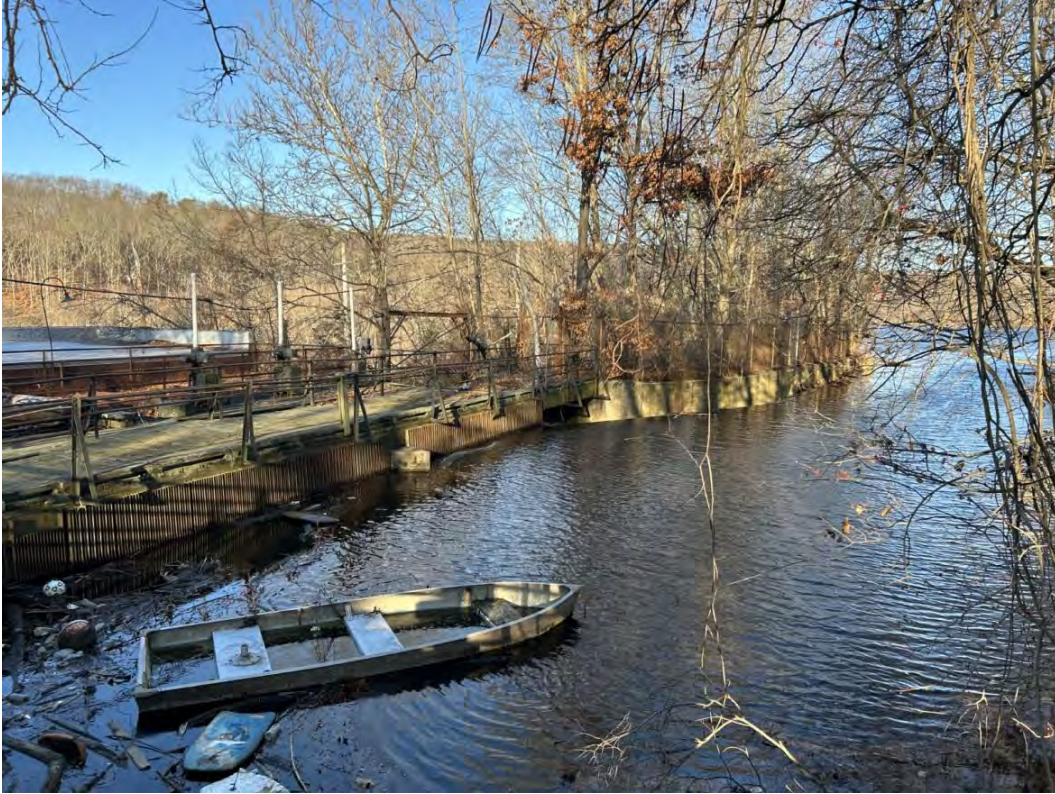
Photo 30. View of Intake Area at Ansonia Powerhouse. Note Trashracks at Intakes

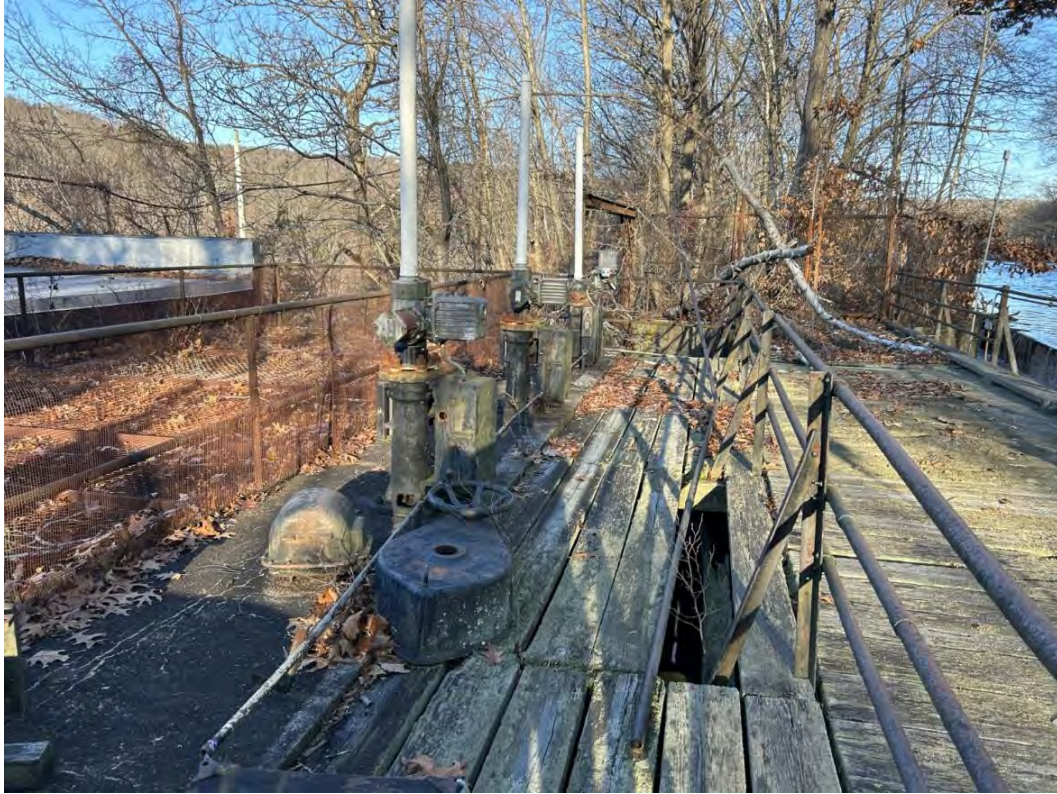
Photo 32. View of Headgates and Gate Platform at Ansonia Powerhouse

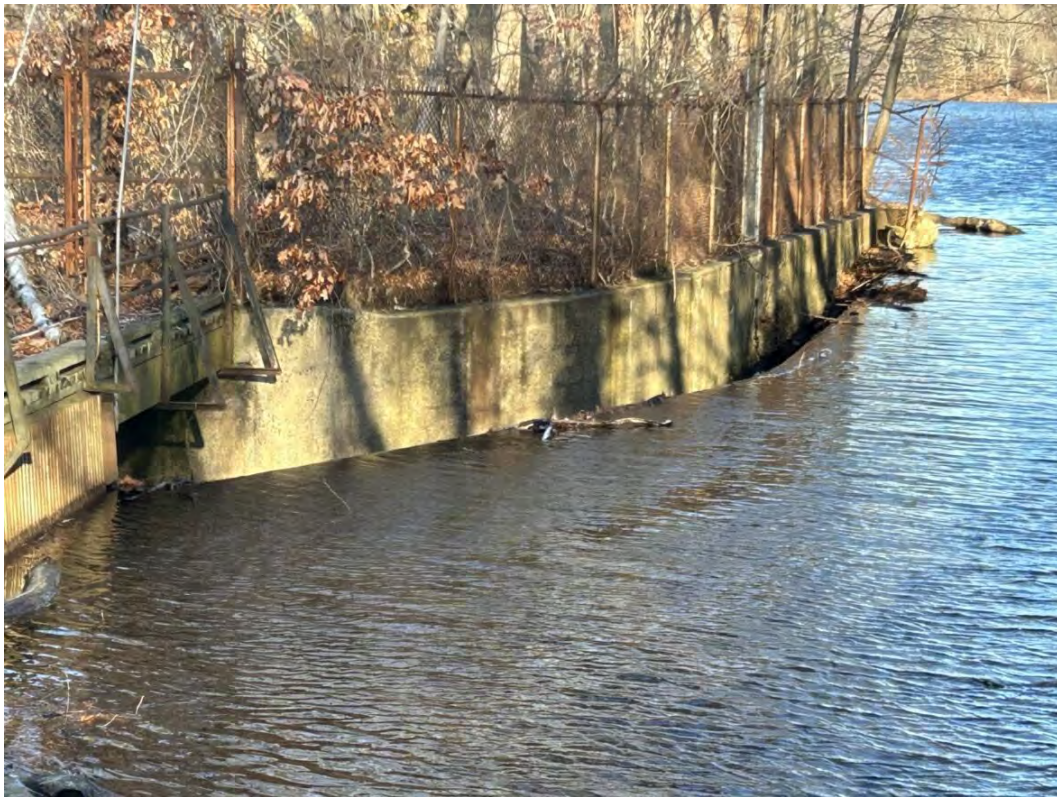
Photo 33. View of Concrete Retaining Wall and Upstream Weir at Ansonia Powerhouse

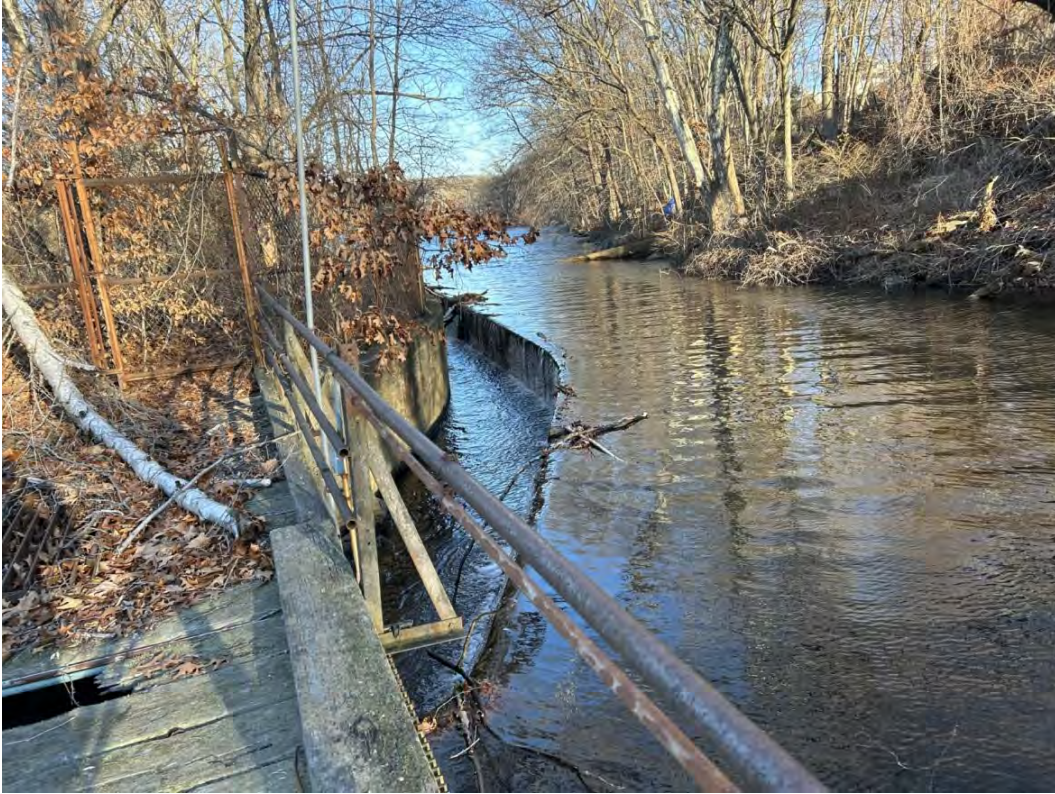
Photo 34. View of Upstream Weir at Ansonia Powerhouse

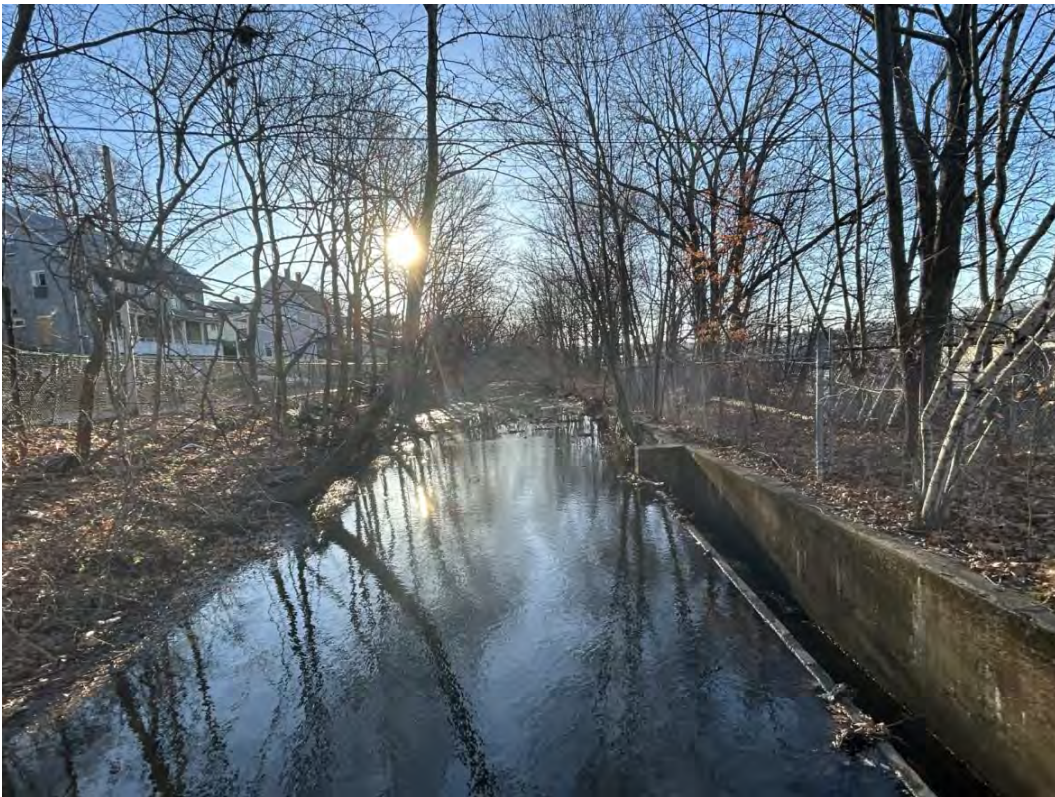
Photo 35. View of Downstream Weir at Ansonia Powerhouse

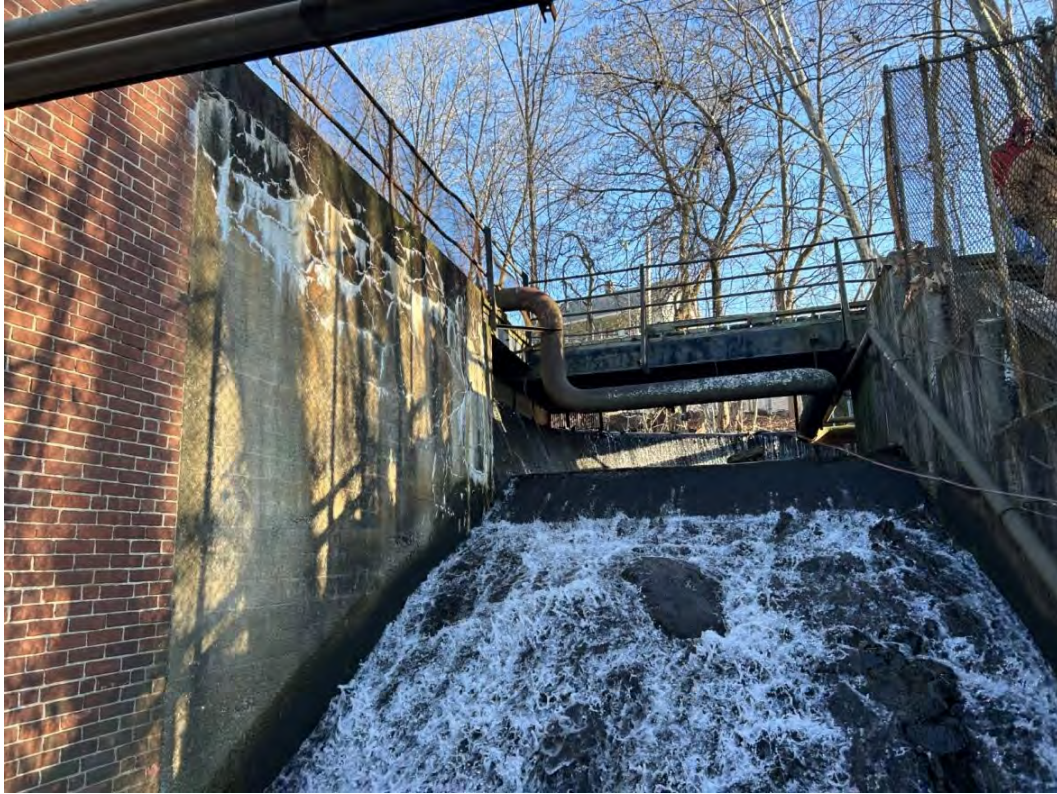
Photo 36. View Looking Up. Right Spillway at Ansonia Powerhouse

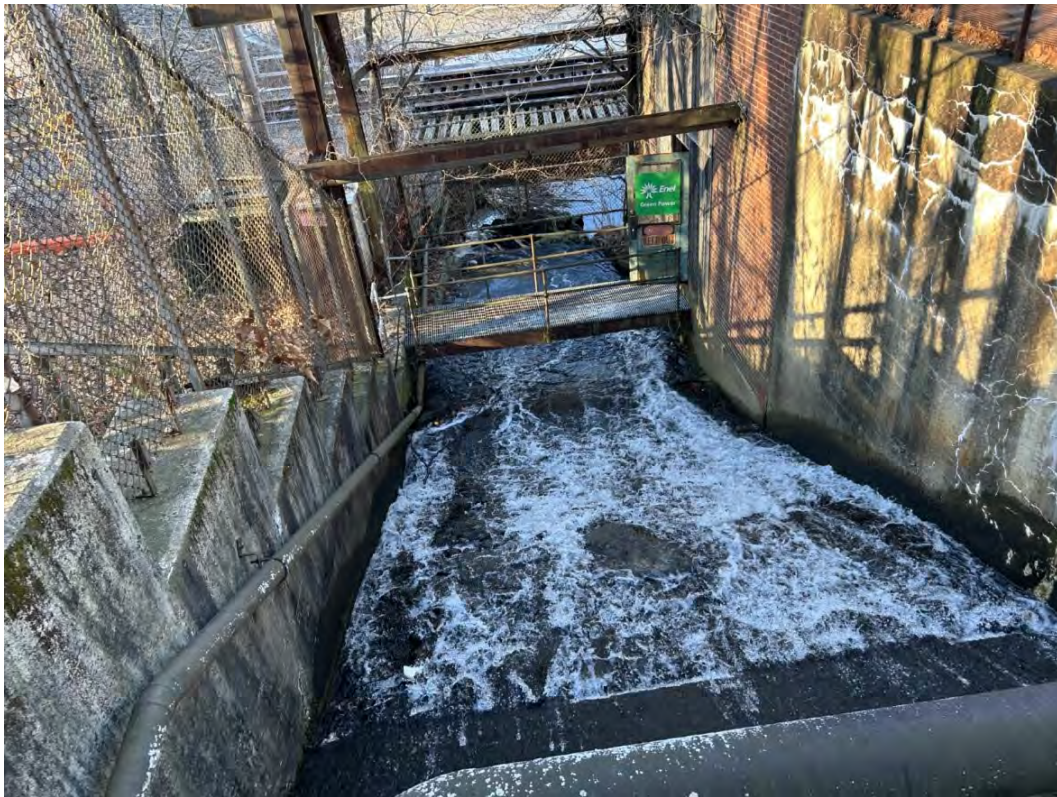
Photo 37. View Looking Down. Left Spillway at Ansonia Powerhouse

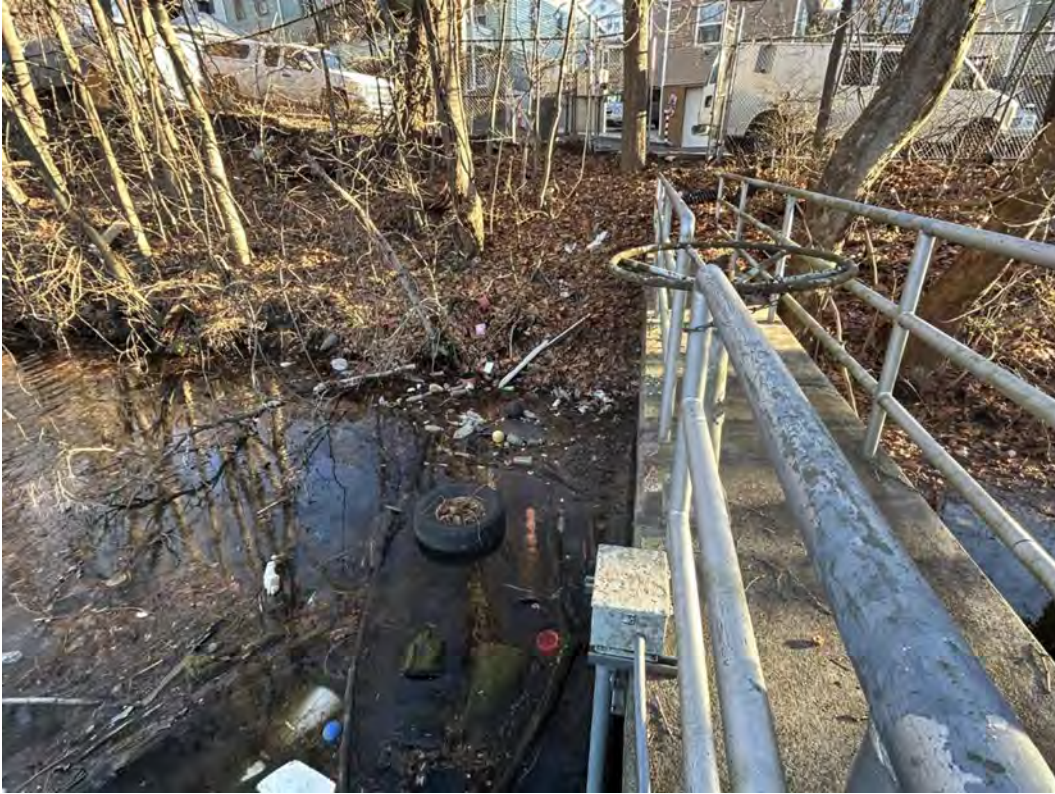
Access to the gatehouse is from South Main Street via an unpaved road, single lane. A chain-link fence with a padlocked gate restricts entry to the gatehouse to authorized personnel only. Access to the Ansonia Powerhouse is from North 4th Street where there is a gate and locked security fence leading to a set of wooden stairs extending down to the east side of the pond. A 3-foot-wide bridge spanning the Coe Pond provides access to the spillways, weirs, sluice gates and powerhouse (**Photo 38**). Personnel can access the earthen dam across the above mentioned 3-foot-wide pedestrian bridge.

Photo 38. View of Bridge from North 4th Street to Ansonia Unit

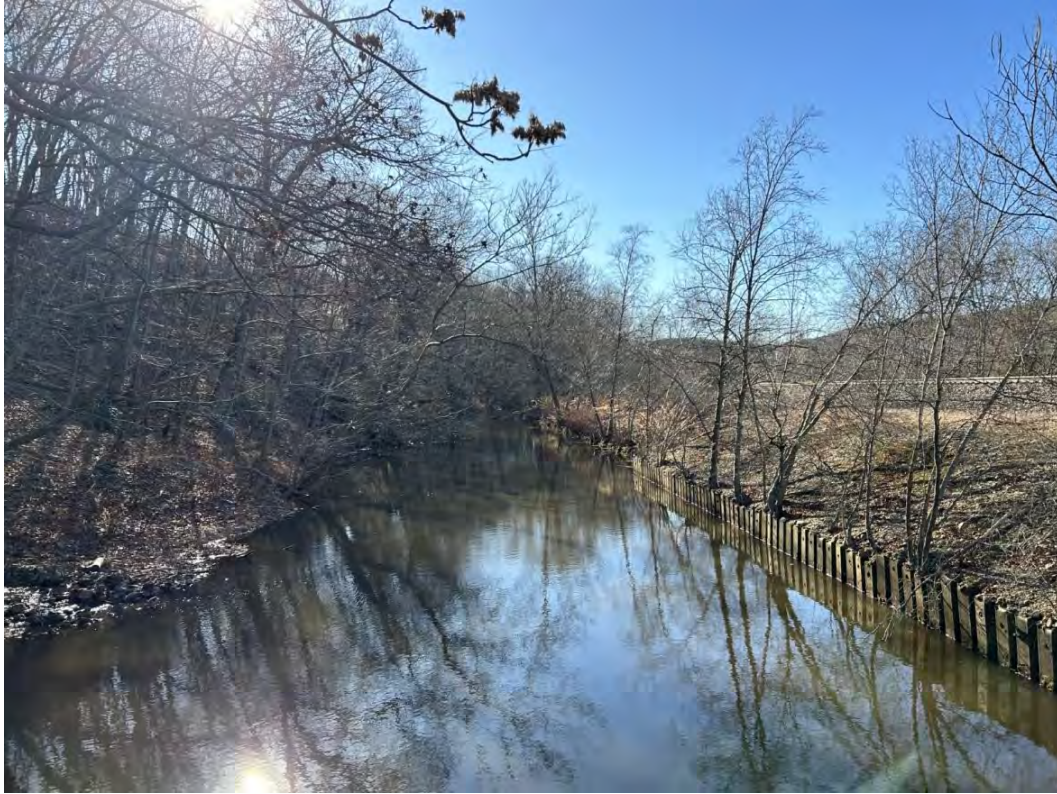
Near the gatehouse adjacent to the dam, the inboard slope consists of sheetpile bulkhead (**Photo 44**).

Photo 44. View of Power Canal. Looking Downstream from Gatehouse. Note Sheetpile Retaining Wall

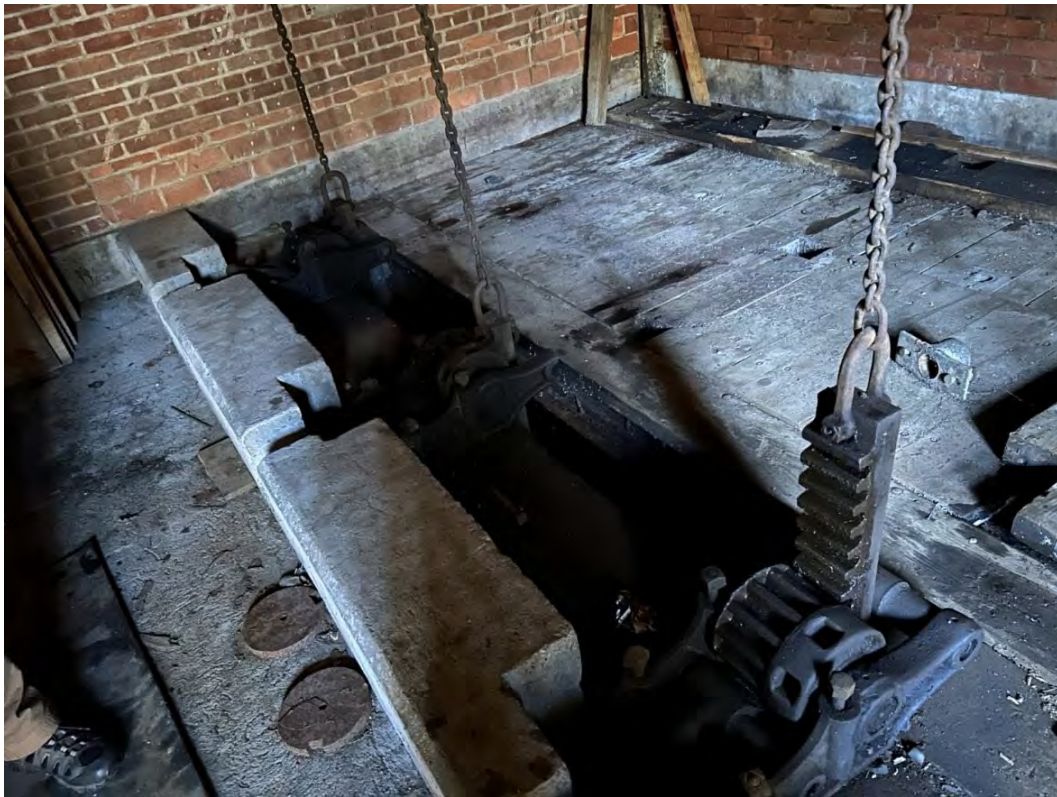
Photo 45. View of Gatehouse Interior
